## Profile/Photo Observation Report

Date:	<b>04/03/2018</b>	Weather:		Coding:	<b>PACP 6.0</b>
Pipe Length (ft):	<b>278.3</b>	Owner:	<b>NA</b>	Pre Clean:	<b>Not Known</b>
P.O.#:		Surveyor:	<b>Jen Costello</b>	PSR:	<b>P-103-014-013</b>
Customer:		Clean Date:	<b>01/01/1900</b>	Shape:	<b>C</b>

Location Details:		Direction of Survey:	<b>Upstream</b>
US MH:	<b>M-103-013</b>	DS MH:	<b>M-103-014</b>
		Total Length Surveyed (ft):	<b>7.7</b>

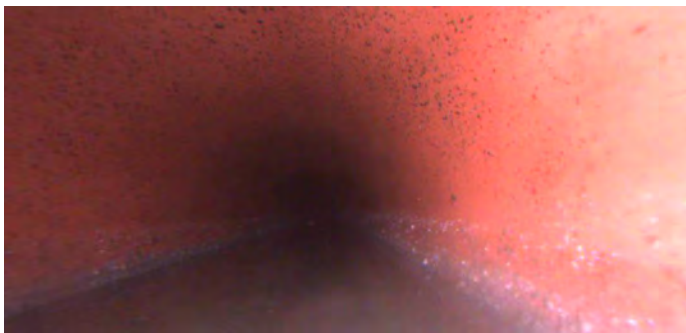
Code: **AMH**  
Description: **Manhole**

Distance (ft): **.0**  
Structural Grade: **0**  
O&M Grade: **0**  
Clock Start/From:  
Clock To:  
1st Value:  
2nd Value:  
Value Percent:  
Continuous Index:  
Within 8" of Joint: **NO**  
Remarks: **M-103-014**

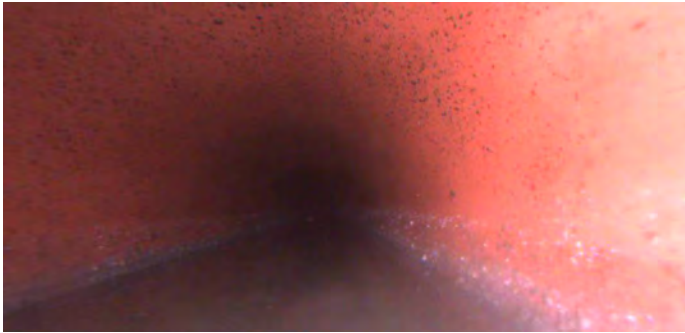
Code:	<b>MWL</b>
Description:	<b>Water Level</b>

Distance (ft):	<b>.0</b>
Structural Grade:	<b>0</b>
O&M Grade:	<b>0</b>
Clock Start/From:	
Clock To:	
1st Value:	
2nd Value:	
Value Percent:	<b>20.000</b>
Continuous Index:	
Within 8" of Joint:	<b>NO</b>
Remarks:

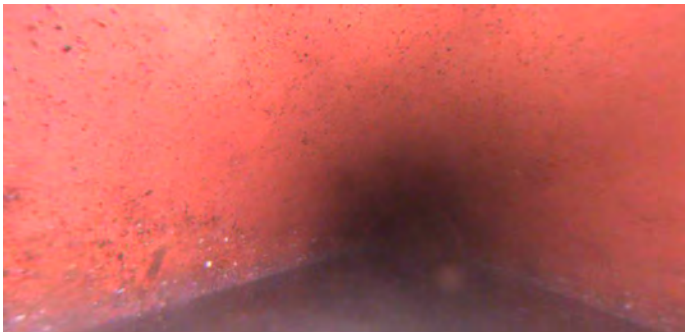
Code:	<b>MSA</b>
Description:	<b>Abandoned Survey</b>

Distance (ft):	<b>7.7</b>
Structural Grade:	<b>0</b>
O&M Grade:	<b>0</b>
Clock Start/From:	
Clock To:	
1st Value:	
2nd Value:	
Value Percent:	
Continuous Index:	
Within 8" of Joint:	<b>NO</b>
Remarks:	<b>debris under water</b>
