## Profile/Photo Observation Report

Street:	<b>34th av</b>	Flow Control:	<b>Not Controlled</b>
City:	<b>Hobart, IN</b>	Year Renewed:	
Location:	<b>Other</b>	Tape/Media #:	
Purpose:	<b>Not Known</b>	Dia/Height:	<b>10"</b>
Use:	<b>Sanitary</b>	Material:	<b>VCP</b>
Drain Area:	<b>NA</b>	Lining:	
Category:	<b>NA</b>		
Comment:

Location Details:		Direction of Survey:	<b>Upstream</b>
US MH:	<b>M-103-013</b>	DS MH:	<b>M-103-014</b>
		Total Length Surveyed (ft):	<b>7.7</b>

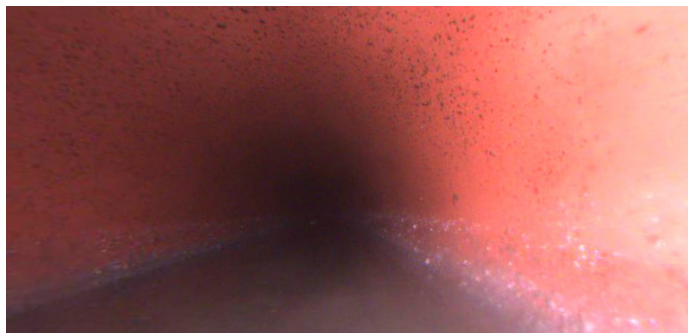
Code: **AMH**  
Description: **Manhole**

Distance (ft): **.0**  
Structural Grade: **0**  
O&M Grade: **0**  
Clock Start/From:  
Clock To:  
1st Value:  
2nd Value:  
Value Percent:  
Continuous Index:  
Within 8" of Joint: **NO**  
Remarks: **M-103-014**

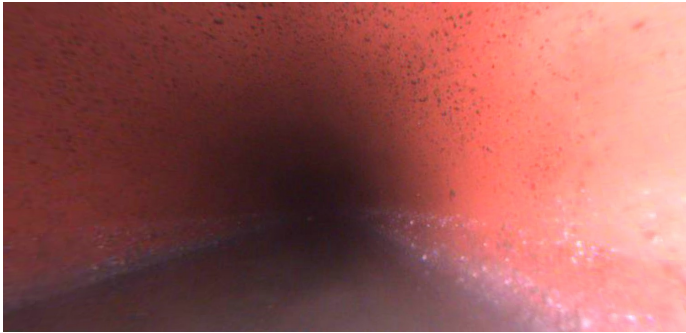
Code:	<b>MWL</b>
Description:	<b>Water Level</b>

Distance (ft):	<b>.0</b>
Structural Grade:	<b>0</b>
O&M Grade:	<b>0</b>
Clock Start/From:	
Clock To:	
1st Value:	
2nd Value:	
Value Percent:	<b>20.000</b>
Continuous Index:	
Within 8" of Joint:	<b>NO</b>
Remarks:

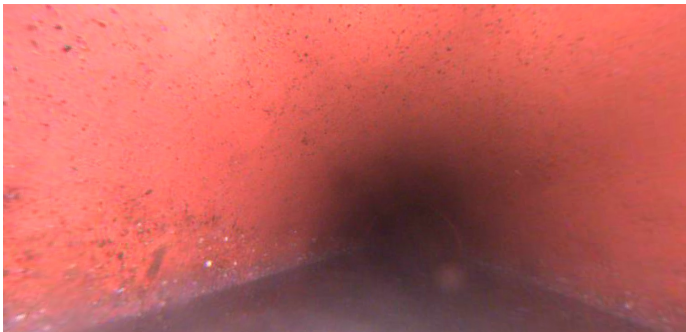
Code:	<b>MSA</b>
Description:	<b>Abandoned Survey</b>

Distance (ft):	<b>7.7</b>
Structural Grade:	<b>0</b>
O&M Grade:	<b>0</b>
Clock Start/From:	
Clock To:	
1st Value:	
2nd Value:	
Value Percent:	
Continuous Index:	
Within 8" of Joint:	<b>NO</b>
Remarks:	<b>debris under water</b>
