## Profile/Photo Observation Report

Street:	<b>I 65 N</b>	Flow Control:	<b>Not Controlled</b>
City:	<b>Hobart, IN</b>	Year Renewed:	
Location:	<b>Other</b>	Tape/Media #:	
Purpose:	<b>Not Known</b>	Dia/Height:	<b>10"</b>
Use:	<b>Sanitary</b>	Material:	<b>VCP</b>
Drain Area:	<b>NA</b>	Lining:	
Category:	<b>NA</b>		
Comment:

Location Details:		Direction of Survey:	<b>Downstream</b>
US MH:	<b>M-103-014</b>	DS MH:	<b>M-103-015</b>
		Total Length Surveyed (ft):	<b>281.8</b>

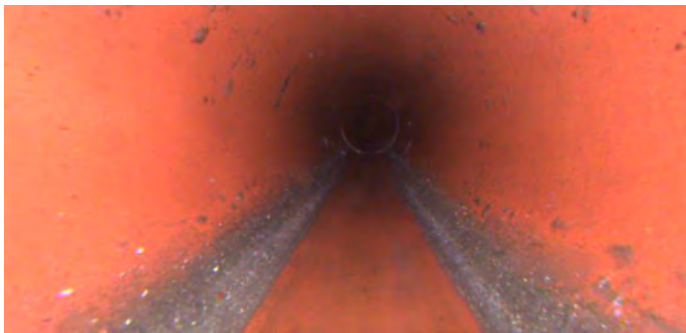
Code: **AMH**  
Description: **Manhole**

Distance (ft): **.0**  
Structural Grade: **0**  
O&M Grade: **0**  
Clock Start/From:  
Clock To:  
1st Value:  
2nd Value:  
Value Percent:  
Continuous Index:  
Within 8" of Joint: **NO**  
Remarks: **M-103-014**

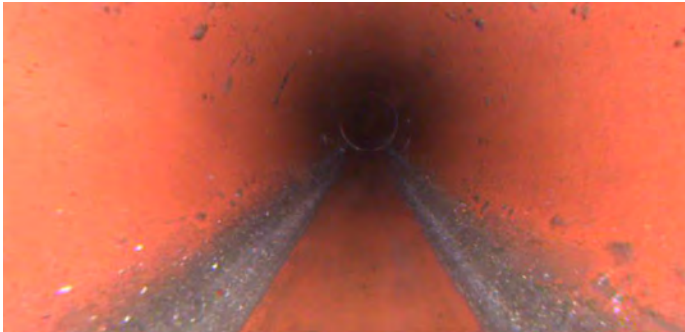
Code:	<b>MWL</b>
Description:	<b>Water Level</b>

Distance (ft):	<b>.0</b>
Structural Grade:	<b>0</b>
O&M Grade:	<b>0</b>
Clock Start/From:	
Clock To:	
1st Value:	
2nd Value:	
Value Percent:	<b>5.000</b>
Continuous Index:	
Within 8" of Joint:	<b>NO</b>
Remarks:

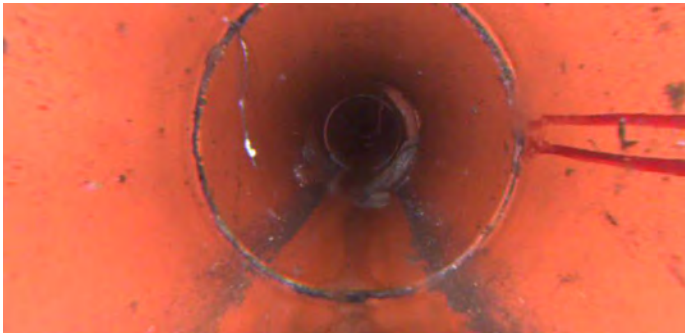
Code:	<b>RFJ</b>
Description:	<b>Roots Fine Joint</b>

Distance (ft):	<b>8.9</b>
Structural Grade:	<b>0</b>
O&M Grade:	<b>1</b>
Clock Start/From:	<b>10</b>
Clock To:	
1st Value:	
2nd Value:	
Value Percent:	
Continuous Index:	
Within 8" of Joint:	<b>YES</b>
Remarks:

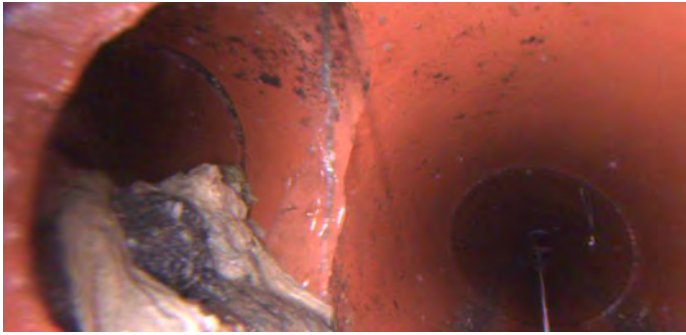
Code: **TFD**  
Description: **Tap Factory Defective**

Distance (ft): **10.9**  
Structural Grade: **0**  
O&M Grade: **2**  
Clock Start/From: **3**  
Clock To:  
1st Value: **4.000**  
2nd Value:  
Value Percent:  
Continuous Index:  
Within 8" of Joint:  
Remarks: **roots and dar**

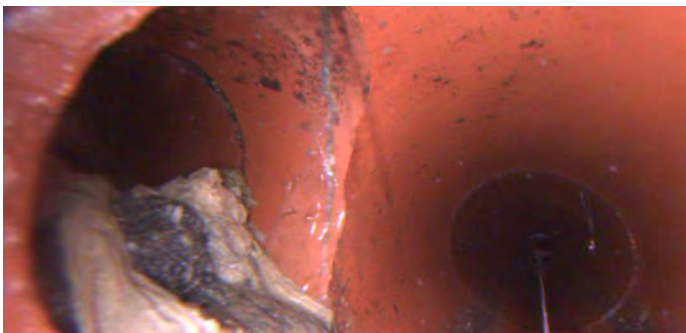
Code: **RFL**  
Description: **Roots Fine Lateral**

Distance (ft): **10.9**  
Structural Grade: **0**  
O&M Grade: **1**  
Clock Start/From: **1**  
Clock To:  
1st Value:  
2nd Value:  
Value Percent:  
Continuous Index:  
Within 8" of Joint: **NO**  
Remarks:

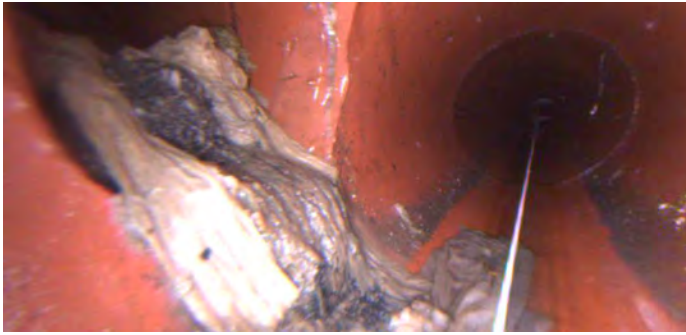
Code: **DAR**  
Description: **Deposits Attached Ragging**

Distance (ft): **10.9**  
Structural Grade: **0**  
O&M Grade: **2**  
Clock Start/From: **3**  
Clock To: **4**  
1st Value:  
2nd Value:  
Value Percent: **5.000**  
Continuous Index:  
Within 8" of Joint: **NO**  
Remarks:

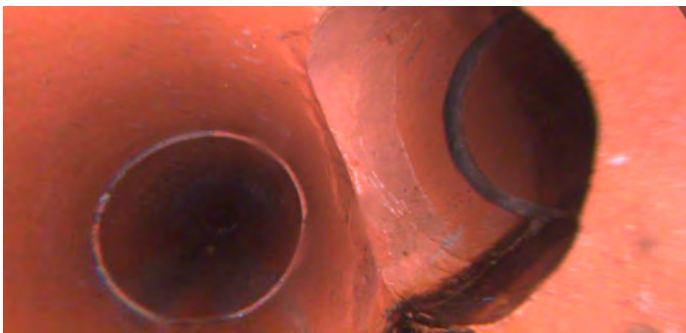
Code: **TF**  
Description: **Tap Factory**

Distance (ft): **66.4**  
Structural Grade: **0**  
O&M Grade: **0**  
Clock Start/From: **3**  
Clock To:  
1st Value: **4.000**  
2nd Value:  
Value Percent:  
Continuous Index:  
Within 8" of Joint:  
Remarks:

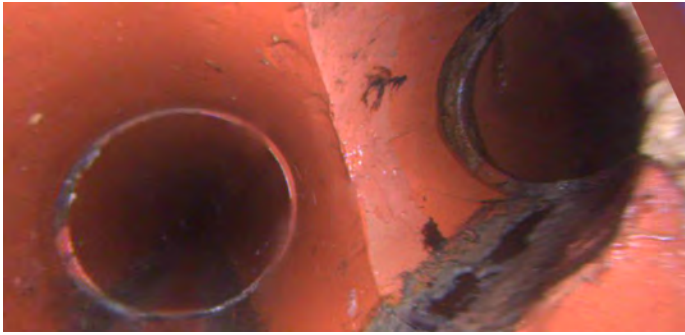
Code: **TFA**  
Description: **Tap Factory Active**

Distance (ft): **107.9**  
Structural Grade: **0**  
O&M Grade: **0**  
Clock Start/From: **3**  
Clock To:  
1st Value: **4.000**  
2nd Value:  
Value Percent:  
Continuous Index:  
Within 8" of Joint:  
Remarks:

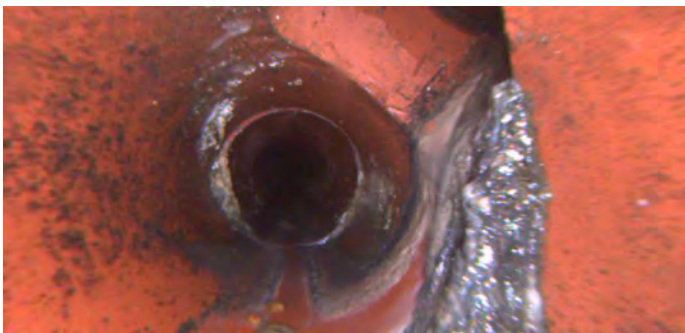
Code: **DAE**  
Description: **Deposits Attached Encrustation**

Distance (ft): **173.7**  
Structural Grade: **0**  
O&M Grade: **2**  
Clock Start/From: **1**  
Clock To: **4**  
1st Value:  
2nd Value:  
Value Percent: **10.000**  
Continuous Index:  
Within 8" of Joint: **NO**  
Remarks:

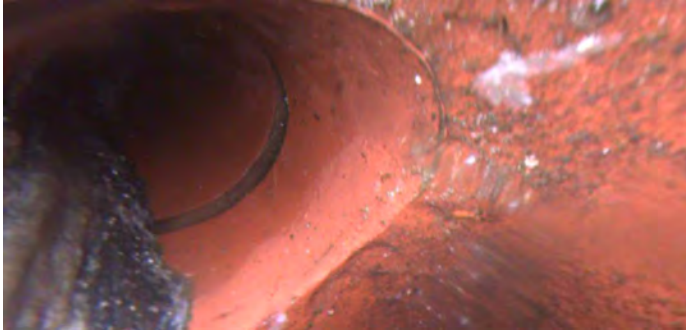
Code: **TFD**  
Description: **Tap Factory Defective**

Distance (ft): **174.4**  
Structural Grade: **0**  
O&M Grade: **2**  
Clock Start/From: **1**  
Clock To:  
1st Value: **4.000**  
2nd Value:  
Value Percent:  
Continuous Index:  
Within 8" of Joint:  
Remarks: **dae**

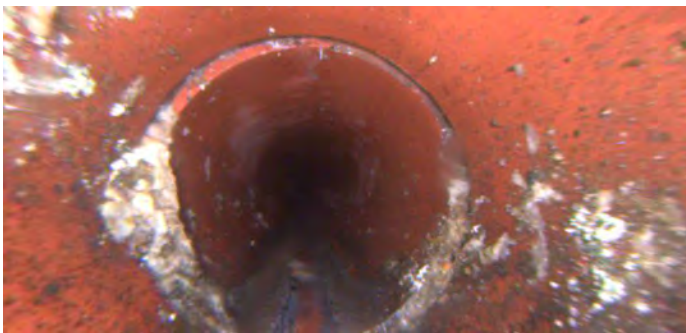
Code: **DAGS**  
Description: **Deposits Attached Grease**

Distance (ft): **174.5**  
Structural Grade: **0**  
O&M Grade: **2**  
Clock Start/From: **8**  
Clock To: **4**  
1st Value:  
2nd Value:  
Value Percent: **5.000**  
Continuous Index:  
Within 8" of Joint: **YES**  
Remarks:

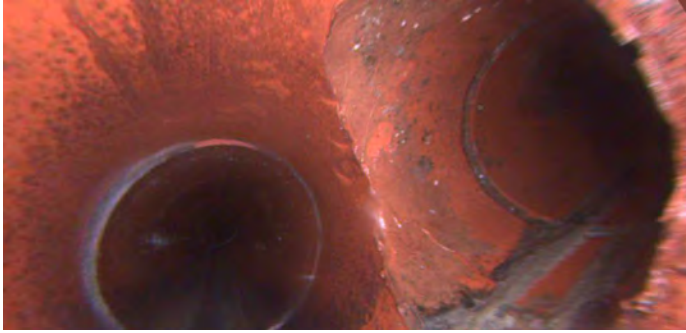
Code: **TF**  
Description: **Tap Factory**

Distance (ft): **210.5**  
Structural Grade: **0**  
O&M Grade: **0**  
Clock Start/From: **3**  
Clock To:  
1st Value: **4.000**  
2nd Value:  
Value Percent:  
Continuous Index:  
Within 8" of Joint:  
Remarks:

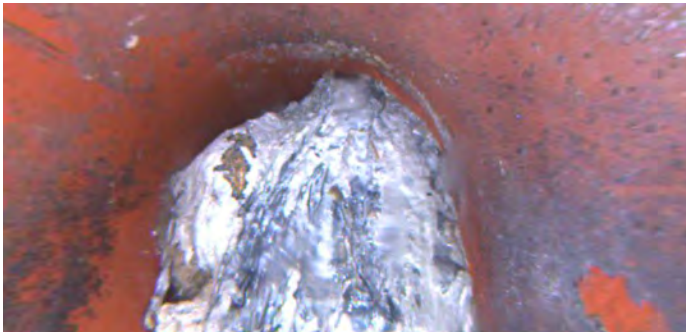
Code: **TFD**  
Description: **Tap Factory Defective**

Distance (ft): **281.0**  
Structural Grade: **0**  
O&M Grade: **2**  
Clock Start/From: **1**  
Clock To:  
1st Value: **4.000**  
2nd Value:  
Value Percent:  
Continuous Index:  
Within 8" of Joint:  
Remarks: **roots**

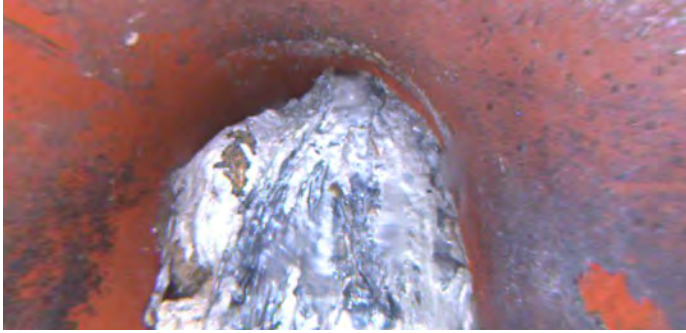
Code: **RBL**  
Description: **Roots Ball Lateral**

Distance (ft): **281.0**  
Structural Grade: **0**  
O&M Grade: **4**  
Clock Start/From: **12**  
Clock To: **12**  
1st Value:  
2nd Value:  
Value Percent: **90.000**  
Continuous Index:  
Within 8" of Joint: **NO**  
Remarks:
