Profile/Photo Observation Report

Date:	04/03/2018	Weather:		Coding:	PACP 6.0
Pipe Length (ft):	294.4	Owner:	NA	Pre Clean:	Not Known
P.O.#:		Surveyor:	Jen Costello	PSR:	P-103-015-014
Customer:		Clean Date:	01/01/1900	Shape:	C

Street:	34th av	Flow Control:	Not Controlled
City:	Hobart, IN	Year Renewed:	
Location:	Other	Tape/Media #:	
Purpose:	Not Known	Dia/Height:	10"
Use:	Sanitary	Material:	VCP
Drain Area:	NA	Lining:	
Category:	NA		
Comment:

Location Details:		Direction of Survey:	Downstream
US MH:	M-103-014	DS MH:	M-103-015
		Total Length Surveyed (ft):	281.8

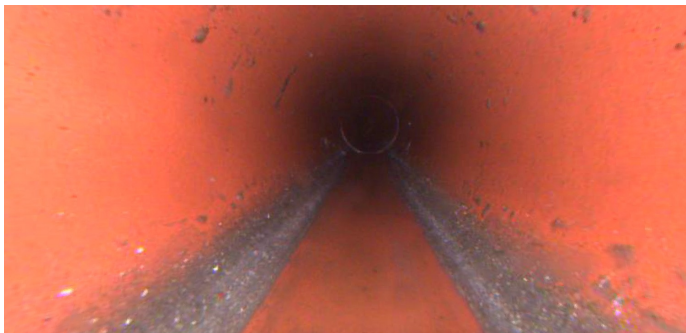
Code: **AMH**
Description: **Manhole**

Distance (ft): **.0**
Structural Grade: **0**
O&M Grade: **0**
Clock Start/From:
Clock To:
1st Value:
2nd Value:
Value Percent:
Continuous Index:
Within 8" of Joint: **NO**
Remarks: **M-103-014**

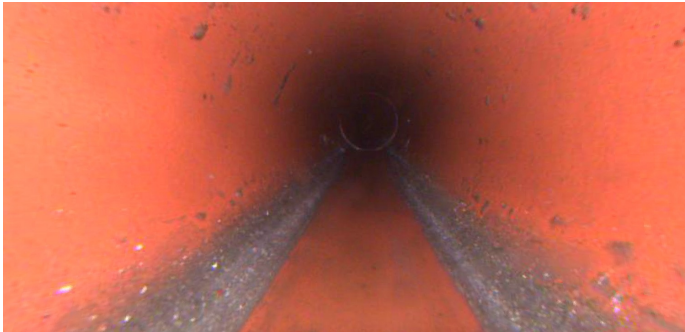
Code:	MWL
Description:	Water Level

Distance (ft):	.0
Structural Grade:	0
O&M Grade:	0
Clock Start/From:	
Clock To:	
1st Value:	
2nd Value:	
Value Percent:	5.000
Continuous Index:	
Within 8" of Joint:	NO
Remarks:

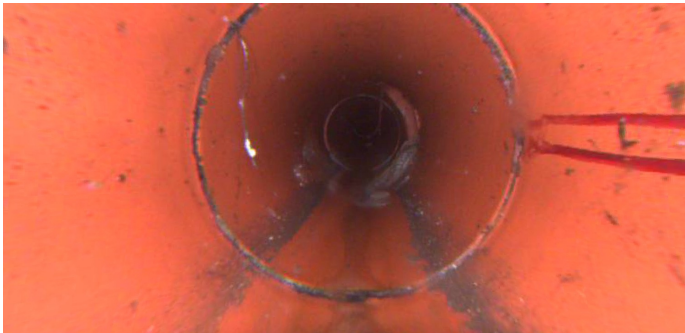
Code:	RFJ
Description:	Roots Fine Joint

Distance (ft):	8.9
Structural Grade:	0
O&M Grade:	1
Clock Start/From:	10
Clock To:	
1st Value:	
2nd Value:	
Value Percent:	
Continuous Index:	
Within 8" of Joint:	YES
Remarks:

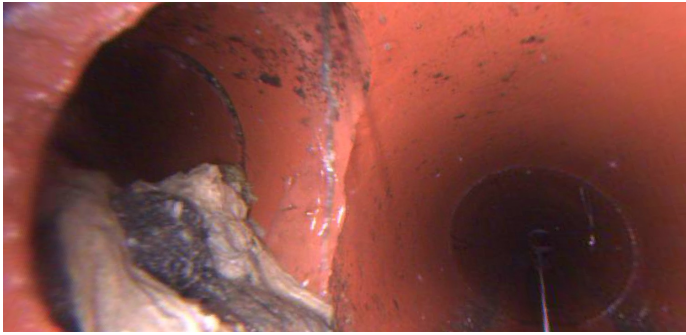
Code: **TFD**
Description: **Tap Factory Defective**

Distance (ft): **10.9**
Structural Grade: **0**
O&M Grade: **2**
Clock Start/From: **3**
Clock To:
1st Value: **4.000**
2nd Value:
Value Percent:
Continuous Index:
Within 8" of Joint:
Remarks: **roots and dar**

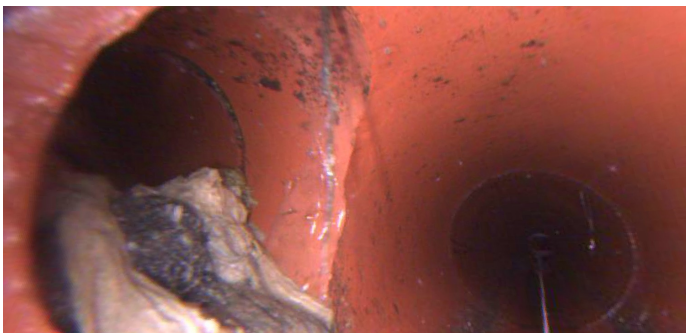
Code: **RFL**
Description: **Roots Fine Lateral**

Distance (ft): **10.9**
Structural Grade: **0**
O&M Grade: **1**
Clock Start/From: **1**
Clock To:
1st Value:
2nd Value:
Value Percent:
Continuous Index:
Within 8" of Joint: **NO**
Remarks:

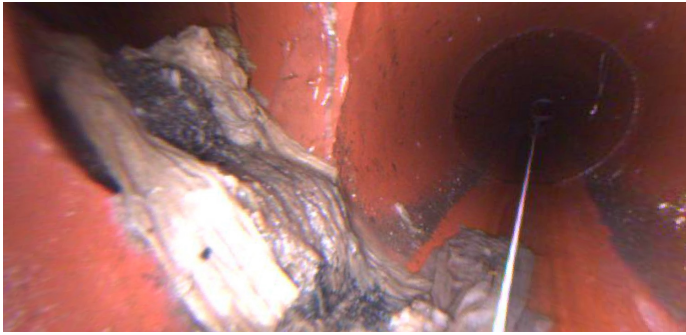
Code: **DAR**
Description: **Deposits Attached Ragging**

Distance (ft): **10.9**
Structural Grade: **0**
O&M Grade: **2**
Clock Start/From: **3**
Clock To: **4**
1st Value:
2nd Value:
Value Percent: **5.000**
Continuous Index:
Within 8" of Joint: **NO**
Remarks:

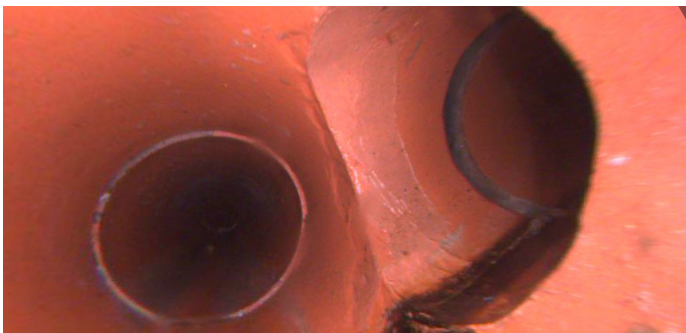
Code: **TF**
Description: **Tap Factory**

Distance (ft): **66.4**
Structural Grade: **0**
O&M Grade: **0**
Clock Start/From: **3**
Clock To:
1st Value: **4.000**
2nd Value:
Value Percent:
Continuous Index:
Within 8" of Joint:
Remarks:

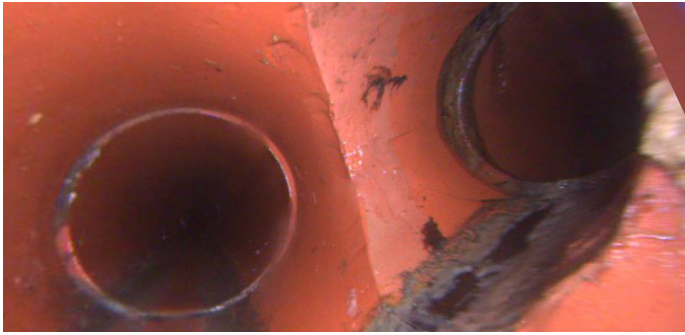
Code: **TFA**
Description: **Tap Factory Active**

Distance (ft): **107.9**
Structural Grade: **0**
O&M Grade: **0**
Clock Start/From: **3**
Clock To:
1st Value: **4.000**
2nd Value:
Value Percent:
Continuous Index:
Within 8" of Joint:
Remarks:

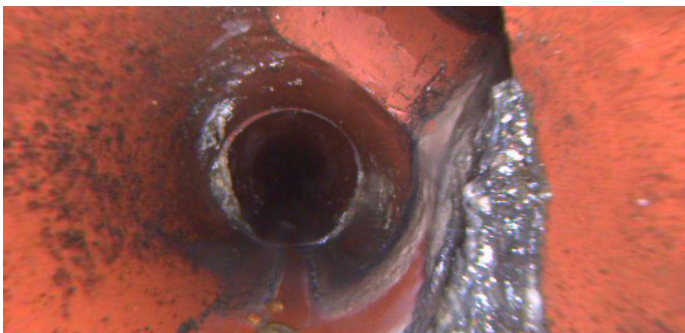
Code: **DAE**
Description: **Deposits Attached Encrustation**

Distance (ft): **173.7**
Structural Grade: **0**
O&M Grade: **2**
Clock Start/From: **1**
Clock To: **4**
1st Value:
2nd Value:
Value Percent: **10.000**
Continuous Index:
Within 8" of Joint: **NO**
Remarks:

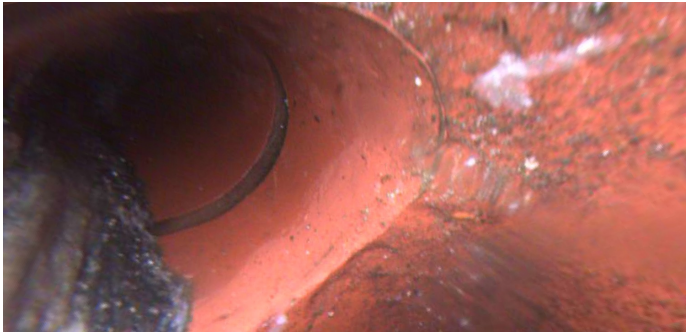
Code: **TFD**
Description: **Tap Factory Defective**

Distance (ft): **174.4**
Structural Grade: **0**
O&M Grade: **2**
Clock Start/From: **1**
Clock To:
1st Value: **4.000**
2nd Value:
Value Percent:
Continuous Index:
Within 8" of Joint:
Remarks: **dae**

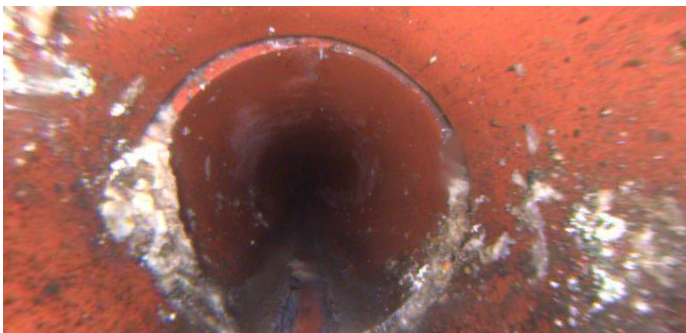
Code: **DAGS**
Description: **Deposits Attached Grease**

Distance (ft): **174.5**
Structural Grade: **0**
O&M Grade: **2**
Clock Start/From: **8**
Clock To: **4**
1st Value:
2nd Value:
Value Percent: **5.000**
Continuous Index:
Within 8" of Joint: **YES**
Remarks:

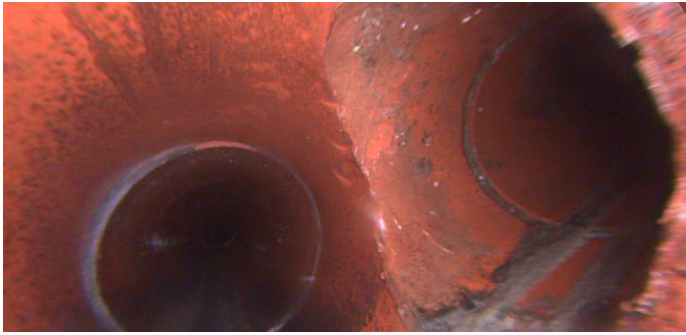
Code: **TF**
Description: **Tap Factory**

Distance (ft): **210.5**
Structural Grade: **0**
O&M Grade: **0**
Clock Start/From: **3**
Clock To:
1st Value: **4.000**
2nd Value:
Value Percent:
Continuous Index:
Within 8" of Joint:
Remarks:

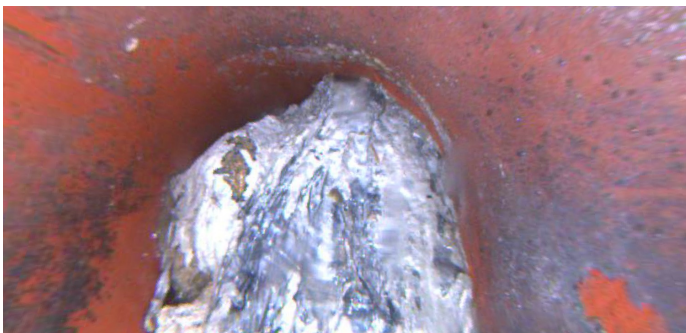
Code: **TFD**
Description: **Tap Factory Defective**

Distance (ft): **281.0**
Structural Grade: **0**
O&M Grade: **2**
Clock Start/From: **1**
Clock To:
1st Value: **4.000**
2nd Value:
Value Percent:
Continuous Index:
Within 8" of Joint:
Remarks: **roots**

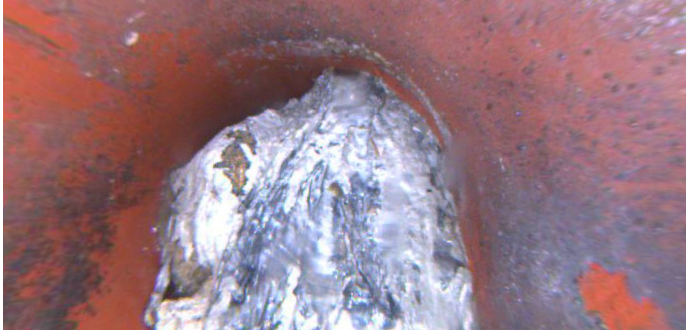
Code: **RBL**
Description: **Roots Ball Lateral**

Distance (ft): **281.0**
Structural Grade: **0**
O&M Grade: **4**
Clock Start/From: **12**
Clock To: **12**
1st Value:
2nd Value:
Value Percent: **90.000**
Continuous Index:
Within 8" of Joint: **NO**
Remarks:
