Profile/Photo Observation Report

Street:	I 65 N	Flow Control:	Not Controlled
City:	Hobart, IN	Year Renewed:	
Location:	Light Highway	Tape/Media #:	
Purpose:	Routine Assessment	Dia/Height:	8"
Use:	Sanitary	Material:	VCP
Drain Area:	NA	Lining:	
Category:	NA		
Comment:

Location Details:		Direction of Survey:	Upstream
US MH:	M-103-017	DS MH:	M-103-016
		Total Length Surveyed (ft):	199.7

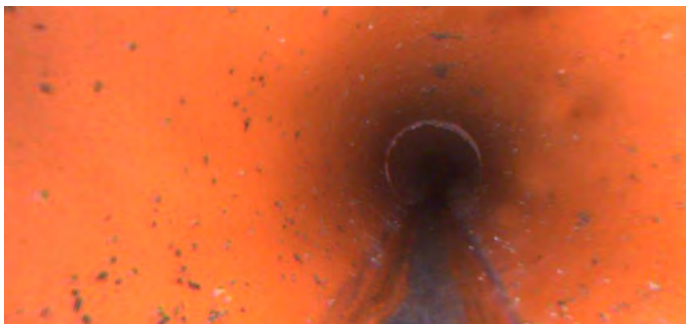
Code: **AMH**
Description: **Manhole**

Distance (ft): **.0**
Structural Grade: **0**
O&M Grade: **0**
Clock Start/From:
Clock To:
1st Value:
2nd Value:
Value Percent:
Continuous Index:
Within 8" of Joint: **NO**
Remarks: **M-103-016**

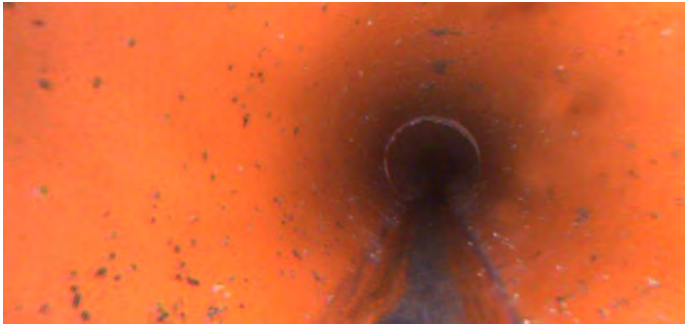
Code:	MWL
Description:	Water Level

Distance (ft):	.0
Structural Grade:	0
O&M Grade:	0
Clock Start/From:	
Clock To:	
1st Value:	
2nd Value:	
Value Percent:	5.000
Continuous Index:	
Within 8" of Joint:	NO
Remarks:

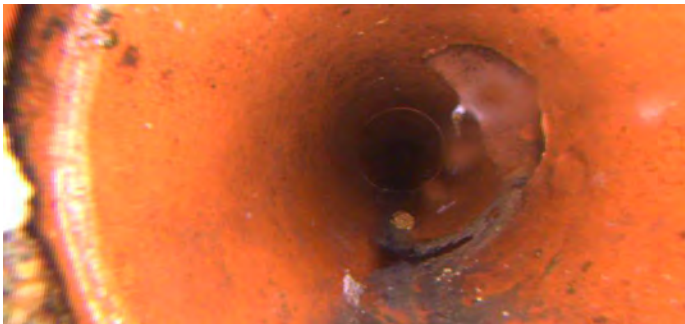
Code:	TF
Description:	Tap Factory

Distance (ft):	42.7
Structural Grade:	0
O&M Grade:	0
Clock Start/From:	2
Clock To:	
1st Value:	4.000
2nd Value:	
Value Percent:	
Continuous Index:	
Within 8" of Joint:	
Remarks:

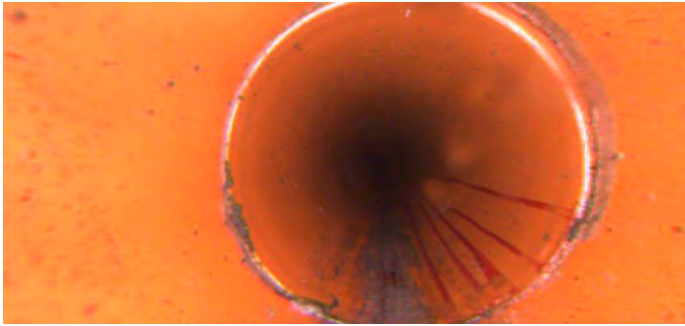
Code: **RFJ**
Description: **Roots Fine Joint**

Distance (ft): **54.2**
Structural Grade: **0**
O&M Grade: **1**
Clock Start/From: **7**
Clock To: **5**
1st Value:
2nd Value:
Value Percent:
Continuous Index:
Within 8" of Joint: **YES**
Remarks:

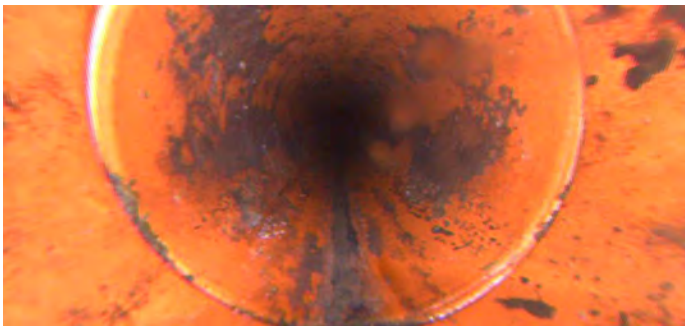
Code: **RFJ**
Description: **Roots Fine Joint**

Distance (ft): **79.2**
Structural Grade: **0**
O&M Grade: **1**
Clock Start/From: **8**
Clock To:
1st Value:
2nd Value:
Value Percent:
Continuous Index:
Within 8" of Joint: **YES**
Remarks:

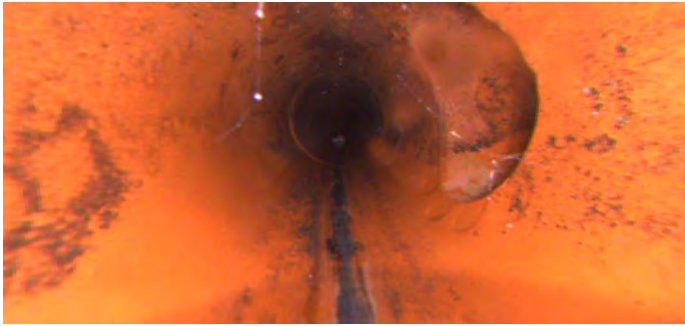
Code: **TF**
Description: **Tap Factory**

Distance (ft): **114.3**
Structural Grade: **0**
O&M Grade: **0**
Clock Start/From: **3**
Clock To:
1st Value: **4.000**
2nd Value:
Value Percent:
Continuous Index:
Within 8" of Joint:
Remarks:

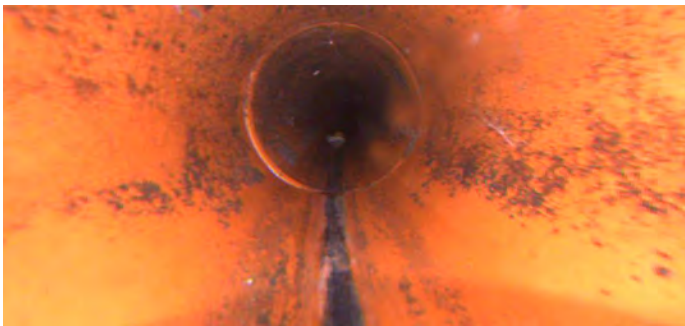
Code: **RFJ**
Description: **Roots Fine Joint**

Distance (ft): **115.2**
Structural Grade: **0**
O&M Grade: **1**
Clock Start/From: **4**
Clock To:
1st Value:
2nd Value:
Value Percent:
Continuous Index:
Within 8" of Joint: **YES**
Remarks:

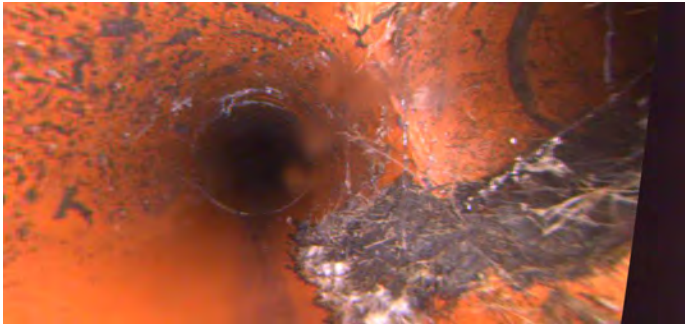
Code: **TFD**
Description: **Tap Factory Defective**

Distance (ft): **121.6**
Structural Grade: **0**
O&M Grade: **2**
Clock Start/From: **3**
Clock To:
1st Value: **4.000**
2nd Value:
Value Percent:
Continuous Index:
Within 8" of Joint:
Remarks: **root infiltration**

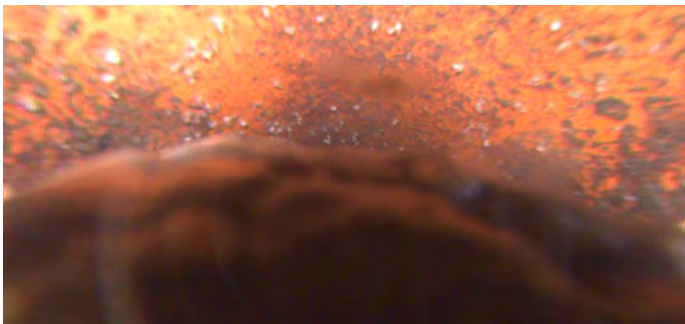
Code: **MWLS**
Description: **Water Level Sag**

Distance (ft): **168.6**
Structural Grade: **3**
O&M Grade: **3**
Clock Start/From:
Clock To:
1st Value:
2nd Value:
Value Percent: **40.000**
Continuous Index: **S01**
Within 8" of Joint: **NO**
Remarks:

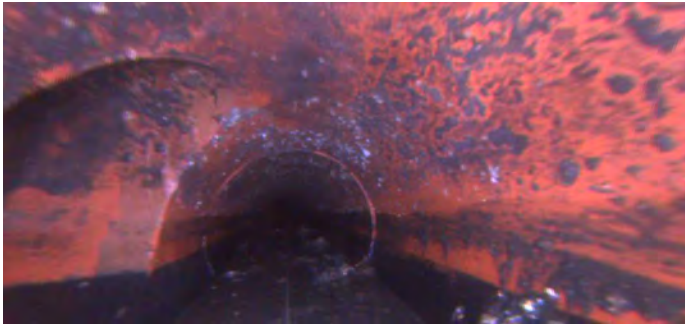
Code: **TF**
Description: **Tap Factory**

Distance (ft): **188.9**
Structural Grade: **0**
O&M Grade: **0**
Clock Start/From: **9**
Clock To:
1st Value: **4.000**
2nd Value:
Value Percent:
Continuous Index:
Within 8" of Joint:
Remarks:
