## Profile/Photo Observation Report

Street:	<b>Willow St.</b>	Flow Control:	<b>Not Controlled</b>
City:	<b>Hobart, IN</b>	Year Renewed:	
Location:	<b>Light Highway</b>	Tape/Media #:	
Purpose:	<b>Routine Assessment</b>	Dia/Height:	<b>8"</b>
Use:	<b>Sanitary</b>	Material:	<b>VCP</b>
Drain Area:	<b>NA</b>	Lining:	
Category:	<b>NA</b>		
Comment:

Location Details:		Direction of Survey:	<b>Upstream</b>
US MH:	<b>M-103-017</b>	DS MH:	<b>M-103-016</b>
		Total Length Surveyed (ft):	<b>199.7</b>

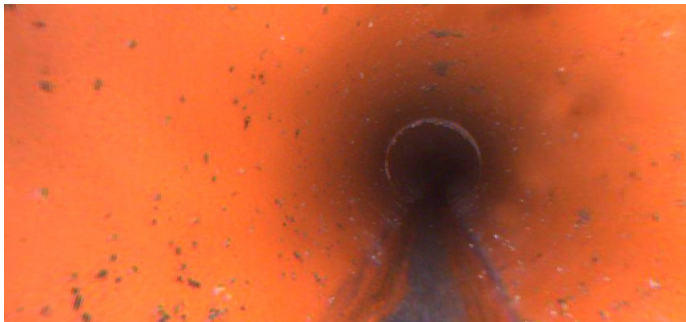
Code: **AMH**  
Description: **Manhole**

Distance (ft): **.0**  
Structural Grade: **0**  
O&M Grade: **0**  
Clock Start/From:  
Clock To:  
1st Value:  
2nd Value:  
Value Percent:  
Continuous Index:  
Within 8" of Joint: **NO**  
Remarks: **M-103-016**

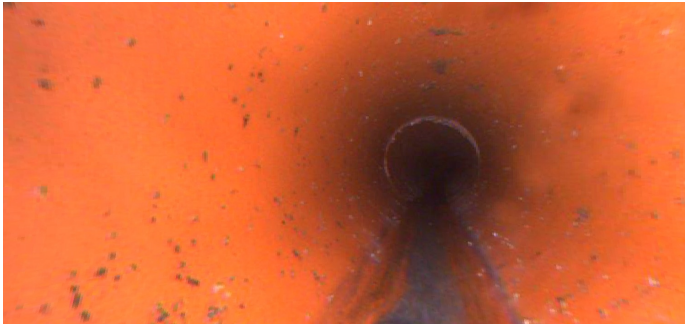
Code:	<b>MWL</b>
Description:	<b>Water Level</b>

Distance (ft):	<b>.0</b>
Structural Grade:	<b>0</b>
O&M Grade:	<b>0</b>
Clock Start/From:	
Clock To:	
1st Value:	
2nd Value:	
Value Percent:	<b>5.000</b>
Continuous Index:	
Within 8" of Joint:	<b>NO</b>
Remarks:

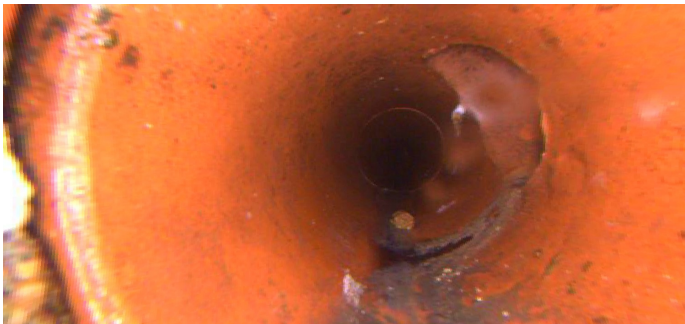
Code:	<b>TF</b>
Description:	<b>Tap Factory</b>

Distance (ft):	<b>42.7</b>
Structural Grade:	<b>0</b>
O&M Grade:	<b>0</b>
Clock Start/From:	<b>2</b>
Clock To:	
1st Value:	<b>4.000</b>
2nd Value:	
Value Percent:	
Continuous Index:	
Within 8" of Joint:	
Remarks:

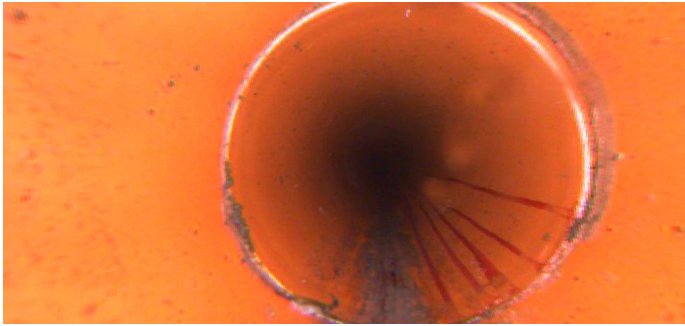
Code: **RFJ**  
Description: **Roots Fine Joint**

Distance (ft): **54.2**  
Structural Grade: **0**  
O&M Grade: **1**  
Clock Start/From: **7**  
Clock To: **5**  
1st Value:  
2nd Value:  
Value Percent:  
Continuous Index:  
Within 8" of Joint: **YES**  
Remarks:

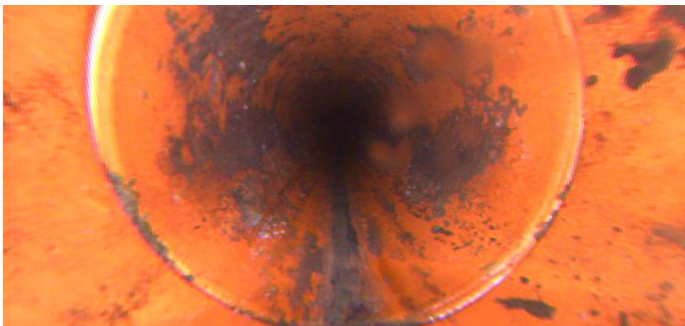
Code: **RFJ**  
Description: **Roots Fine Joint**

Distance (ft): **79.2**  
Structural Grade: **0**  
O&M Grade: **1**  
Clock Start/From: **8**  
Clock To:  
1st Value:  
2nd Value:  
Value Percent:  
Continuous Index:  
Within 8" of Joint: **YES**  
Remarks:

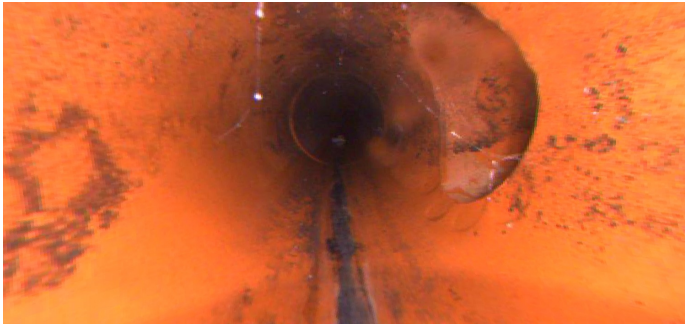
Code: **TF**  
Description: **Tap Factory**

Distance (ft): **114.3**  
Structural Grade: **0**  
O&M Grade: **0**  
Clock Start/From: **3**  
Clock To:  
1st Value: **4.000**  
2nd Value:  
Value Percent:  
Continuous Index:  
Within 8" of Joint:  
Remarks:

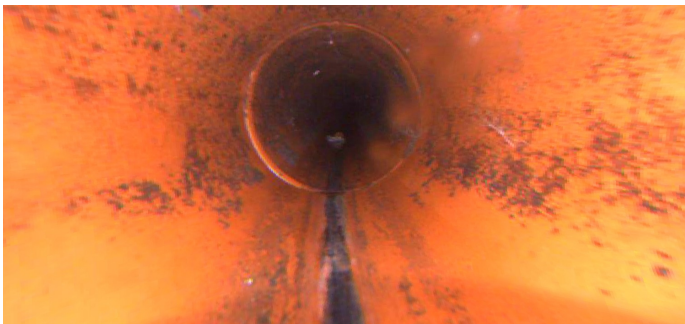
Code: **RFJ**  
Description: **Roots Fine Joint**

Distance (ft): **115.2**  
Structural Grade: **0**  
O&M Grade: **1**  
Clock Start/From: **4**  
Clock To:  
1st Value:  
2nd Value:  
Value Percent:  
Continuous Index:  
Within 8" of Joint: **YES**  
Remarks:

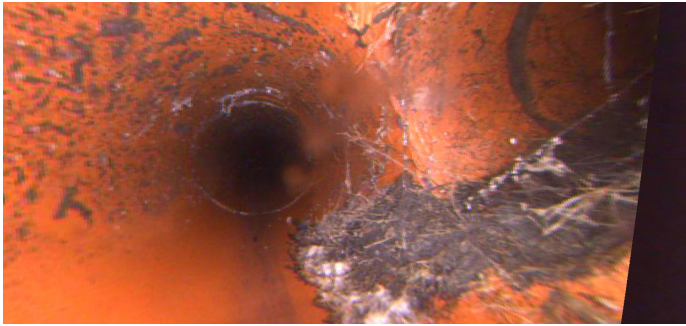
Code: **TFD**  
Description: **Tap Factory Defective**

Distance (ft): **121.6**  
Structural Grade: **0**  
O&M Grade: **2**  
Clock Start/From: **3**  
Clock To:  
1st Value: **4.000**  
2nd Value:  
Value Percent:  
Continuous Index:  
Within 8" of Joint:  
Remarks: **root infiltration**

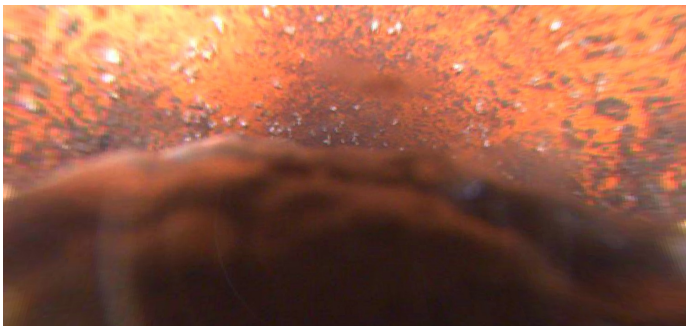
Code: **MWLS**  
Description: **Water Level Sag**

Distance (ft): **168.6**  
Structural Grade: **3**  
O&M Grade: **3**  
Clock Start/From:  
Clock To:  
1st Value:  
2nd Value:  
Value Percent: **40.000**  
Continuous Index: **S01**  
Within 8" of Joint: **NO**  
Remarks:

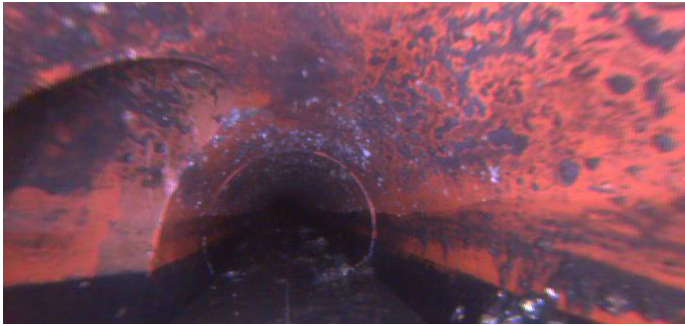
Code: **TF**  
Description: **Tap Factory**

Distance (ft): **188.9**  
Structural Grade: **0**  
O&M Grade: **0**  
Clock Start/From: **9**  
Clock To:  
1st Value: **4.000**  
2nd Value:  
Value Percent:  
Continuous Index:  
Within 8" of Joint:  
Remarks:
