Profile/Photo Observation Report

Street:	Willow St.	Flow Control:	Not Controlled
City:	Hobart, IN	Year Renewed:	
Location:	Light Highway	Tape/Media #:	
Purpose:	Routine Assessment	Dia/Height:	8"
Use:	Sanitary	Material:	VCP
Drain Area:	NA	Lining:	
Category:	NA		
Comment:

Location Details:		Direction of Survey:	Downstream
US MH:	M-103-017	DS MH:	M-103-016
		Total Length Surveyed (ft):	169.2

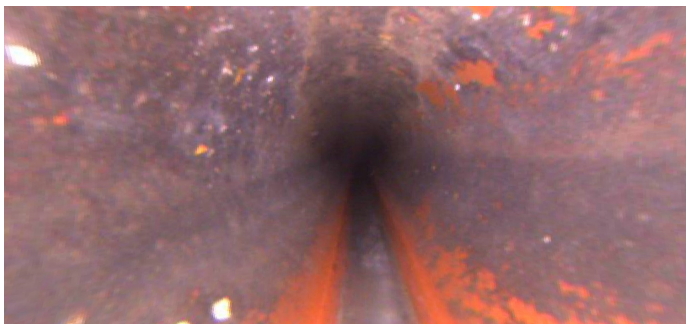
Code: **AMH**
Description: **Manhole**

Distance (ft): **.0**
Structural Grade: **0**
O&M Grade: **0**
Clock Start/From:
Clock To:
1st Value:
2nd Value:
Value Percent:
Continuous Index:
Within 8" of Joint: **NO**
Remarks: **M-103-017**

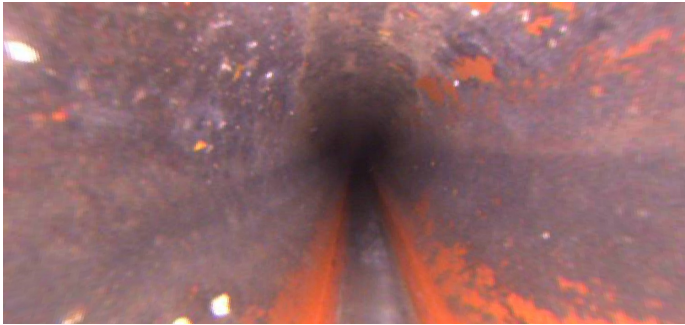
Code:	MWL
Description:	Water Level

Distance (ft):	.0
Structural Grade:	0
O&M Grade:	0
Clock Start/From:	
Clock To:	
1st Value:	
2nd Value:	
Value Percent:	5.000
Continuous Index:	
Within 8" of Joint:	NO
Remarks:

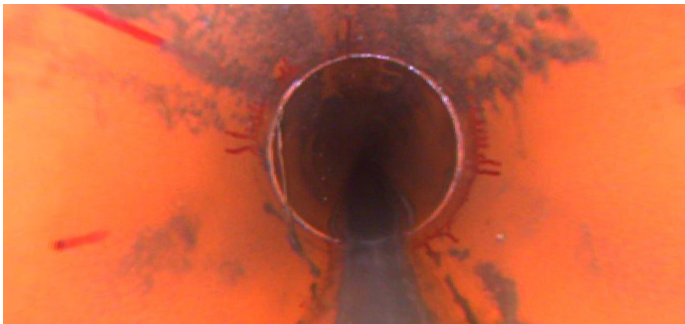
Code:	RFJ
Description:	Roots Fine Joint

Distance (ft):	61.9
Structural Grade:	0
O&M Grade:	1
Clock Start/From:	7
Clock To:	5
1st Value:	
2nd Value:	
Value Percent:	
Continuous Index:	
Within 8" of Joint:	YES
Remarks:

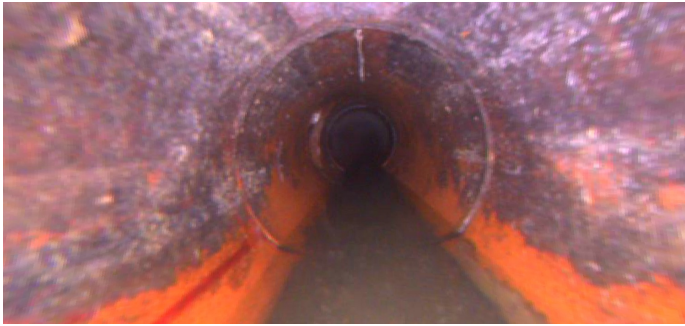
Code: **RFJ**
Description: **Roots Fine Joint**

Distance (ft): **136.9**
Structural Grade: **0**
O&M Grade: **1**
Clock Start/From: **12**
Clock To:
1st Value:
2nd Value:
Value Percent:
Continuous Index:
Within 8" of Joint: **YES**
Remarks:

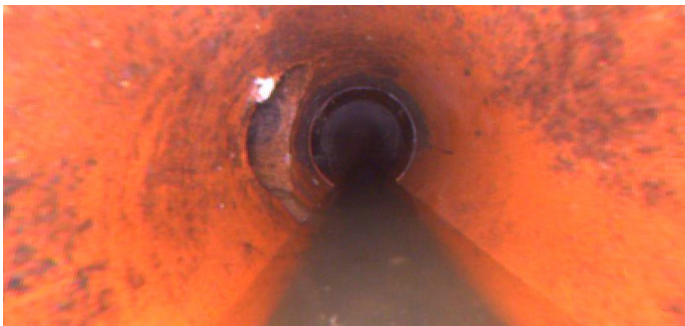
Code: **TF**
Description: **Tap Factory**

Distance (ft): **137.8**
Structural Grade: **0**
O&M Grade: **0**
Clock Start/From: **9**
Clock To:
1st Value: **4.000**
2nd Value:
Value Percent:
Continuous Index:
Within 8" of Joint:
Remarks:

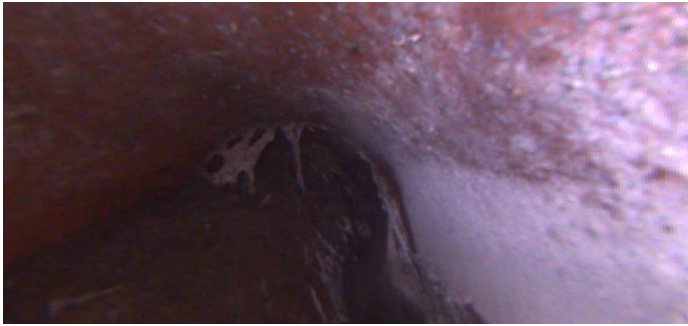
Code:	MSA
Description:	Abandoned Survey
Distance (ft):	169.2
Structural Grade:	0
O&M Grade:	0
Clock Start/From:	
Clock To:	
1st Value:	
2nd Value:	
Value Percent:	
Continuous Index:	
Within 8" of Joint:	NO
Remarks:	root infiltration
