Profile/Photo Observation Report

Street:	WILLOW ST	Flow Control:	Not Controlled
City:	Hobart, IN	Year Renewed:	
Location:	Other	Tape/Media #:	
Purpose:	Not Known	Dia/Height:	10"
Use:	Sanitary	Material:	VCP
Drain Area:	NA	Lining:	
Category:	NA		
Comment:

Location Details:		Direction of Survey:	Downstream
US MH:	M-103-018	DS MH:	M-103-017
		Total Length Surveyed (ft):	19.0

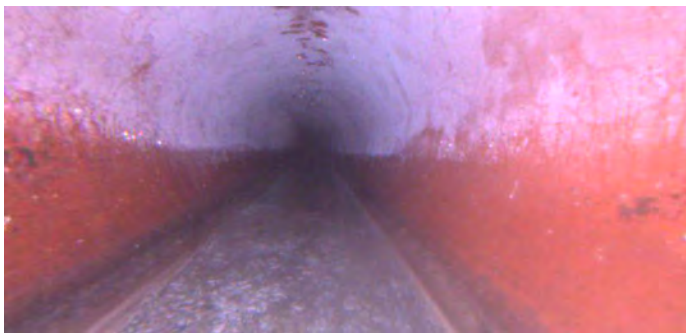
Code: **AMH**
Description: **Manhole**

Distance (ft): **.0**
Structural Grade: **0**
O&M Grade: **0**
Clock Start/From:
Clock To:
1st Value:
2nd Value:
Value Percent:
Continuous Index:
Within 8" of Joint: **NO**
Remarks: **M-103-018**

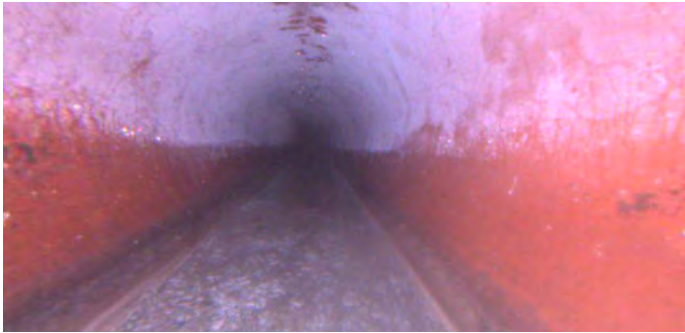
Code:	MWL
Description:	Water Level

Distance (ft):	.0
Structural Grade:	0
O&M Grade:	0
Clock Start/From:	
Clock To:	
1st Value:	
2nd Value:	
Value Percent:	10.000
Continuous Index:	
Within 8" of Joint:	NO
Remarks:

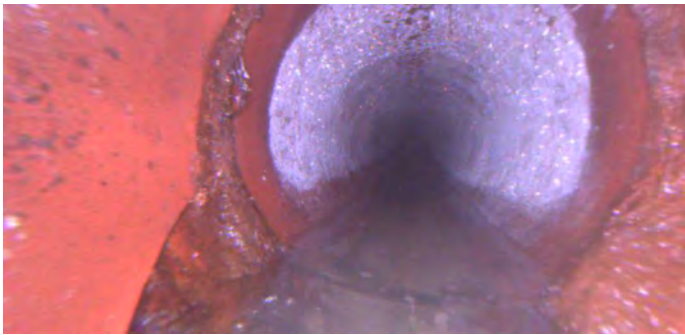
Code:	FS
Description:	Fracture Spiral

Distance (ft):	9.3
Structural Grade:	3
O&M Grade:	0
Clock Start/From:	7
Clock To:	9
1st Value:	
2nd Value:	
Value Percent:	
Continuous Index:	
Within 8" of Joint:	YES
Remarks:

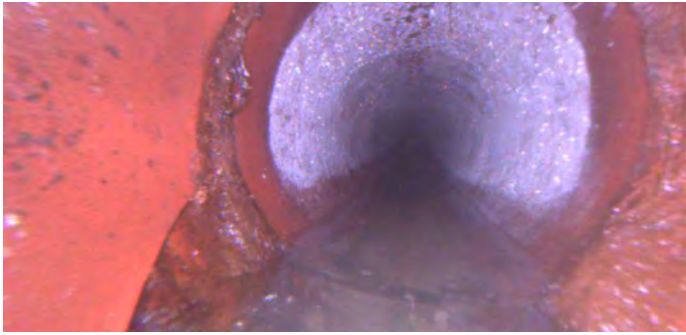
Code: **IW**
Description: **Infil Weeper**

Distance (ft): **9.3**
Structural Grade: **0**
O&M Grade: **2**
Clock Start/From: **8**
Clock To: **9**
1st Value:
2nd Value:
Value Percent:
Continuous Index:
Within 8" of Joint: **YES**
Remarks:

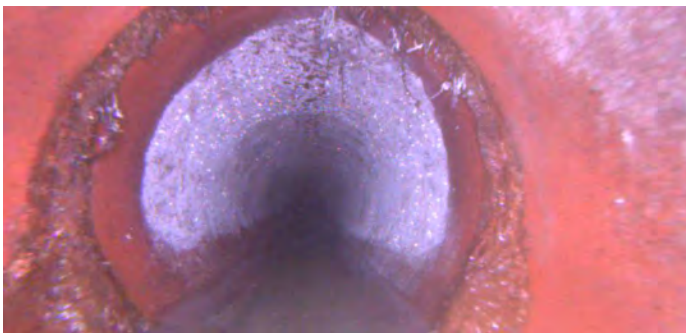
Code: **DAE**
Description: **Deposits Attached Encrustation**

Distance (ft): **9.3**
Structural Grade: **0**
O&M Grade: **2**
Clock Start/From: **8**
Clock To: **4**
1st Value:
2nd Value:
Value Percent: **5.000**
Continuous Index:
Within 8" of Joint: **YES**
Remarks:

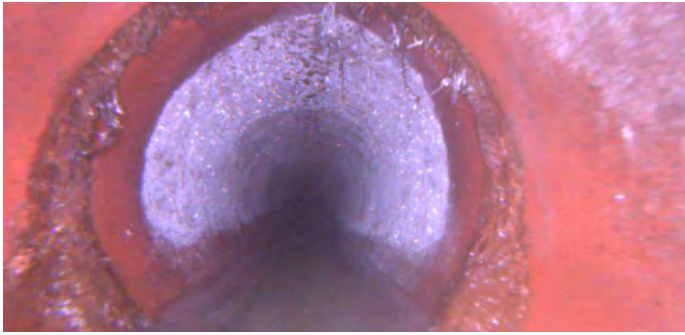
Code: **RFJ**
Description: **Roots Fine Joint**

Distance (ft): **9.3**
Structural Grade: **0**
O&M Grade: **1**
Clock Start/From: **10**
Clock To: **2**
1st Value:
2nd Value:
Value Percent:
Continuous Index:
Within 8" of Joint: **YES**
Remarks:

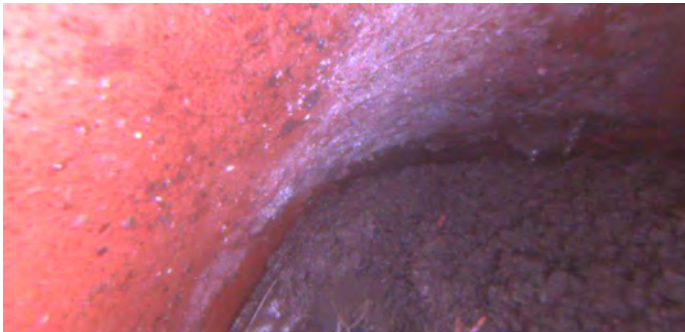
Code: **DSF**
Description: **Deposits Settled Fine**

Distance (ft): **19.0**
Structural Grade: **0**
O&M Grade: **5**
Clock Start/From: **12**
Clock To: **12**
1st Value:
2nd Value:
Value Percent: **100.000**
Continuous Index:
Within 8" of Joint: **YES**
Remarks:

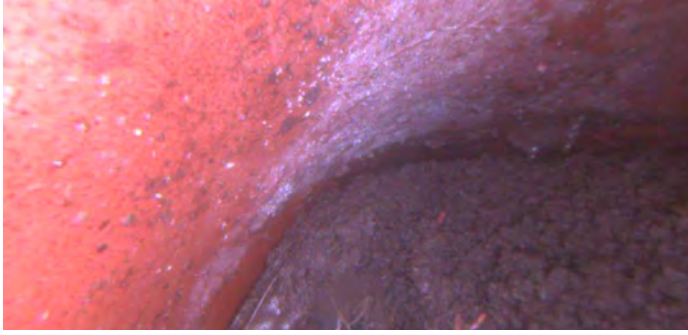
Code:	MSA
Description:	Abandoned Survey
Distance (ft):	19.0
Structural Grade:	0
O&M Grade:	0
Clock Start/From:	
Clock To:	
1st Value:	
2nd Value:	
Value Percent:	
Continuous Index:	
Within 8" of Joint:	NO
Remarks:	dsf
