Profile/Photo Observation Report

Date:	04/06/2018	Weather:		Coding:	PACP 6.0
Pipe Length (ft):	134.2	Owner:	NA	Pre Clean:	Not Known
P.O.#:		Surveyor:	Jen Costello	PSR:	P-103-017-018
Customer:		Clean Date:	01/01/1900	Shape:	C

Street:	willow st	Flow Control:	Not Controlled
City:	Hobart, IN	Year Renewed:	
Location:	Other	Tape/Media #:	
Purpose:	Not Known	Dia/Height:	10"
Use:	Sanitary	Material:	VCP
Drain Area:	NA	Lining:	
Category:	NA		
Comment:

Location Details:		Direction of Survey:	Downstream
US MH:	M-103-018	DS MH:	M-103-017
		Total Length Surveyed (ft):	19.0

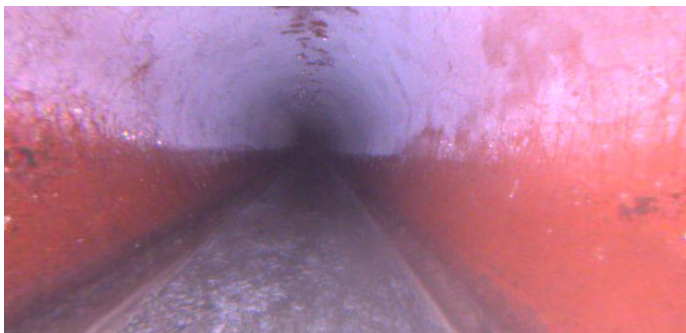
Code: **AMH**
Description: **Manhole**

Distance (ft): **.0**
Structural Grade: **0**
O&M Grade: **0**
Clock Start/From:
Clock To:
1st Value:
2nd Value:
Value Percent:
Continuous Index:
Within 8" of Joint: **NO**
Remarks: **M-103-018**

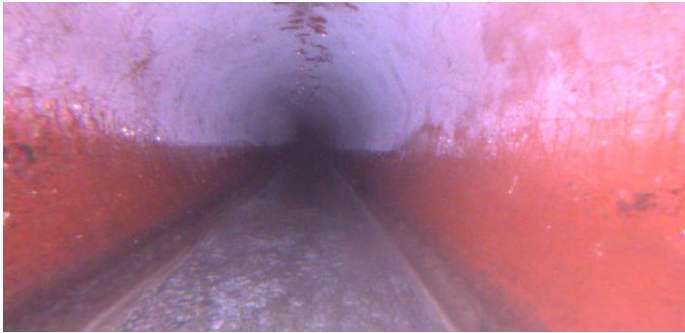
Code:	MWL
Description:	Water Level

Distance (ft):	.0
Structural Grade:	0
O&M Grade:	0
Clock Start/From:	
Clock To:	
1st Value:	
2nd Value:	
Value Percent:	10.000
Continuous Index:	
Within 8" of Joint:	NO
Remarks:

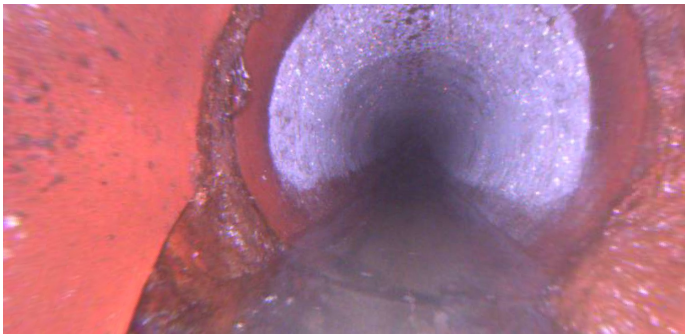
Code:	FS
Description:	Fracture Spiral

Distance (ft):	9.3
Structural Grade:	3
O&M Grade:	0
Clock Start/From:	7
Clock To:	9
1st Value:	
2nd Value:	
Value Percent:	
Continuous Index:	
Within 8" of Joint:	YES
Remarks:

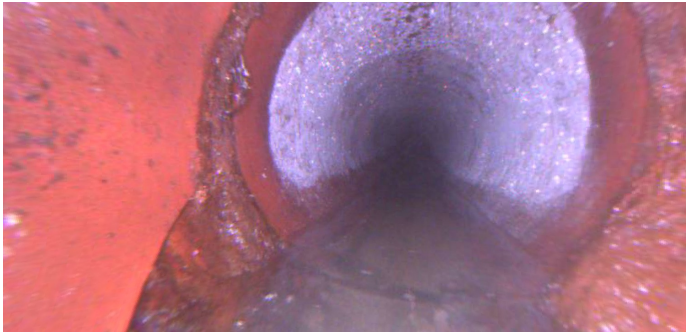
Code: **IW**
Description: **Infil Weeper**

Distance (ft): **9.3**
Structural Grade: **0**
O&M Grade: **2**
Clock Start/From: **8**
Clock To: **9**
1st Value:
2nd Value:
Value Percent:
Continuous Index:
Within 8" of Joint: **YES**
Remarks:

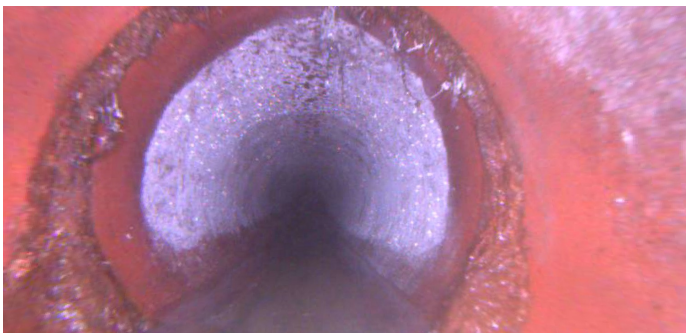
Code: **DAE**
Description: **Deposits Attached Encrustation**

Distance (ft): **9.3**
Structural Grade: **0**
O&M Grade: **2**
Clock Start/From: **8**
Clock To: **4**
1st Value:
2nd Value:
Value Percent: **5.000**
Continuous Index:
Within 8" of Joint: **YES**
Remarks:

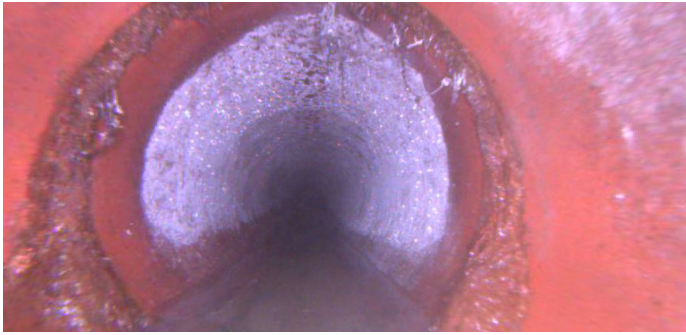
Code: **RFJ**
Description: **Roots Fine Joint**

Distance (ft): **9.3**
Structural Grade: **0**
O&M Grade: **1**
Clock Start/From: **10**
Clock To: **2**
1st Value:
2nd Value:
Value Percent:
Continuous Index:
Within 8" of Joint: **YES**
Remarks:

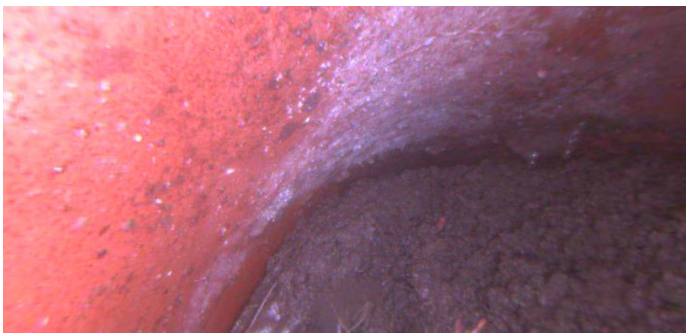
Code: **DSF**
Description: **Deposits Settled Fine**

Distance (ft): **19.0**
Structural Grade: **0**
O&M Grade: **5**
Clock Start/From: **12**
Clock To: **12**
1st Value:
2nd Value:
Value Percent: **100.000**
Continuous Index:
Within 8" of Joint: **YES**
Remarks:

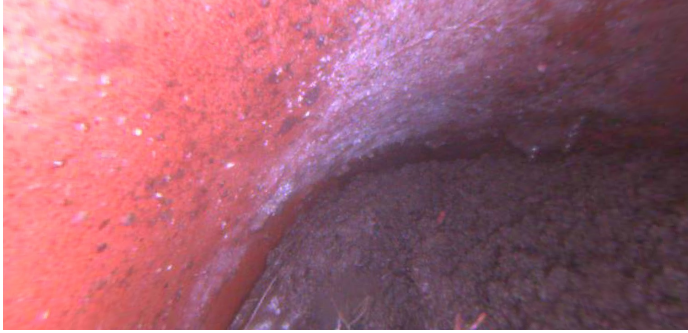
Code:	MSA
Description:	Abandoned Survey
Distance (ft):	19.0
Structural Grade:	0
O&M Grade:	0
Clock Start/From:	
Clock To:	
1st Value:	
2nd Value:	
Value Percent:	
Continuous Index:	
Within 8" of Joint:	NO
Remarks:	dsf
