Profile/Photo Observation Report

Street:	Willow St.	Flow Control:	Not Controlled
City:	Hobart, IN	Year Renewed:	
Location:	Light Highway	Tape/Media #:	
Purpose:	Routine Assessment	Dia/Height:	10"
Use:	Sanitary	Material:	VCP
Drain Area:	NA	Lining:	
Category:	NA		
Comment:

Location Details:		Direction of Survey:	Upstream
US MH:	M-103-018	DS MH:	M-103-017
		Total Length Surveyed (ft):	36.6

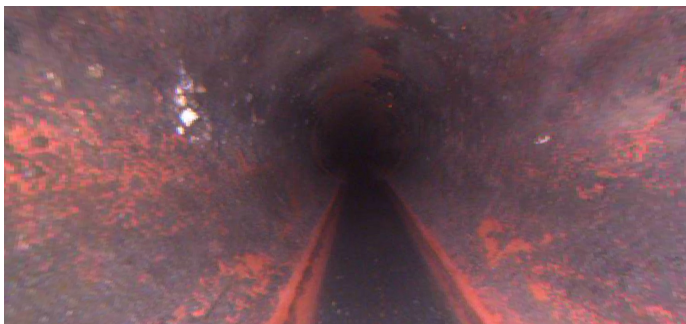
Code: **AMH**
Description: **Manhole**

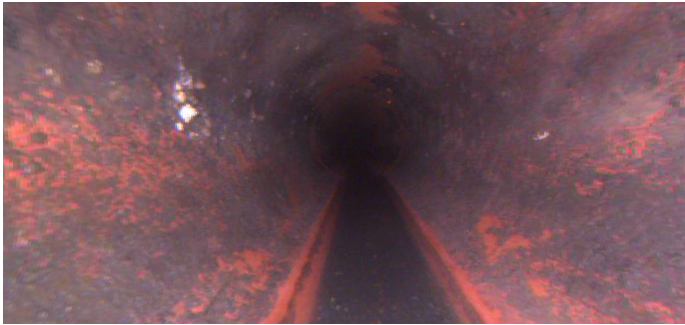
Code:	MWL
Description:	Water Level

Distance (ft):	.0
Structural Grade:	0
O&M Grade:	0
Clock Start/From:	
Clock To:	
1st Value:	
2nd Value:	
Value Percent:	5.000
Continuous Index:	
Within 8" of Joint:	NO
Remarks:

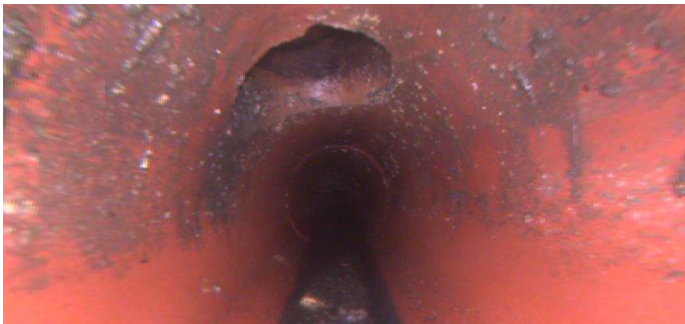
Code:	TF
Description:	Tap Factory

Distance (ft):	23.8
Structural Grade:	0
O&M Grade:	0
Clock Start/From:	12
Clock To:	
1st Value:	4.000
2nd Value:	
Value Percent:	
Continuous Index:	
Within 8" of Joint:	
Remarks:

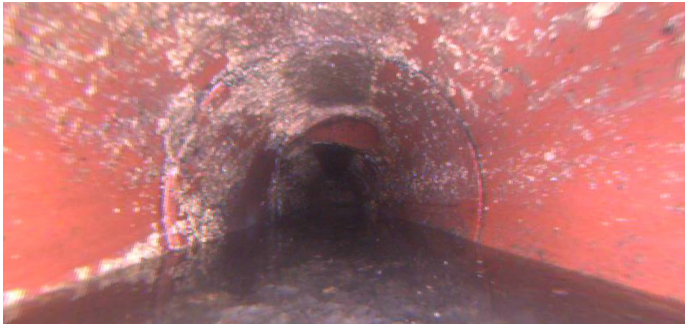
Code: **TF**
Description: **Tap Factory**

Distance (ft): **30.4**
Structural Grade: **0**
O&M Grade: **0**
Clock Start/From: **12**
Clock To:
1st Value: **4.000**
2nd Value:
Value Percent:
Continuous Index:
Within 8" of Joint:
Remarks:

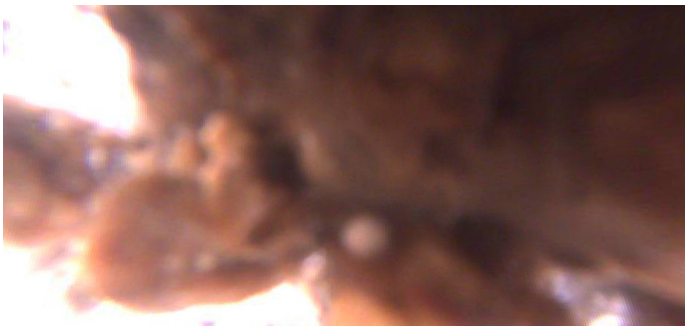
Code: **MSA**
Description: **Abandoned Survey**

Distance (ft): **36.6**
Structural Grade: **0**
O&M Grade: **0**
Clock Start/From:
Clock To:
1st Value:
2nd Value:
Value Percent:
Continuous Index:
Within 8" of Joint: **NO**
Remarks: **deposit settled grease**
