Profile/Photo Observation Report

Date:	09/28/2018	Weather:		Coding:	PACP 6.0
Pipe Length (ft):	134.2	Owner:	NA	Pre Clean:	Not Known
P.O.#:		Surveyor:	Selasie Honu	PSR:	P-103-017-018
Customer:		Clean Date:	01/01/1900	Shape:	C

Street:	WILLOW ST	Flow Control:	Not Controlled
City:	Hobart, IN	Year Renewed:	
Location:	Light Highway	Tape/Media #:	
Purpose:	Routine Assessment	Dia/Height:	8"
Use:	Sanitary	Material:	VCP
Drain Area:	NA	Lining:	
Category:	NA		
Comment:

Location Details:		Direction of Survey:	Downstream
US MH:	M-103-018	DS MH:	M-103-017
		Total Length Surveyed (ft):	19.6

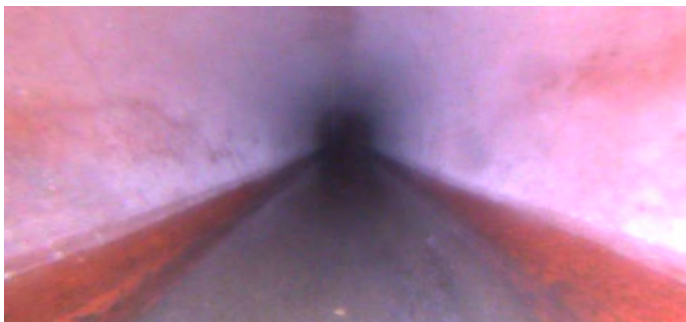
Code: **AMH**
Description: **Manhole**

Distance (ft): **.0**
Structural Grade: **0**
O&M Grade: **0**
Clock Start/From:
Clock To:
1st Value:
2nd Value:
Value Percent:
Continuous Index:
Within 8" of Joint: **NO**
Remarks: **M-103-018**

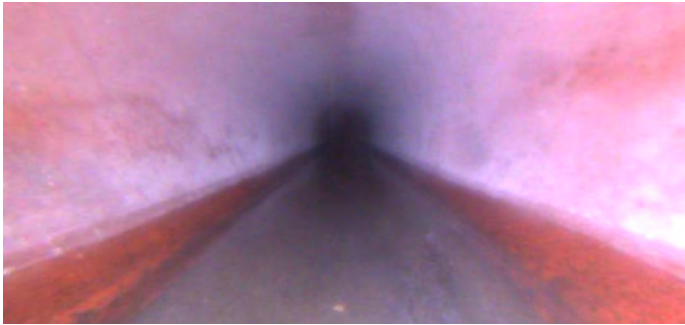
Code:	MWL
Description:	Water Level

Distance (ft):	.0
Structural Grade:	0
O&M Grade:	0
Clock Start/From:	
Clock To:	
1st Value:	
2nd Value:	
Value Percent:	5.000
Continuous Index:	
Within 8" of Joint:	NO
Remarks:

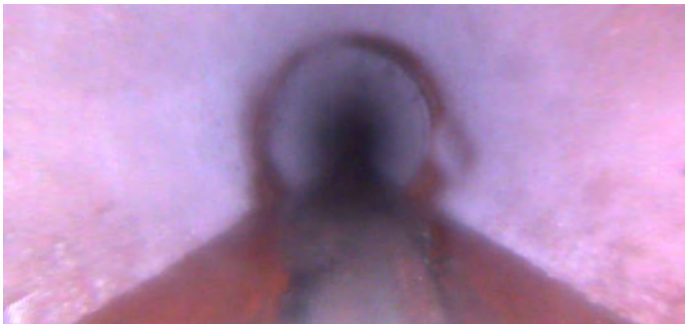
Code:	RFJ
Description:	Roots Fine Joint

Distance (ft):	8.6
Structural Grade:	0
O&M Grade:	1
Clock Start/From:	8
Clock To:	4
1st Value:	
2nd Value:	
Value Percent:	
Continuous Index:	
Within 8" of Joint:	YES
Remarks:

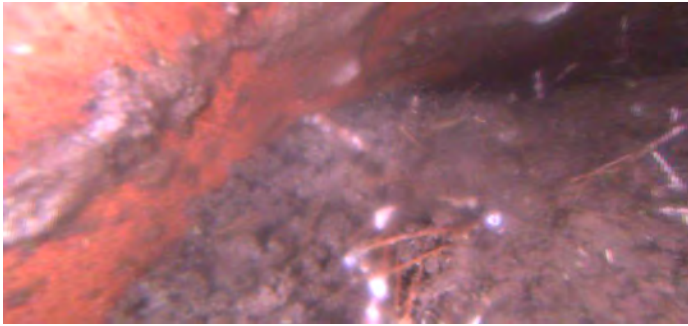
Code:	MSA
Description:	Abandoned Survey
Distance (ft):	19.6
Structural Grade:	0
O&M Grade:	0
Clock Start/From:	
Clock To:	
1st Value:	
2nd Value:	
Value Percent:	
Continuous Index:	
Within 8" of Joint:	NO
Remarks:	ROOT INFILTRATION
