Profile/Photo Observation Report

| Street: | Willow St. | Flow Control: | Not Controlled |
| City: | Hobart, IN | Year Renewed: | |

| US MH: | M-103-018 | DS MH: | M-103-017 |

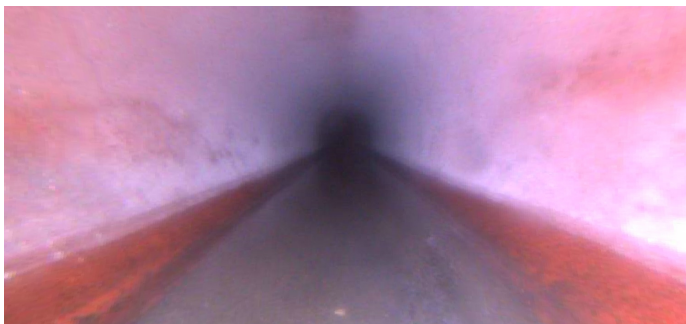
Code: **AMH**
Description: **Manhole**

Distance (ft): **.0**
Structural Grade: **0**
O&M Grade: **0**
Clock Start/From:
Clock To:
1st Value:
2nd Value:
Value Percent:
Continuous Index:
Within 8" of Joint: **NO**
Remarks: **M-103-018**

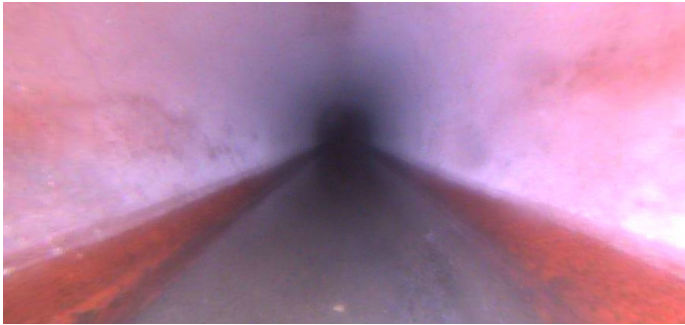
| Code: | MWL |
| Description: | Water Level |

| Value Percent: | 5.000 |

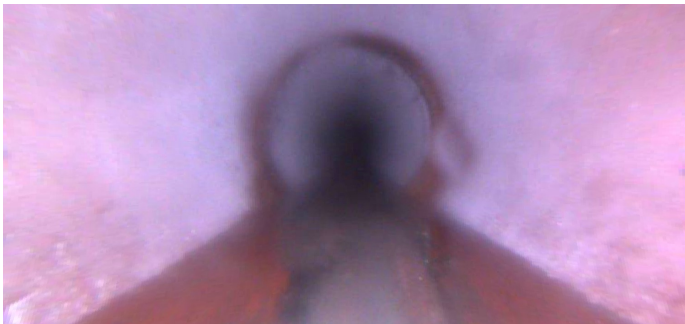
| Code: | RFJ |
| Description: | Roots Fine Joint |

| Distance (ft): | 8.6 |
| O&M Grade: | 1 |
| Clock Start/From: | 8 |
| Clock To: | 4 |
| Within 8" of Joint: | YES |

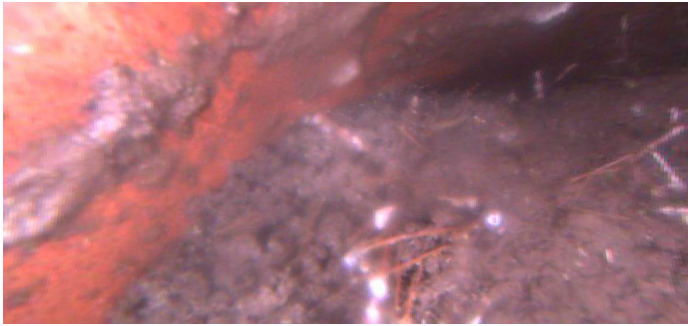
| Code: | MSA |
| Description: | Abandoned Survey |
| Distance (ft): | 19.6 |
| Remarks: | ROOT INFILTRATION |
