Profile/Photo Observation Report

| Profile/Photo Observation Report | | | | | | | | | |
|---|---|---|---|---|---|--|--|--|--|
| Street: | South Colorado Street | | Flow Control: | Not Controlled | | | | | |
| City: | Hobart, IN | | Year Renewed: | | | | | | |
| US MH: | M-506-011 | DS MH: | M-506-026 | Total Length Surveyed (ft) | : 52.3 | | | | |

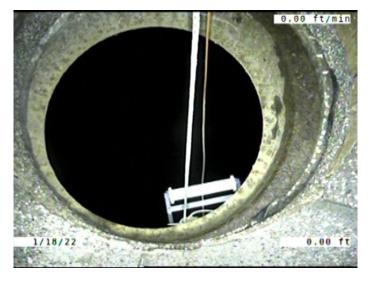
| Code: | AMH |
|---|---|
| Remarks: | M-506-011 |

| Code: | AMH |
|---|---|
| Description: | Manhole |

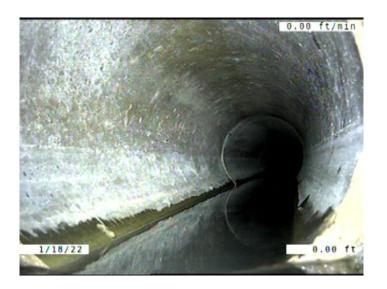
Description: **Miscellaneous Water Level**

Distance (ft): .0 Structural Grade: 0 O&M Grade: 0

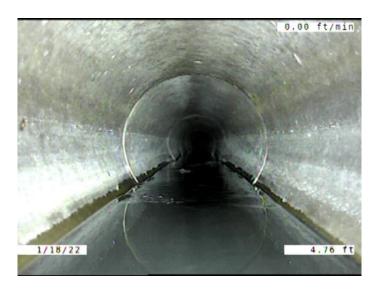
Description: **Deposits Settled Fine**

Distance (ft): 4.8 Structural Grade: 0 O&M Grade: 2 Clock Start/From: 5 Clock To: 7 1st Value:

Value Percent: 5.000 Continuous Index: **S01** Within 8" of Joint: YES

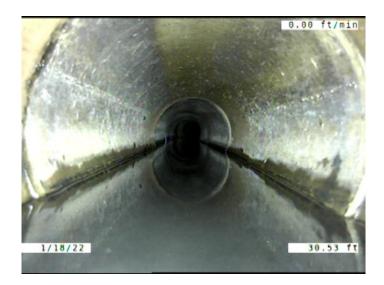
Description: Miscellaneous Water Level

Distance (ft): 30.5
Structural Grade: 0

Value Percent: 15.000

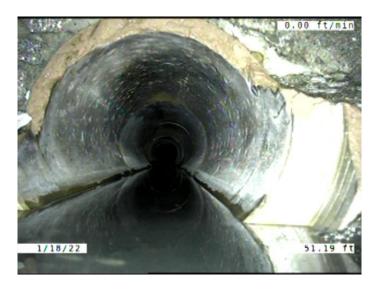
Description: Deposits Settled Fine

Distance (ft): 51.2
Structural Grade: 0
O&M Grade: 2
Clock Start/From: 5
Clock To: 7
1st Value:

Value Percent: 5.000
Continuous Index: F01
Within 8" of Joint: YES

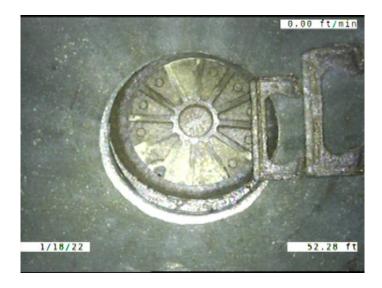
Remarks: M-506-026

Code: AMH
Description: Manhole

Distance (ft): 52.3
Structural Grade: 0
