Profile/Photo Observation Report

Date:	03/29/2018	Weather:		Coding:	PACP 6.0
Pipe Length (ft):	269.0	Owner:	NA	Pre Clean:	Not Known
P.O.#:		Surveyor:	Jen Costello	PSR:	P-103-021-022
Customer:		Clean Date:	01/01/1900	Shape:	C

Street:	MISSOURI ST	Flow Control:	Not Controlled
City:	Hobart, IN	Year Renewed:	
Location:	Other	Tape/Media #:	
Purpose:	Not Known	Dia/Height:	8"
Use:	Sanitary	Material:	PVC
Drain Area:	NA	Lining:	
Category:	NA		
Comment:

Location Details:		Direction of Survey:	Upstream
US MH:	M-103-022	DS MH:	M-103-021
		Total Length Surveyed (ft):	259.3

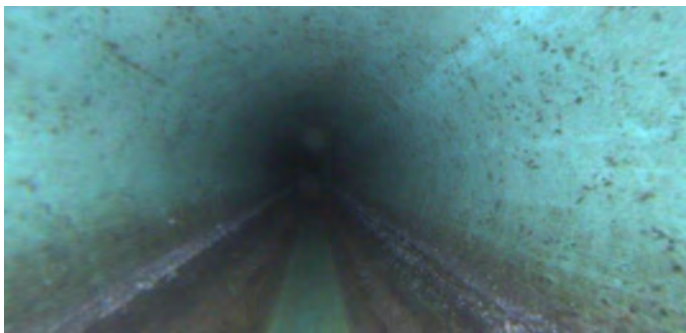
Code: **AMH**
Description: **Manhole**

Distance (ft): **.0**
Structural Grade: **0**
O&M Grade: **0**
Clock Start/From:
Clock To:
1st Value:
2nd Value:
Value Percent:
Continuous Index:
Within 8" of Joint: **NO**
Remarks: **M-103-021**

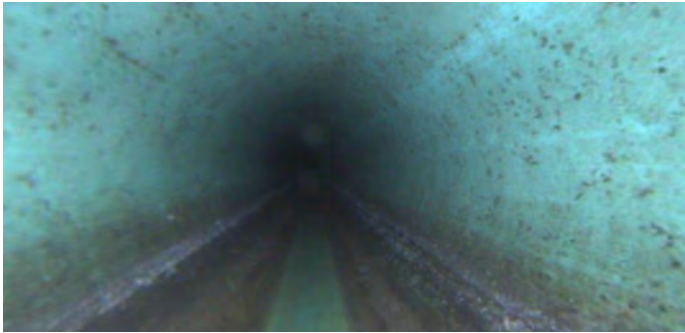
Code:	MWL
Description:	Water Level

Distance (ft):	.0
Structural Grade:	0
O&M Grade:	0
Clock Start/From:	
Clock To:	
1st Value:	
2nd Value:	
Value Percent:	5.000
Continuous Index:	
Within 8" of Joint:	NO
Remarks:

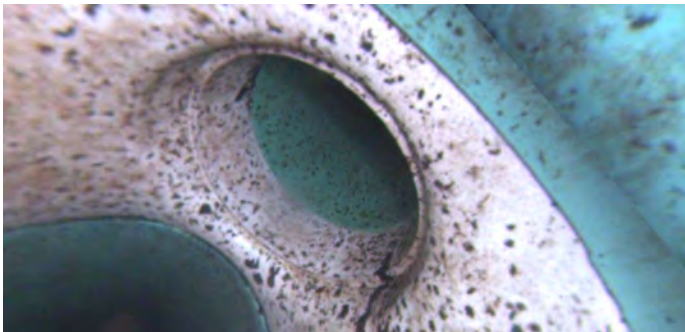
Code:	TF
Description:	Tap Factory

Distance (ft):	5.6
Structural Grade:	0
O&M Grade:	0
Clock Start/From:	1
Clock To:	
1st Value:	4.000
2nd Value:	
Value Percent:	
Continuous Index:	
Within 8" of Joint:	
Remarks:

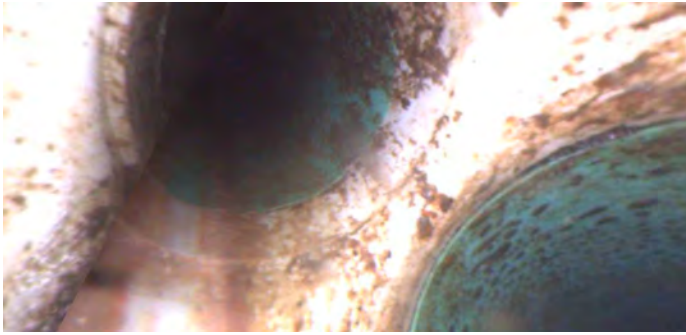
Code: **TF**
Description: **Tap Factory**

Distance (ft): **80.8**
Structural Grade: **0**
O&M Grade: **0**
Clock Start/From: **2**
Clock To:
1st Value: **4.000**
2nd Value:
Value Percent:
Continuous Index:
Within 8" of Joint:
Remarks:

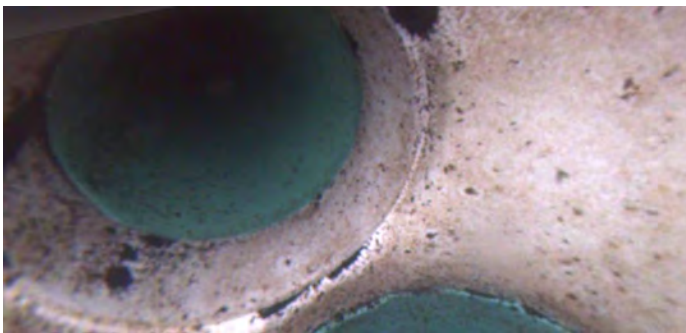
Code: **TF**
Description: **Tap Factory**

Distance (ft): **94.7**
Structural Grade: **0**
O&M Grade: **0**
Clock Start/From: **11**
Clock To:
1st Value: **4.000**
2nd Value:
Value Percent:
Continuous Index:
Within 8" of Joint:
Remarks:

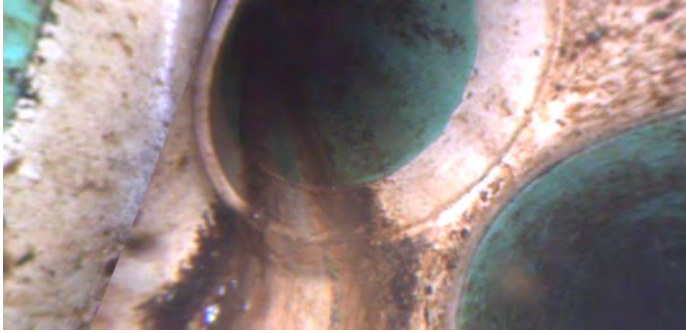
Code: **TF**
Description: **Tap Factory**

Distance (ft): **118.2**
Structural Grade: **0**
O&M Grade: **0**
Clock Start/From: **2**
Clock To:
1st Value: **4.000**
2nd Value:
Value Percent:
Continuous Index:
Within 8" of Joint:
Remarks:

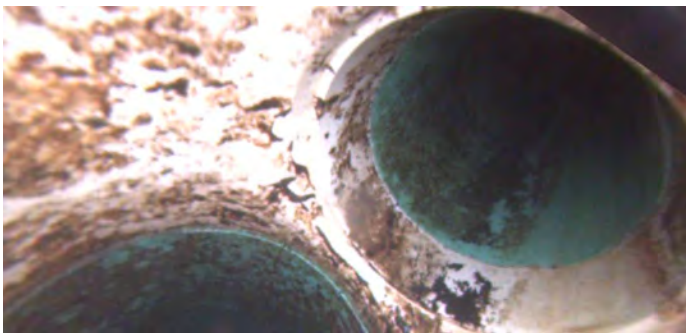
Code: **TF**
Description: **Tap Factory**

Distance (ft): **132.2**
Structural Grade: **0**
O&M Grade: **0**
Clock Start/From: **2**
Clock To:
1st Value: **4.000**
2nd Value:
Value Percent:
Continuous Index:
Within 8" of Joint:
Remarks:

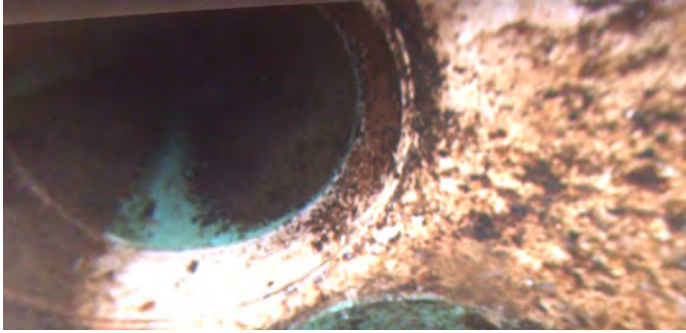
Code: **TF**
Description: **Tap Factory**

Distance (ft): **147.8**
Structural Grade: **0**
O&M Grade: **0**
Clock Start/From: **11**
Clock To:
1st Value: **4.000**
2nd Value:
Value Percent:
Continuous Index:
Within 8" of Joint:
Remarks:

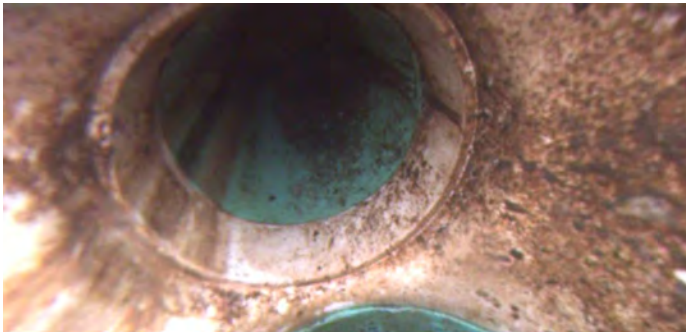
Code: **TF**
Description: **Tap Factory**

Distance (ft): **157.3**
Structural Grade: **0**
O&M Grade: **0**
Clock Start/From: **11**
Clock To:
1st Value: **4.000**
2nd Value:
Value Percent:
Continuous Index:
Within 8" of Joint:
Remarks:

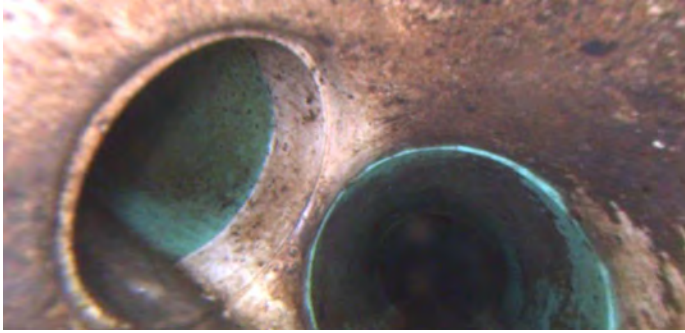
Code: **TFA**
Description: **Tap Factory Active**

Distance (ft): **218.6**
Structural Grade: **0**
O&M Grade: **0**
Clock Start/From: **10**
Clock To:
1st Value: **4.000**
2nd Value:
Value Percent:
Continuous Index:
Within 8" of Joint:
Remarks:

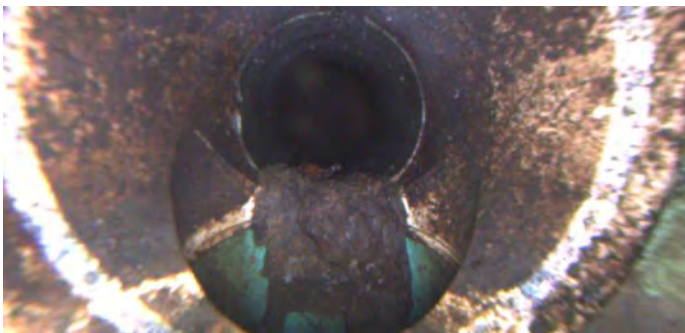
Code: **TF**
Description: **Tap Factory**

Distance (ft): **257.5**
Structural Grade: **0**
O&M Grade: **0**
Clock Start/From: **6**
Clock To:
1st Value: **6.000**
2nd Value:
Value Percent:
Continuous Index:
Within 8" of Joint:
Remarks: **DROP CONNECTION**
