Profile/Photo Observation Report

Date:	03/29/2018	Weather:		Coding:	PACP 6.0
Pipe Length (ft):	199.5	Owner:	NA	Pre Clean:	Not Known
P.O.#:		Surveyor:	Jen Costello	PSR:	P-103-023-024
Customer:		Clean Date:	01/01/1900	Shape:	C

Street:	W 39TH AVE	Flow Control:	Not Controlled
City:	Hobart, IN	Year Renewed:	
Location:	Other	Tape/Media #:	
Purpose:	Not Known	Dia/Height:	8"
Use:	Sanitary	Material:	PVC
Drain Area:	NA	Lining:	
Category:	NA		
Comment:

Location Details:		Direction of Survey:	Downstream
US MH:	M-103-023	DS MH:	M-103-024
		Total Length Surveyed (ft):	124.9

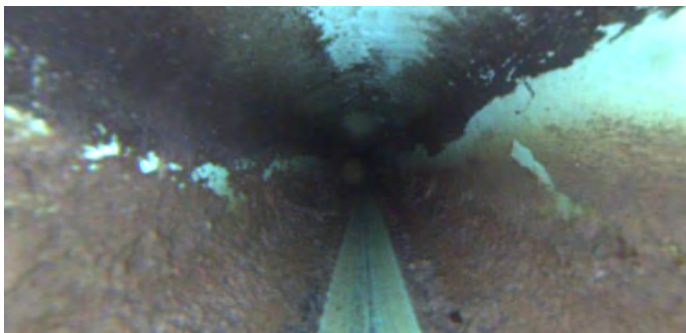
Code: **AMH**
Description: **Manhole**

Distance (ft): **.0**
Structural Grade: **0**
O&M Grade: **0**
Clock Start/From:
Clock To:
1st Value:
2nd Value:
Value Percent:
Continuous Index:
Within 8" of Joint: **NO**
Remarks: **M-103-023**

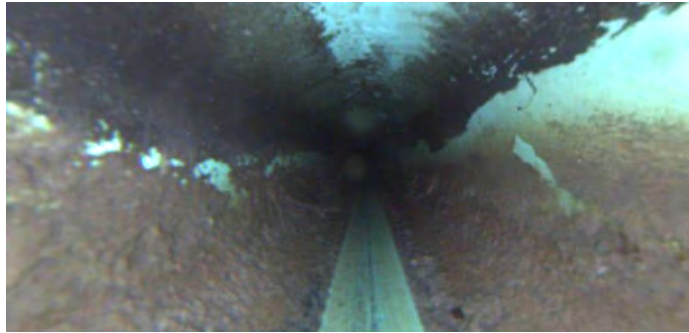
Code: **MWL**
Description: **Water Level**

Distance (ft): **.0**
Structural Grade: **0**
O&M Grade: **0**
Clock Start/From:
Clock To:
1st Value:
2nd Value:
Value Percent: **5.000**
Continuous Index:
Within 8" of Joint: **NO**
Remarks:

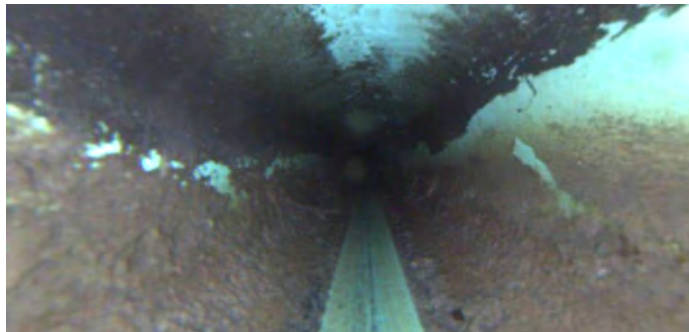
Code: **DAGS**
Description: **Deposits Attached Grease**

Distance (ft): **.0**
Structural Grade: **0**
O&M Grade: **2**
Clock Start/From: **7**
Clock To: **5**
1st Value:
2nd Value:
Value Percent: **5.000**
Continuous Index: **S01**
Within 8" of Joint: **NO**
Remarks:

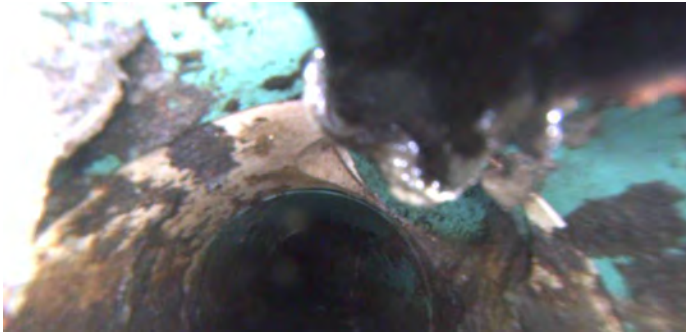
Code: **TF**
Description: **Tap Factory**

Distance (ft): **122.9**
Structural Grade: **0**
O&M Grade: **0**
Clock Start/From: **2**
Clock To:
1st Value: **4.000**
2nd Value:
Value Percent:
Continuous Index:
Within 8" of Joint:
Remarks:

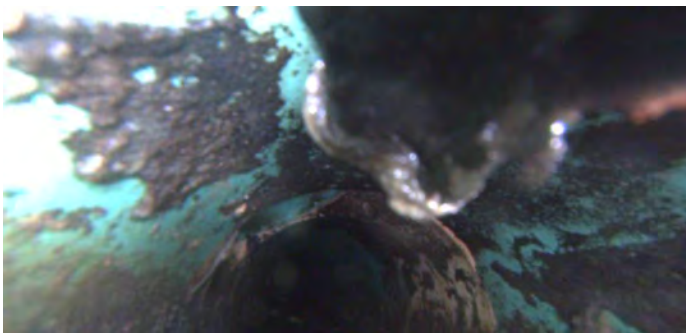
Code: **MSA**
Description: **Abandoned Survey**

Distance (ft): **124.9**
Structural Grade: **0**
O&M Grade: **0**
Clock Start/From:
Clock To:
1st Value:
2nd Value:
Value Percent:
Continuous Index:
Within 8" of Joint: **NO**
Remarks: **DAGS**

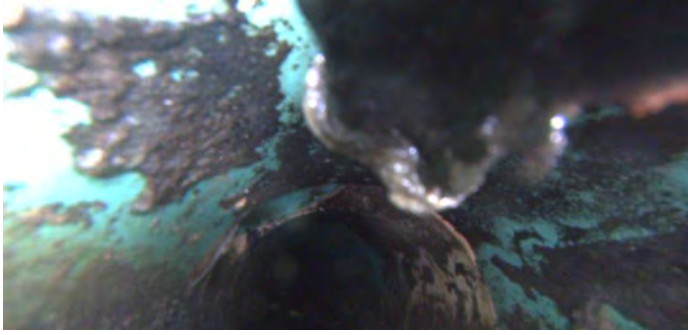
Code:	DAGS
Description:	Deposits Attached Grease
Distance (ft):	124.9
Structural Grade:	0
O&M Grade:	2
Clock Start/From:	7
Clock To:	5
1st Value:	
2nd Value:	
Value Percent:	5.000
Continuous Index:	F01
Within 8" of Joint:	NO
Remarks:
