## Profile/Photo Observation Report

Date:	<b>04/03/2018</b>	Weather:		Coding:	<b>PACP 6.0</b>
Pipe Length (ft):	<b>304.2</b>	Owner:	<b>NA</b>	Pre Clean:	<b>Not Known</b>
P.O.#:		Surveyor:	<b>Jen Costello</b>	PSR:	<b>P-103-024-025</b>
Customer:		Clean Date:	<b>01/01/1900</b>	Shape:	<b>C</b>

Street:	<b>34th av</b>	Flow Control:	<b>Not Controlled</b>
City:	<b>Hobart, IN</b>	Year Renewed:	
Location:	<b>Other</b>	Tape/Media #:	
Purpose:	<b>Not Known</b>	Dia/Height:	<b>10"</b>
Use:	<b>Sanitary</b>	Material:	<b>PVC</b>
Drain Area:	<b>NA</b>	Lining:	
Category:	<b>NA</b>		
Comment:

Location Details:		Direction of Survey:	<b>Upstream</b>
US MH:	<b>M-103-024</b>	DS MH:	<b>M-103-025</b>
		Total Length Surveyed (ft):	<b>298.2</b>

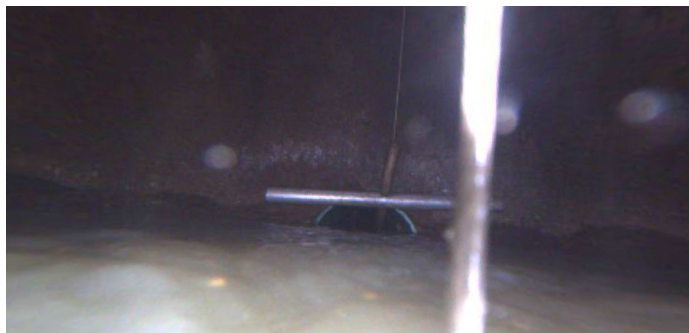
Code: **AMH**  
 Description: **Manhole**

Distance (ft): **.0**  
 Structural Grade: **0**  
 O&M Grade: **0**  
 Clock Start/From:  
 Clock To:  
 1st Value:  
 2nd Value:  
 Value Percent:  
 Continuous Index:  
 Within 8" of Joint: **NO**  
 Remarks: **M-103-025**

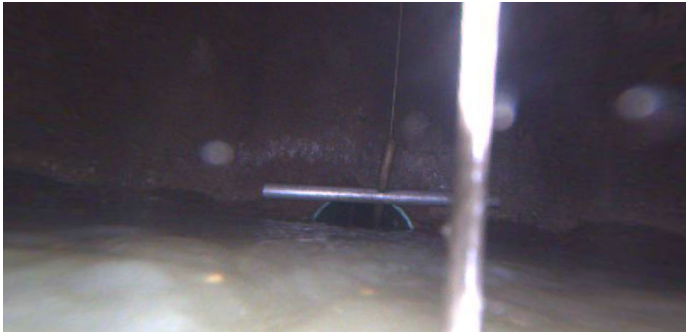
Code:	<b>MWL</b>
Description:	<b>Water Level</b>

Distance (ft):	<b>.0</b>
Structural Grade:	<b>0</b>
O&M Grade:	<b>0</b>
Clock Start/From:	
Clock To:	
1st Value:	
2nd Value:	
Value Percent:	<b>30.000</b>
Continuous Index:	
Within 8" of Joint:	<b>NO</b>
Remarks:

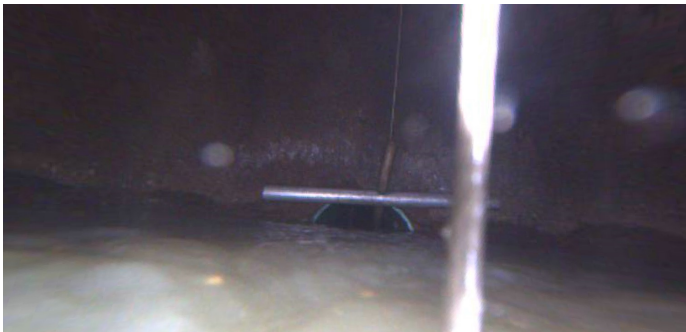
Code:	<b>MGO</b>
Description:	<b>General Observation</b>

Distance (ft):	<b>.0</b>
Structural Grade:	<b>0</b>
O&M Grade:	<b>0</b>
Clock Start/From:	
Clock To:	
1st Value:	
2nd Value:	
Value Percent:	
Continuous Index:	
Within 8" of Joint:	<b>NO</b>
Remarks:	<b>REAR CAMERA</b>

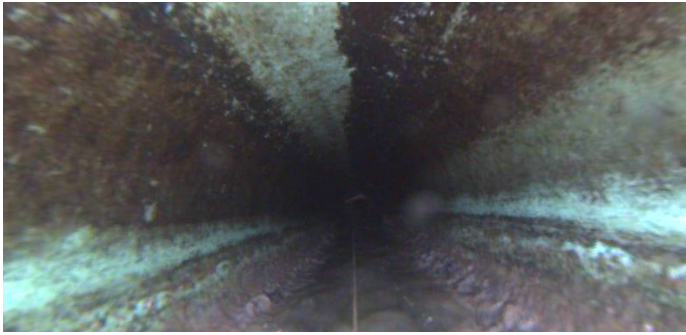
Code: **DAGS**  
Description: **Deposits Attached Grease**

Distance (ft): **6.8**  
Structural Grade: **0**  
O&M Grade: **2**  
Clock Start/From: **7**  
Clock To: **5**  
1st Value:  
2nd Value:  
Value Percent: **5.000**  
Continuous Index: **S01**  
Within 8" of Joint: **NO**  
Remarks:

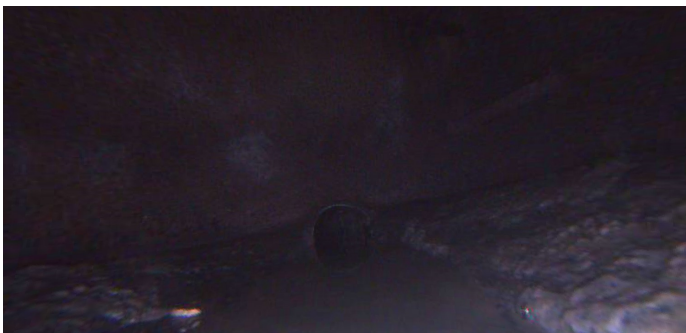
Code: **AMH**  
Description: **Manhole**

Distance (ft): **298.2**  
Structural Grade: **0**  
O&M Grade: **0**  
Clock Start/From:  
Clock To:  
1st Value:  
2nd Value:  
Value Percent:  
Continuous Index:  
Within 8" of Joint: **NO**  
Remarks: **M-103-024**

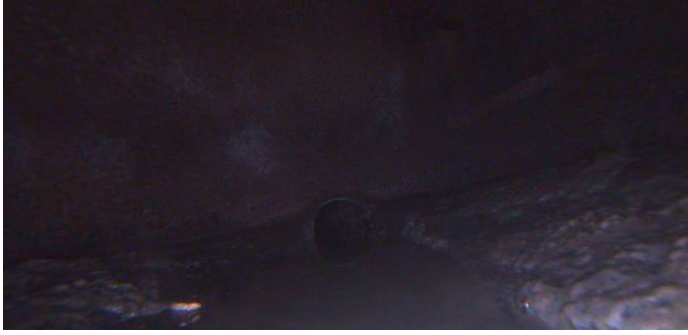
Code:	<b>DAGS</b>
Description:	<b>Deposits Attached Grease</b>
Distance (ft):	<b>298.2</b>
Structural Grade:	<b>0</b>
O&M Grade:	<b>2</b>
Clock Start/From:	<b>7</b>
Clock To:	<b>5</b>
1st Value:	
2nd Value:	
Value Percent:	<b>5.000</b>
Continuous Index:	<b>F01</b>
Within 8" of Joint:	<b>NO</b>
Remarks:
