Profile/Photo Observation Report

Date:	04/03/2018	Weather:		Coding:	PACP 6.0
Pipe Length (ft):	173.9	Owner:	NA	Pre Clean:	Not Known
P.O.#:		Surveyor:	Jen Costello	PSR:	P-103-025-026
Customer:		Clean Date:	01/01/1900	Shape:	C

Street:	34th av	Flow Control:	Not Controlled
City:	Hobart, IN	Year Renewed:	
Location:	Other	Tape/Media #:	
Purpose:	Not Known	Dia/Height:	10"
Use:	Sanitary	Material:	PVC
Drain Area:	NA	Lining:	
Category:	NA		
Comment:

Location Details:		Direction of Survey:	Downstream
US MH:	M-103-025	DS MH:	M-103-026
		Total Length Surveyed (ft):	19.0

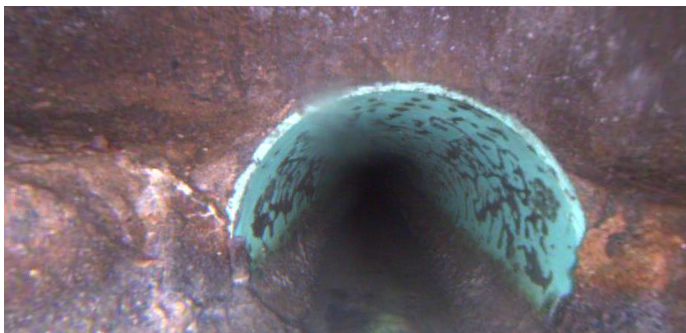
Code: **AMH**
Description: **Manhole**

Distance (ft): **.0**
Structural Grade: **0**
O&M Grade: **0**
Clock Start/From:
Clock To:
1st Value:
2nd Value:
Value Percent:
Continuous Index:
Within 8" of Joint: **NO**
Remarks: **M-103-025**

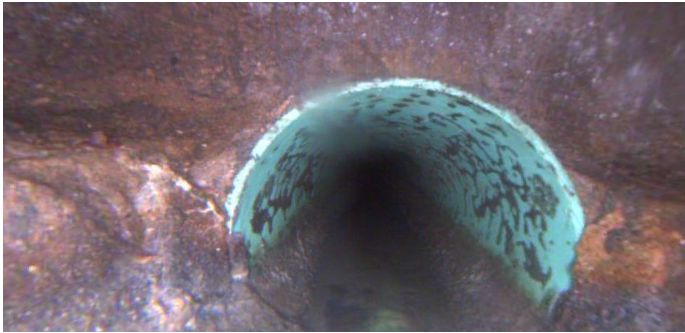
Code:	MWL
Description:	Water Level

Distance (ft):	.0
Structural Grade:	0
O&M Grade:	0
Clock Start/From:	
Clock To:	
1st Value:	
2nd Value:	
Value Percent:	5.000
Continuous Index:	
Within 8" of Joint:	NO
Remarks:

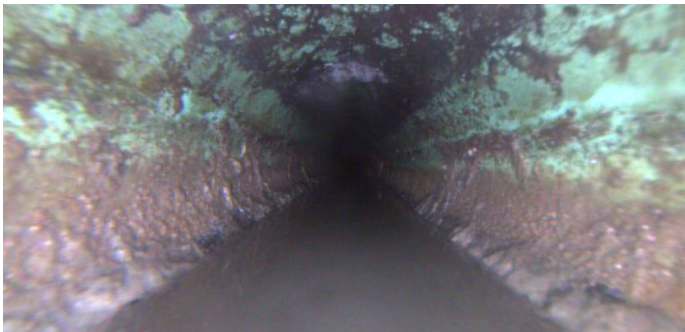
Code:	DAGS
Description:	Deposits Attached Grease

Distance (ft):	3.5
Structural Grade:	0
O&M Grade:	2
Clock Start/From:	8
Clock To:	4
1st Value:	
2nd Value:	
Value Percent:	5.000
Continuous Index:	S01
Within 8" of Joint:	NO
Remarks:

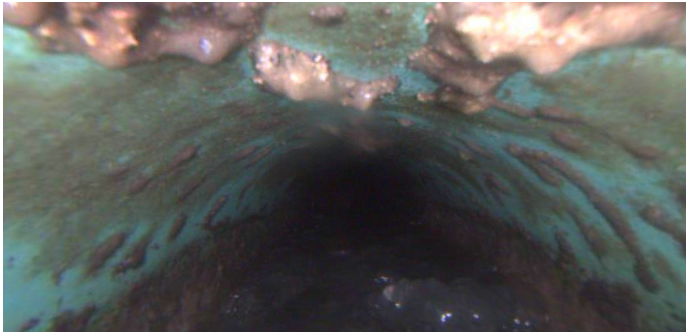
Code: **DAGS**
Description: **Deposits Attached Grease**

Distance (ft): **19.0**
Structural Grade: **0**
O&M Grade: **2**
Clock Start/From: **8**
Clock To: **4**
1st Value:
2nd Value:
Value Percent: **5.000**
Continuous Index: **F01**
Within 8" of Joint: **NO**
Remarks:

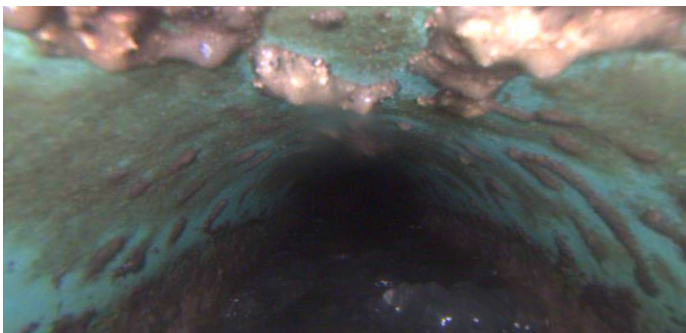
Code: **MSA**
Description: **Abandoned Survey**

Distance (ft): **19.0**
Structural Grade: **0**
O&M Grade: **0**
Clock Start/From:
Clock To:
1st Value:
2nd Value:
Value Percent:
Continuous Index:
Within 8" of Joint: **NO**
Remarks: **DEBRIS UNDER WATER**
