Profile/Photo Observation Report

Date:	09/28/2018	Weather:		Coding:	PACP 6.0
Pipe Length (ft):	173.9	Owner:	NA	Pre Clean:	Not Known
P.O.#:		Surveyor:	Selasie Honu	PSR:	P-103-025-026
Customer:		Clean Date:	01/01/1900	Shape:	C

Location Details:		Direction of Survey:	Upstream
US MH:	M-103-025	DS MH:	M-103-026
		Total Length Surveyed (ft):	166.7

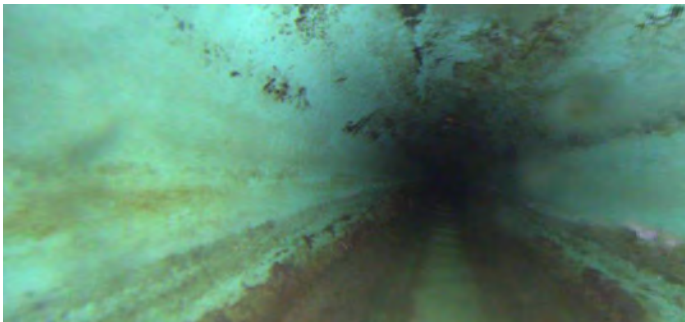
Code: **AMH**
Description: **Manhole**

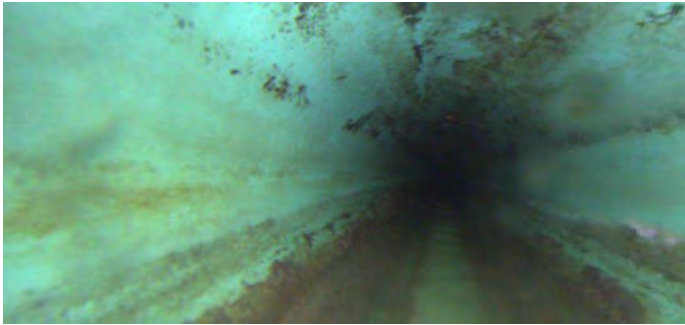
Code:	MWL
Description:	Water Level

Distance (ft):	.0
Structural Grade:	0
O&M Grade:	0
Clock Start/From:	
Clock To:	
1st Value:	
2nd Value:	
Value Percent:	5.000
Continuous Index:	
Within 8" of Joint:	NO
Remarks:

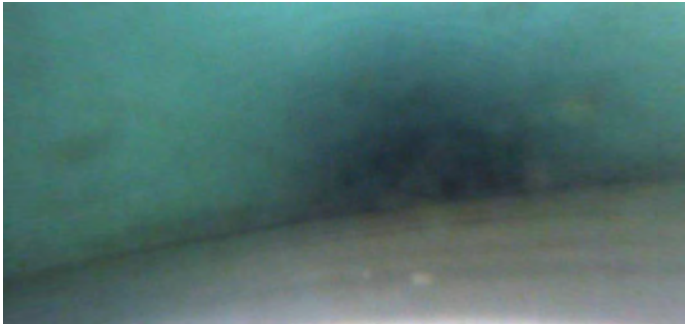
Code: **MWLS**
Description: **Water Level Sag**

Distance (ft): **138.5**
Structural Grade: **2**
O&M Grade: **3**
Clock Start/From:
Clock To:
1st Value:
2nd Value:
Value Percent: **20.000**
Continuous Index: **F01**
Within 8" of Joint: **NO**
Remarks:

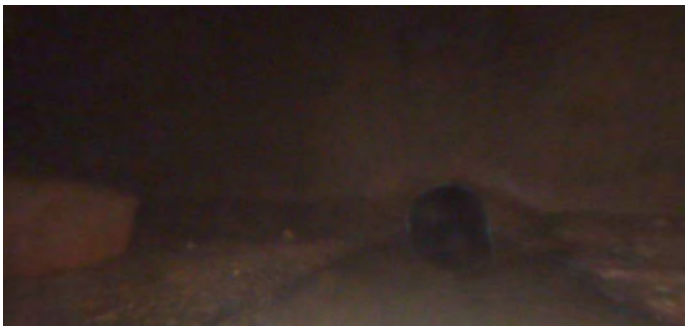
Code: **AMH**
Description: **Manhole**

Distance (ft): **166.7**
Structural Grade: **0**
O&M Grade: **0**
Clock Start/From:
Clock To:
1st Value:
2nd Value:
Value Percent:
Continuous Index:
Within 8" of Joint: **NO**
Remarks: **M-103-025**
