## Profile/Photo Observation Report

Street:	<b>W 39TH AVE</b>	Flow Control:	<b>Not Controlled</b>
City:	<b>Hobart, IN</b>	Year Renewed:	
Location:	<b>Other</b>	Tape/Media #:	
Purpose:	<b>Not Known</b>	Dia/Height:	<b>10"</b>
Use:	<b>Sanitary</b>	Material:	<b>PVC</b>
Drain Area:	<b>NA</b>	Lining:	
Category:	<b>NA</b>		
Comment:

Location Details:		Direction of Survey:	<b>Upstream</b>
US MH:	<b>M-103-026</b>	DS MH:	<b>M-103-027</b>
		Total Length Surveyed (ft):	<b>320.3</b>

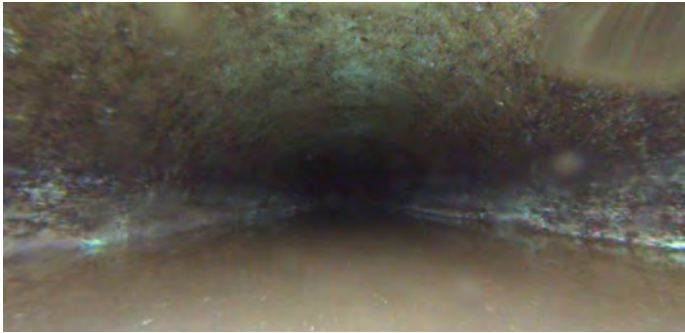
Code:	<b>MWL</b>
Description:	<b>Water Level</b>

Distance (ft):	<b>.0</b>
Structural Grade:	<b>0</b>
O&M Grade:	<b>0</b>
Clock Start/From:	
Clock To:	
1st Value:	
2nd Value:	
Value Percent:	<b>40.000</b>
Continuous Index:	
Within 8" of Joint:	<b>NO</b>
Remarks:

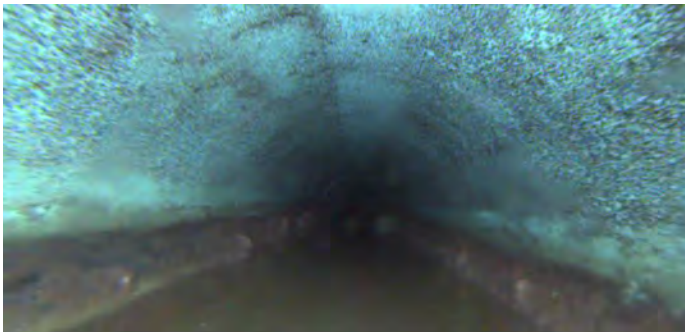
Code:	<b>DAGS</b>
Description:	<b>Deposits Attached Grease</b>

Distance (ft):	<b>94.6</b>
Structural Grade:	<b>0</b>
O&M Grade:	<b>2</b>
Clock Start/From:	<b>8</b>
Clock To:	<b>4</b>
1st Value:	
2nd Value:	
Value Percent:	<b>5.000</b>
Continuous Index:	<b>S01</b>
Within 8" of Joint:	<b>NO</b>
Remarks:

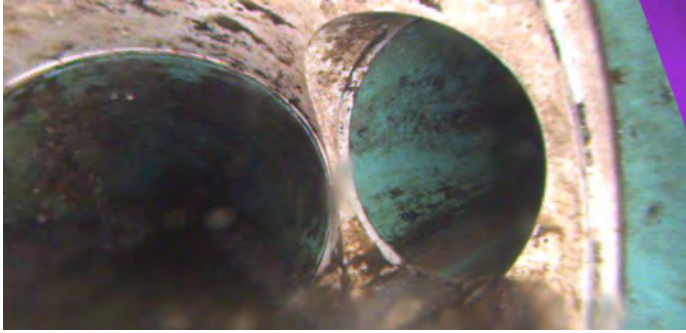
Code: **TFA**  
Description: **Tap Factory Active**

Distance (ft): **195.1**  
Structural Grade: **0**  
O&M Grade: **0**  
Clock Start/From: **3**  
Clock To:  
1st Value: **4.000**  
2nd Value:  
Value Percent:  
Continuous Index:  
Within 8" of Joint:  
Remarks:

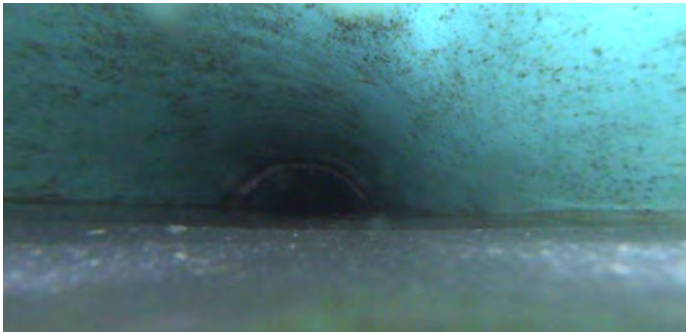
Code: **DAGS**  
Description: **Deposits Attached Grease**

Distance (ft): **231.3**  
Structural Grade: **0**  
O&M Grade: **2**  
Clock Start/From: **8**  
Clock To: **4**  
1st Value:  
2nd Value:  
Value Percent: **5.000**  
Continuous Index: **F01**  
Within 8" of Joint: **NO**  
Remarks:

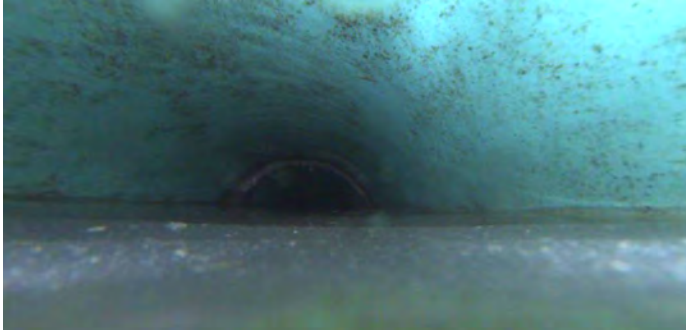
Code: **MWL**  
Description: **Water Level**

Distance (ft): **231.3**  
Structural Grade: **0**  
O&M Grade: **0**  
Clock Start/From:  
Clock To:  
1st Value:  
2nd Value:  
Value Percent: **60.000**  
Continuous Index:  
Within 8" of Joint: **NO**  
Remarks:
