Profile/Photo Observation Report

Street:	34th av	Flow Control:	Not Controlled
City:	Hobart, IN	Year Renewed:	
Location:	Other	Tape/Media #:	
Purpose:	Not Known	Dia/Height:	10"
Use:	Sanitary	Material:	PVC
Drain Area:	NA	Lining:	
Category:	NA		
Comment:

Location Details:		Direction of Survey:	Upstream
US MH:	M-103-026	DS MH:	M-103-027
		Total Length Surveyed (ft):	320.3

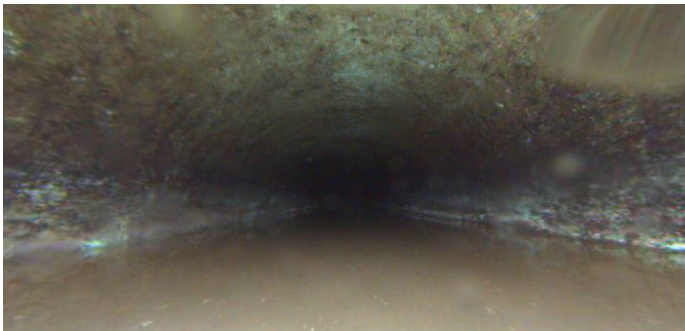
Code: **AMH**
Description: **Manhole**

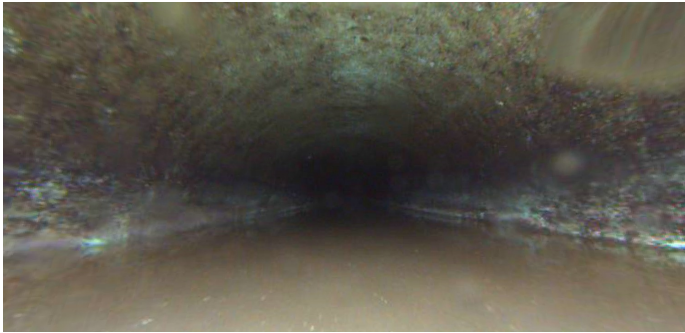
Code:	MWL
Description:	Water Level

Distance (ft):	.0
Structural Grade:	0
O&M Grade:	0
Clock Start/From:	
Clock To:	
1st Value:	
2nd Value:	
Value Percent:	40.000
Continuous Index:	
Within 8" of Joint:	NO
Remarks:

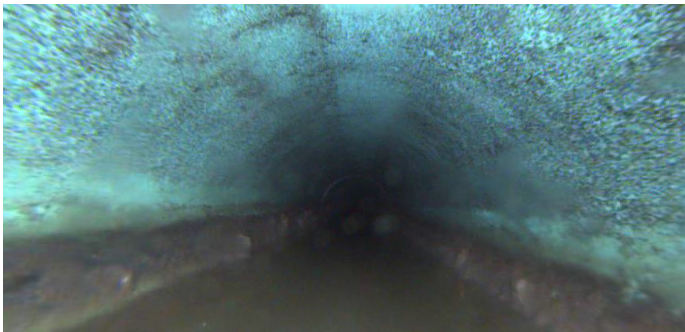
Code:	DAGS
Description:	Deposits Attached Grease

Distance (ft):	94.6
Structural Grade:	0
O&M Grade:	2
Clock Start/From:	8
Clock To:	4
1st Value:	
2nd Value:	
Value Percent:	5.000
Continuous Index:	S01
Within 8" of Joint:	NO
Remarks:

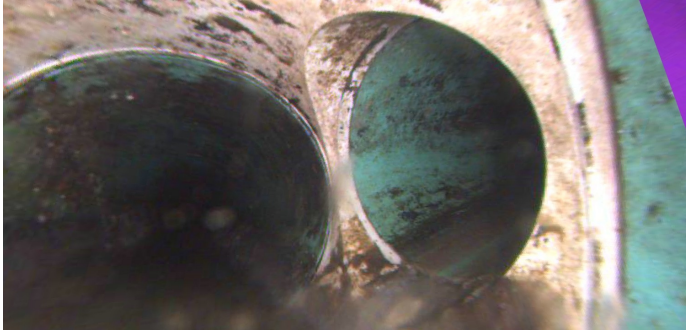
Code: **TFA**
Description: **Tap Factory Active**

Distance (ft): **195.1**
Structural Grade: **0**
O&M Grade: **0**
Clock Start/From: **3**
Clock To:
1st Value: **4.000**
2nd Value:
Value Percent:
Continuous Index:
Within 8" of Joint:
Remarks:

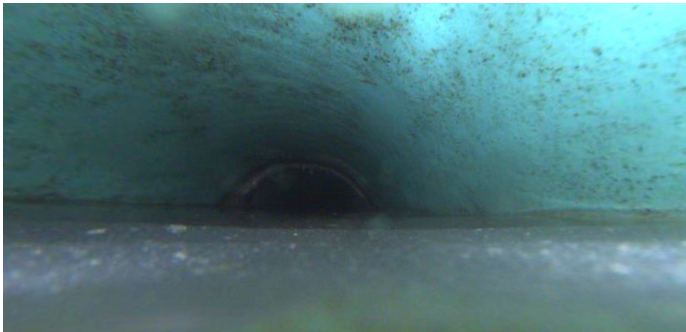
Code: **DAGS**
Description: **Deposits Attached Grease**

Distance (ft): **231.3**
Structural Grade: **0**
O&M Grade: **2**
Clock Start/From: **8**
Clock To: **4**
1st Value:
2nd Value:
Value Percent: **5.000**
Continuous Index: **F01**
Within 8" of Joint: **NO**
Remarks:

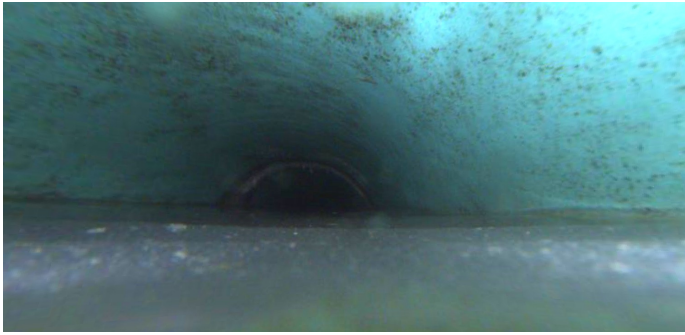
Code: **MWL**
Description: **Water Level**

Distance (ft): **231.3**
Structural Grade: **0**
O&M Grade: **0**
Clock Start/From:
Clock To:
1st Value:
2nd Value:
Value Percent: **60.000**
Continuous Index:
Within 8" of Joint: **NO**
Remarks:
