Profile/Photo Observation Report

Street:	HOWARD ST	Flow Control:	Not Controlled
City:	Hobart, IN	Year Renewed:	
Location:	Other	Tape/Media #:	
Purpose:	Not Known	Dia/Height:	10"
Use:	Sanitary	Material:	VCP
Drain Area:	NA	Lining:	
Category:	NA		
Comment:

Location Details:		Direction of Survey:	Downstream
US MH:	M-103-027	DS MH:	M-103-007
		Total Length Surveyed (ft):	169.3

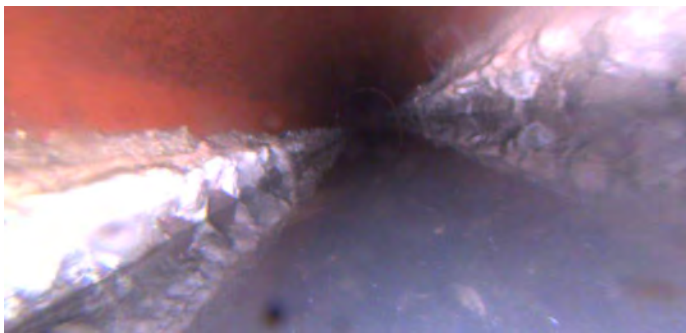
Code: **AMH**
Description: **Manhole**

Distance (ft): **.0**
Structural Grade: **0**
O&M Grade: **0**
Clock Start/From:
Clock To:
1st Value:
2nd Value:
Value Percent:
Continuous Index:
Within 8" of Joint: **NO**
Remarks: **M-103-027**

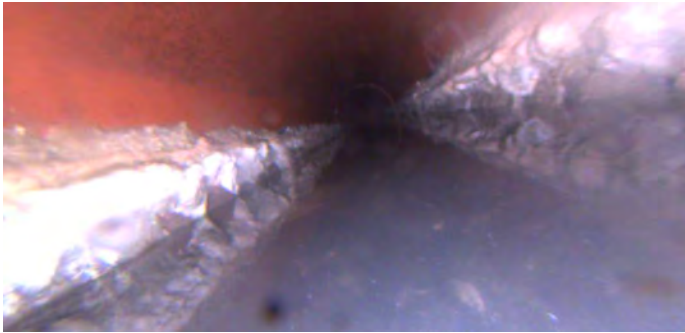
Code:	MWL
Description:	Water Level

Distance (ft):	.0
Structural Grade:	0
O&M Grade:	0
Clock Start/From:	
Clock To:	
1st Value:	
2nd Value:	
Value Percent:	30.000
Continuous Index:	
Within 8" of Joint:	NO
Remarks:

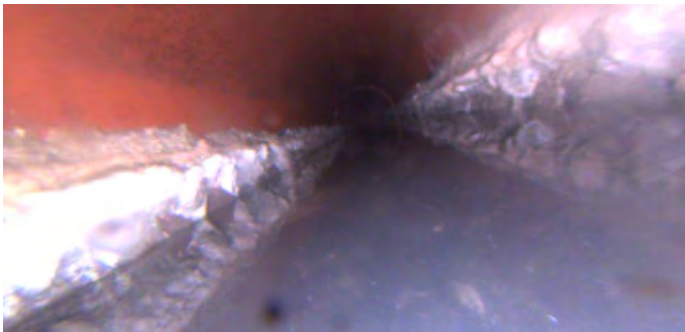
Code:	DAGS
Description:	Deposits Attached Grease

Distance (ft):	.0
Structural Grade:	0
O&M Grade:	2
Clock Start/From:	8
Clock To:	4
1st Value:	
2nd Value:	
Value Percent:	10.000
Continuous Index:	S01
Within 8" of Joint:	NO
Remarks:

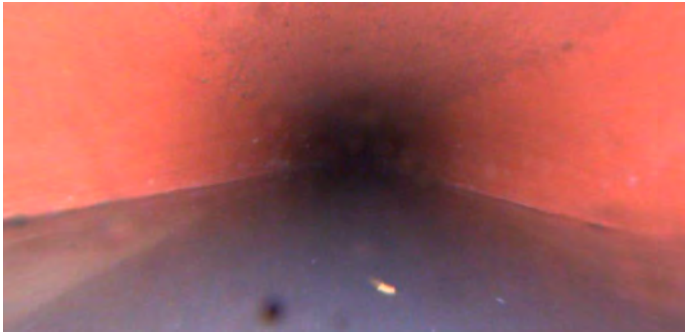
Code: **DAGS**
Description: **Deposits Attached Grease**

Distance (ft): **34.7**
Structural Grade: **0**
O&M Grade: **2**
Clock Start/From: **8**
Clock To: **4**
1st Value:
2nd Value:
Value Percent: **10.000**
Continuous Index: **F01**
Within 8" of Joint: **NO**
Remarks:

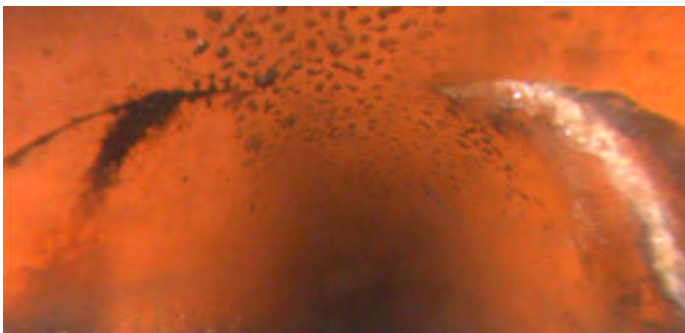
Code: **FC**
Description: **Fracture Circumferential**

Distance (ft): **166.9**
Structural Grade: **2**
O&M Grade: **0**
Clock Start/From: **8**
Clock To: **4**
1st Value:
2nd Value:
Value Percent:
Continuous Index:
Within 8" of Joint:
Remarks:

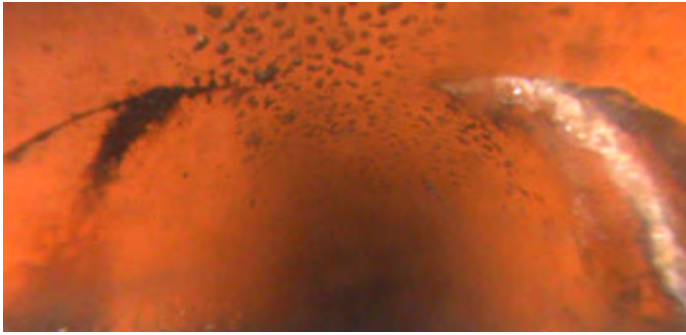
Code: **DAE**
Description: **Deposits Attached Encrustation**

Distance (ft): **166.9**
Structural Grade: **0**
O&M Grade: **2**
Clock Start/From: **8**
Clock To: **4**
1st Value:
2nd Value:
Value Percent: **5.000**
Continuous Index:
Within 8" of Joint: **NO**
Remarks:
