Profile/Photo Observation Report

Date:	04/03/2018	Weather:		Coding:	PACP 6.0
Pipe Length (ft):	176.6	Owner:	NA	Pre Clean:	Not Known
P.O.#:		Surveyor:	Jen Costello	PSR:	P-103-007-027
Customer:		Clean Date:	01/01/1900	Shape:	C

Street:	34th av	Flow Control:	Not Controlled
City:	Hobart, IN	Year Renewed:	
Location:	Other	Tape/Media #:	
Purpose:	Not Known	Dia/Height:	10"
Use:	Sanitary	Material:	VCP
Drain Area:	NA	Lining:	
Category:	NA		
Comment:

Location Details:		Direction of Survey:	Downstream
US MH:	M-103-027	DS MH:	M-103-007
		Total Length Surveyed (ft):	169.3

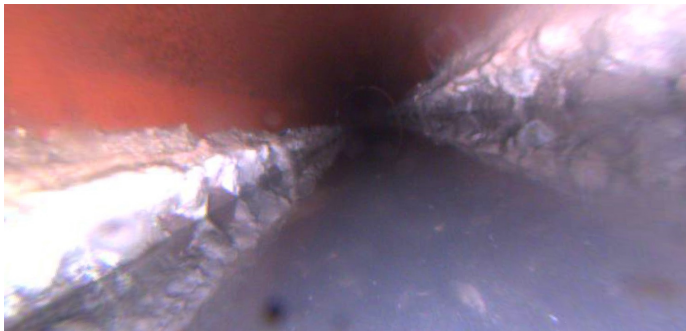
Code: **AMH**
Description: **Manhole**

Distance (ft): **.0**
Structural Grade: **0**
O&M Grade: **0**
Clock Start/From:
Clock To:
1st Value:
2nd Value:
Value Percent:
Continuous Index:
Within 8" of Joint: **NO**
Remarks: **M-103-027**

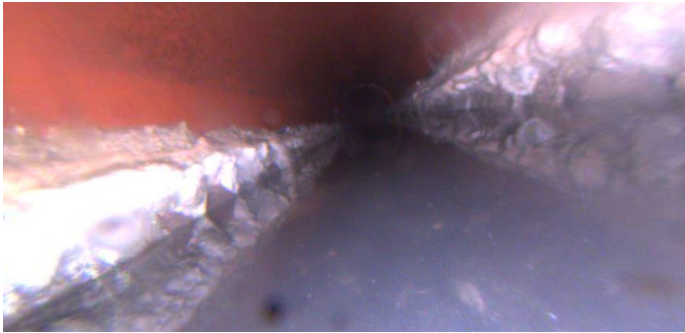
Code:	MWL
Description:	Water Level

Distance (ft):	.0
Structural Grade:	0
O&M Grade:	0
Clock Start/From:	
Clock To:	
1st Value:	
2nd Value:	
Value Percent:	30.000
Continuous Index:	
Within 8" of Joint:	NO
Remarks:

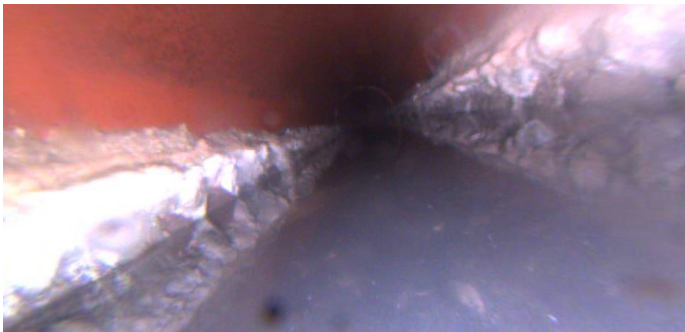
Code:	DAGS
Description:	Deposits Attached Grease

Distance (ft):	.0
Structural Grade:	0
O&M Grade:	2
Clock Start/From:	8
Clock To:	4
1st Value:	
2nd Value:	
Value Percent:	10.000
Continuous Index:	S01
Within 8" of Joint:	NO
Remarks:

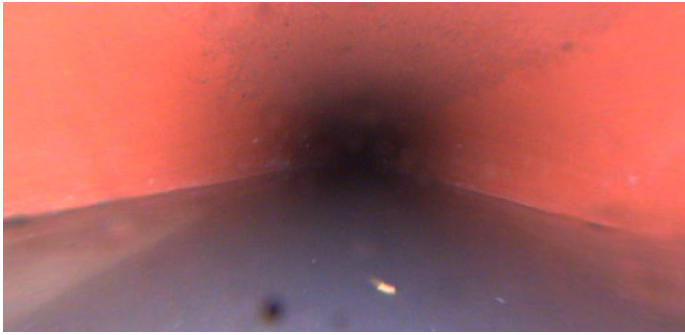
Code: **DAGS**
Description: **Deposits Attached Grease**

Distance (ft): **34.7**
Structural Grade: **0**
O&M Grade: **2**
Clock Start/From: **8**
Clock To: **4**
1st Value:
2nd Value:
Value Percent: **10.000**
Continuous Index: **F01**
Within 8" of Joint: **NO**
Remarks:

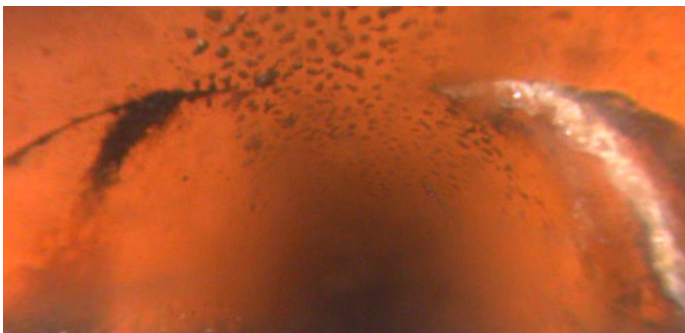
Code: **FC**
Description: **Fracture Circumferential**

Distance (ft): **166.9**
Structural Grade: **2**
O&M Grade: **0**
Clock Start/From: **8**
Clock To: **4**
1st Value:
2nd Value:
Value Percent:
Continuous Index:
Within 8" of Joint:
Remarks:

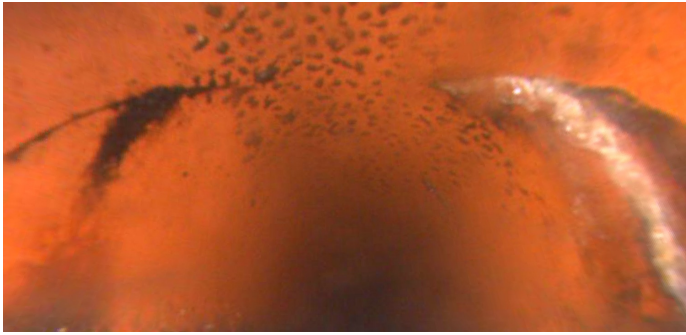
Code: **DAE**
Description: **Deposits Attached Encrustation**

Distance (ft): **166.9**
Structural Grade: **0**
O&M Grade: **2**
Clock Start/From: **8**
Clock To: **4**
1st Value:
2nd Value:
Value Percent: **5.000**
Continuous Index:
Within 8" of Joint: **NO**
Remarks:
