Profile/Photo Observation Report

Location Details:		Direction of Survey:	Upstream
US MH:	M-103-027	DS MH:	M-103-028
		Total Length Surveyed (ft):	11.8

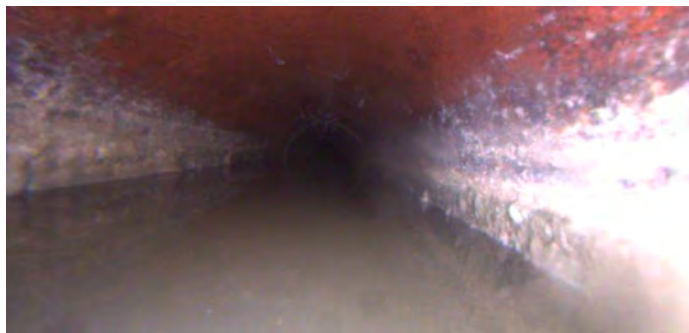
Code: **AMH**
Description: **Manhole**

Distance (ft): **.0**
Structural Grade: **0**
O&M Grade: **0**
Clock Start/From:
Clock To:
1st Value:
2nd Value:
Value Percent:
Continuous Index:
Within 8" of Joint: **NO**
Remarks: **M-103-028**

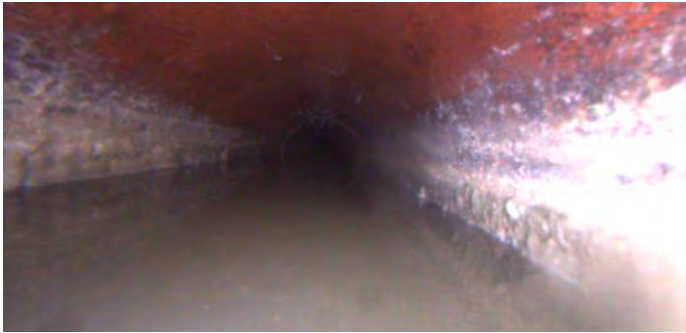
Code:	MWL
Description:	Water Level

Distance (ft):	.0
Structural Grade:	0
O&M Grade:	0
Clock Start/From:	
Clock To:	
1st Value:	
2nd Value:	
Value Percent:	30.000
Continuous Index:	
Within 8" of Joint:	NO
Remarks:

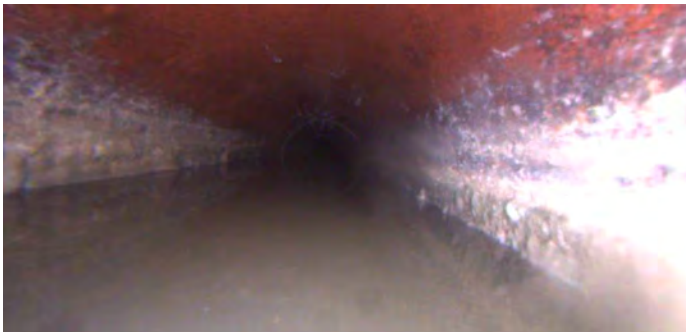
Code:	DAGS
Description:	Deposits Attached Grease

Distance (ft):	.0
Structural Grade:	0
O&M Grade:	2
Clock Start/From:	8
Clock To:	4
1st Value:	
2nd Value:	
Value Percent:	5.000
Continuous Index:	S01
Within 8" of Joint:	NO
Remarks:

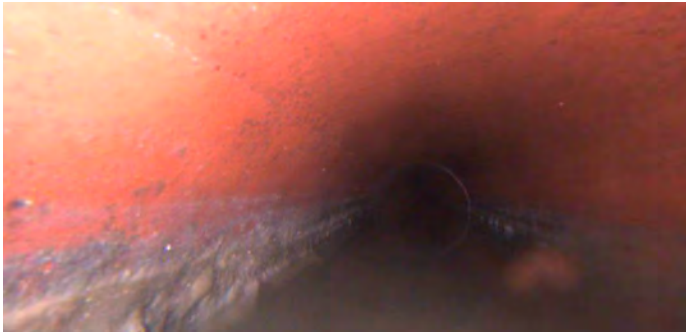
Code: **DAGS**
Description: **Deposits Attached Grease**

Distance (ft): **11.8**
Structural Grade: **0**
O&M Grade: **2**
Clock Start/From: **8**
Clock To: **4**
1st Value:
2nd Value:
Value Percent: **5.000**
Continuous Index: **F01**
Within 8" of Joint: **NO**
Remarks:

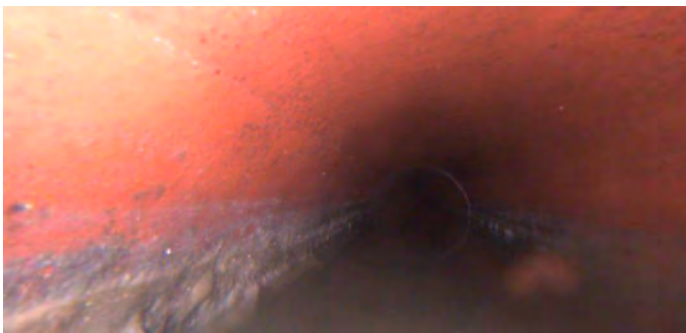
Code: **MSA**
Description: **Abandoned Survey**

Distance (ft): **11.8**
Structural Grade: **0**
O&M Grade: **0**
Clock Start/From:
Clock To:
1st Value:
2nd Value:
Value Percent:
Continuous Index:
Within 8" of Joint: **NO**
Remarks: **DEBRIS UNDER WATER**
