Date:	04/06/2018	Weather:		Coding:	PACP 6.0
Pipe Length (ft):	151.5	Owner:	NA	Pre Clean:	Not Known
P.O.#:		Surveyor:	Jen Costello	PSR:	P-103-027-028
Customer:		Clean Date:	01/01/1900	Shape:	С
Street:	39th av		Flow Control:	Not Controlled	
City:	Hobart, IN		Year Renewed:		
Location:	Other		Tape/Media #:		
Purpose:	Not Known		Dia/Height:	12"	
Use:	Sanitary		Material:	VCP	
Drain Area:	NA		Lining:		
Category:	NA				
Comment:					
Location Details	:		Direction of Survey	/: Upstream	
US MH:	M-103-027	DS MH:	M-103-028	Total Length Surveyed (ft)	: 11.8
D&M Index:	2.00	O&M Quick:	2200	O&M Rating:	4.00
Structural Index:	0.00	Structural Qu	uick: 0000	Structural Rating:	0.00
Overall Index:	2.00	Overall Quic		Overall Rating:	4.00

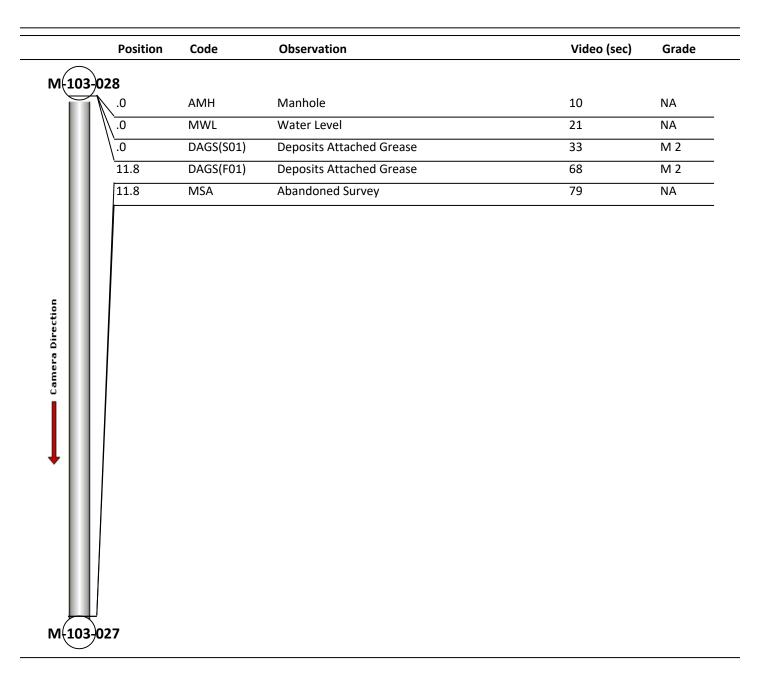
Code:	DAGS
Description:	Deposits Attached Grease

Distance (ft):	.0
Structural Grade:	0
O&M Grade:	2
Clock Start/From:	8
Clock To:	4
1st Value:	
2nd Value:	
Value Percent:	5.000
Continuous Index:	S01
Within 8" of Joint:	NO
Remarks:

Code:DAGSDescription:Deposits Attached Grease

Distance (ft):	11.8
Structural Grade:	0
O&M Grade:	2
Clock Start/From:	8
Clock To:	4
1st Value:	
2nd Value:	
Value Percent:	5.000
Continuous Index:	F01
Within 8" of Joint:	NO
Remarks:

MSA Abandoned Survey

Distance (ft):	11.8
Structural Grade:	0
O&M Grade:	0
Clock Start/From:	
Clock To:	
1st Value:	
2nd Value:	
Value Percent:	
Continuous Index:	
Within 8" of Joint:	NO
Remarks:	DEBRIS UNDER WATER
