## Profile/Photo Observation Report

| P.O.#: | | Surveyor: | <b>Byrd Fitzgerald</b> | PSR: | <b>P-103-028-029</b> |

| Street: | <b>E 38th Ave</b> | Flow Control: | <b>Not Controlled</b> |
| City: | <b>Hobart, IN</b> | Year Renewed: | |

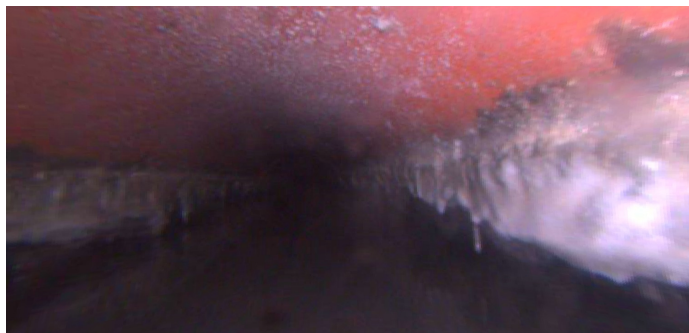
Code: **AMH**  
Description: **Manhole**

Distance (ft): **.0**  
Structural Grade: **0**  
O&M Grade: **0**  
Clock Start/From:  
Clock To:  
1st Value:  
2nd Value:  
Value Percent:  
Continuous Index:  
Within 8" of Joint: **NO**  
Remarks: **M-103-029**

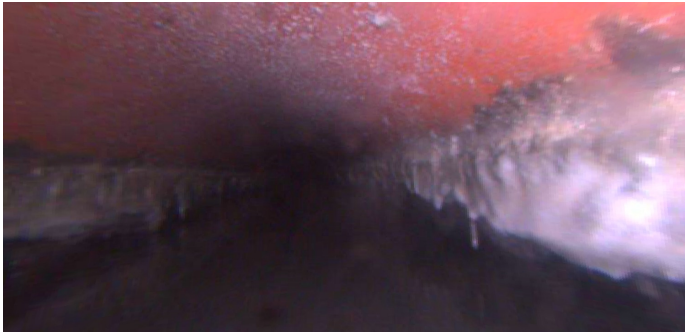
| Code: | <b>MWL</b> |
| Description: | <b>Water Level</b> |

| Value Percent: | <b>50.000</b> |

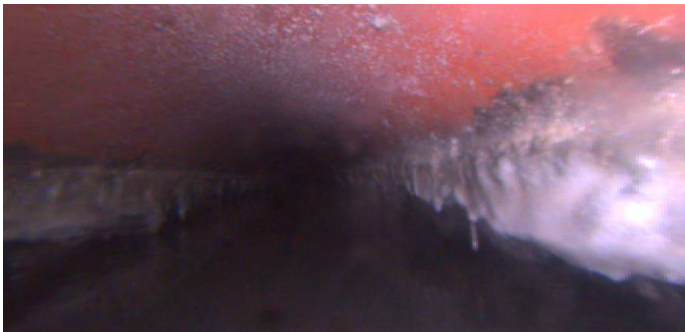
| Code: | <b>DAGS</b> |
| Description: | <b>Deposits Attached Grease</b> |

| O&M Grade: | <b>2</b> |
| Clock Start/From: | <b>9</b> |
| Clock To: | <b>3</b> |
| Value Percent: | <b>10.000</b> |

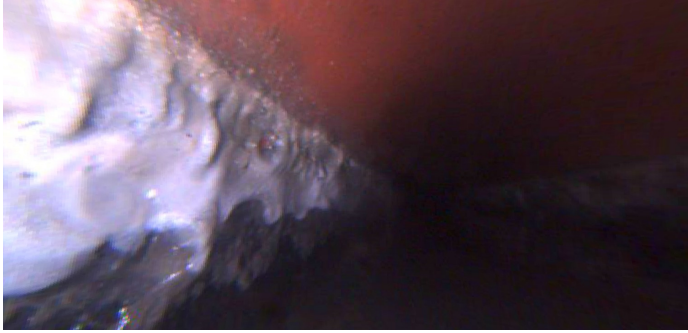
| Code: | <b>MSA</b> |
| Description: | <b>Abandoned Survey</b> |
| Distance (ft): | <b>5.4</b> |
| Remarks: | <b>stuck on wall</b> |
