Profile/Photo Observation Report

Street:	E 38th Ave	Flow Control:	Not Controlled
City:	Hobart, IN	Year Renewed:	
Location:	Other	Tape/Media #:	
Purpose:	Not Known	Dia/Height:	12"
Use:	Sanitary	Material:	VCP
Drain Area:	NA	Lining:	
Category:	NA		
Comment:	Debris, sediment. Solo will not deploy		
Location Details:		Direction of Survey:	Downstream
US MH:	M-103-028	DS MH:	M-103-029
		Total Length Surveyed (ft):	21.5

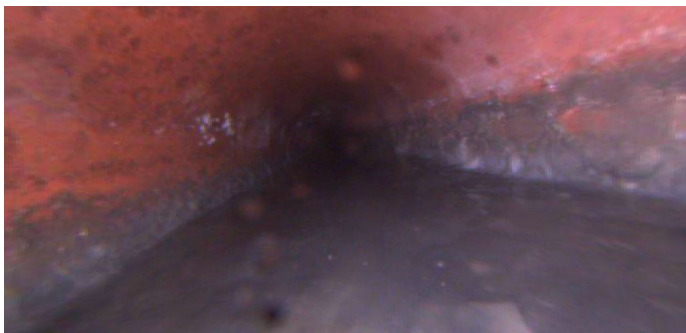
Code: **AMH**
Description: **Manhole**

Distance (ft): **.0**
Structural Grade: **0**
O&M Grade: **0**
Clock Start/From:
Clock To:
1st Value:
2nd Value:
Value Percent:
Continuous Index:
Within 8" of Joint: **NO**
Remarks: **M-103-028**

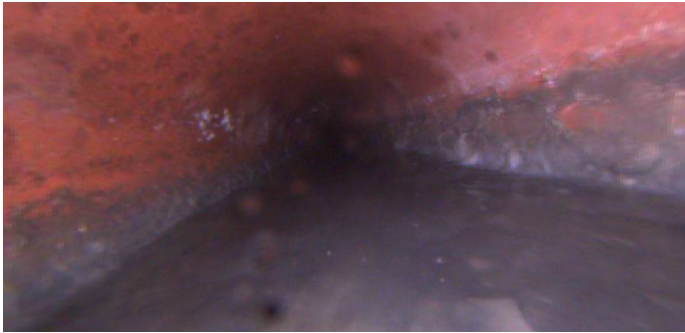
Code:	MWL
Description:	Water Level

Distance (ft):	.0
Structural Grade:	0
O&M Grade:	0
Clock Start/From:	
Clock To:	
1st Value:	
2nd Value:	
Value Percent:	5.000
Continuous Index:	
Within 8" of Joint:	NO
Remarks:

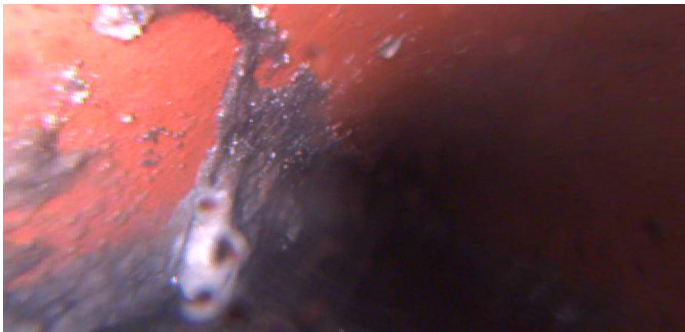
Code:	MSA
Description:	Abandoned Survey

Distance (ft):	21.5
Structural Grade:	0
O&M Grade:	0
Clock Start/From:	
Clock To:	
1st Value:	
2nd Value:	
Value Percent:	
Continuous Index:	
Within 8" of Joint:	NO
Remarks:	stuck on wall
