Profile/Photo Observation Report

Street:	HOWARD ST	Flow Control:	Not Controlled
City:	Hobart, IN	Year Renewed:	
Location:	Light Highway	Tape/Media #:	
Purpose:	Routine Assessment	Dia/Height:	12"
Use:	Sanitary	Material:	VCP
Drain Area:	NA	Lining:	
Category:	NA		
Comment:

Location Details:		Direction of Survey:	Downstream
US MH:	M-103-028	DS MH:	M-103-029
		Total Length Surveyed (ft):	101.3

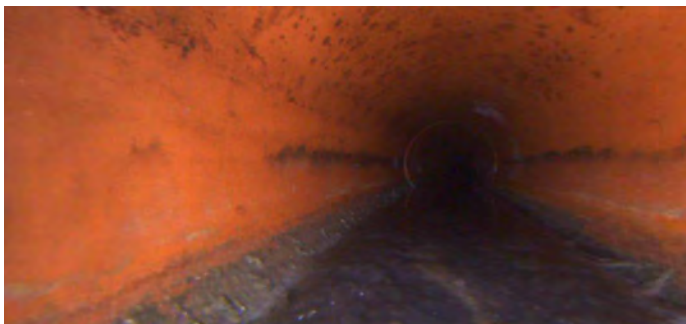
Code: **AMH**
Description: **Manhole**

Distance (ft): **.0**
Structural Grade: **0**
O&M Grade: **0**
Clock Start/From:
Clock To:
1st Value:
2nd Value:
Value Percent:
Continuous Index:
Within 8" of Joint: **NO**
Remarks: **M-103-028**

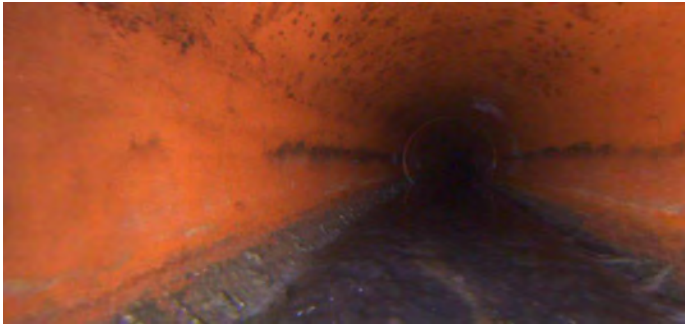
Code:	MWL
Description:	Water Level

Distance (ft):	.0
Structural Grade:	0
O&M Grade:	0
Clock Start/From:	
Clock To:	
1st Value:	
2nd Value:	
Value Percent:	5.000
Continuous Index:	
Within 8" of Joint:	NO
Remarks:

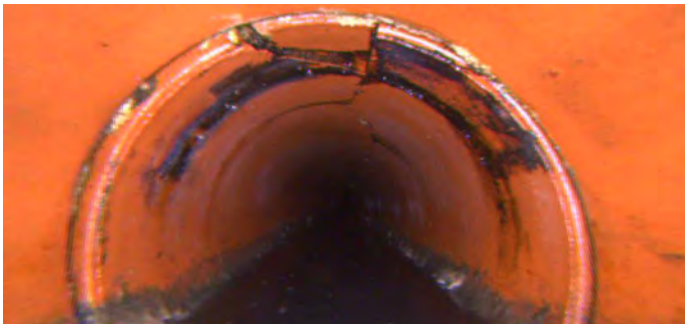
Code:	FL
Description:	Fracture Longitudinal

Distance (ft):	68.4
Structural Grade:	3
O&M Grade:	0
Clock Start/From:	12
Clock To:	
1st Value:	
2nd Value:	
Value Percent:	
Continuous Index:	
Within 8" of Joint:	YES
Remarks:

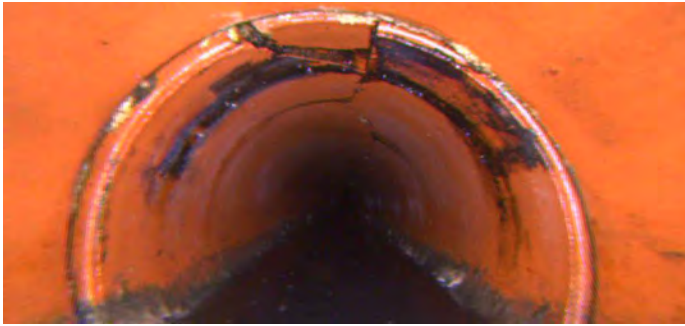
Code: **IS**
Description: **Infil Stain**

Distance (ft): **68.4**
Structural Grade: **0**
O&M Grade: **0**
Clock Start/From: **8**
Clock To: **4**
1st Value:
2nd Value:
Value Percent:
Continuous Index:
Within 8" of Joint: **YES**
Remarks:

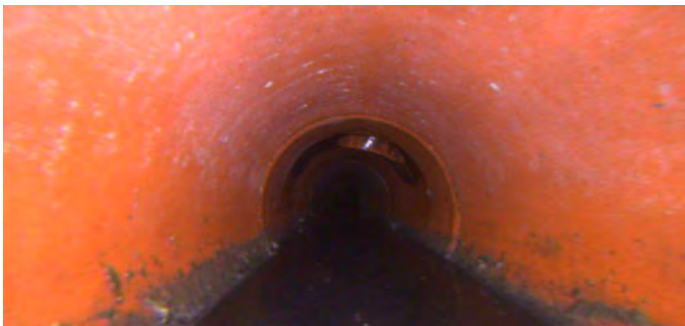
Code: **TF**
Description: **Tap Factory**

Distance (ft): **92.4**
Structural Grade: **0**
O&M Grade: **0**
Clock Start/From: **12**
Clock To:
1st Value: **4.000**
2nd Value:
Value Percent:
Continuous Index:
Within 8" of Joint:
Remarks:

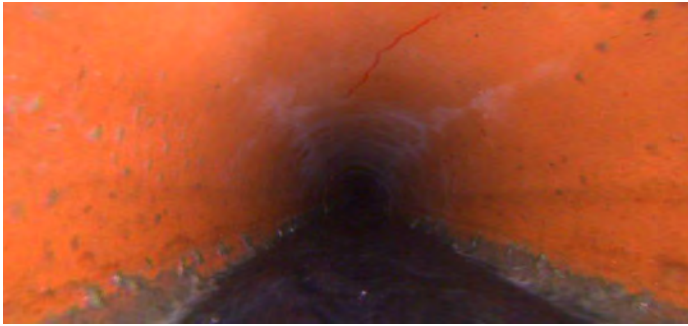
Code:	MSA
Description:	Abandoned Survey
Distance (ft):	101.3
Structural Grade:	0
O&M Grade:	0
Clock Start/From:	
Clock To:	
1st Value:	
2nd Value:	
Value Percent:	
Continuous Index:	
Within 8" of Joint:	NO
Remarks:	camera stopped
