Profile/Photo Observation Report

| Street: | Dell St | Flow Control: | Not Controlled |
| City: | Hobart, IN | Year Renewed: | |

| US MH: | M-103-028 | DS MH: | M-103-029 |

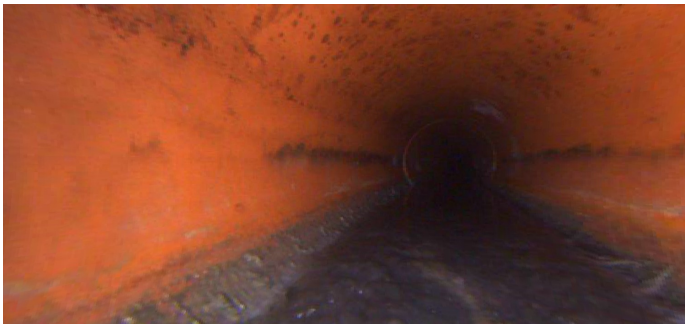
Code: **AMH**
Description: **Manhole**

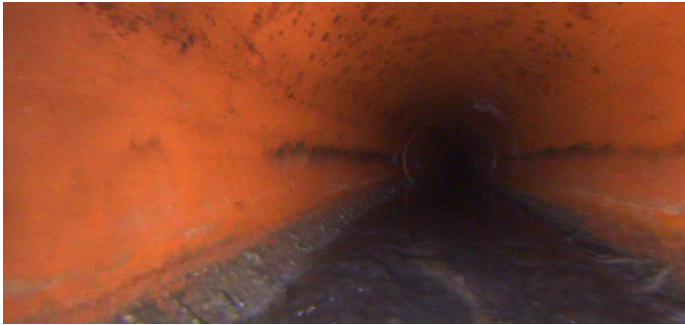
| Code: | MWL |
| Description: | Water Level |

| Value Percent: | 5.000 |

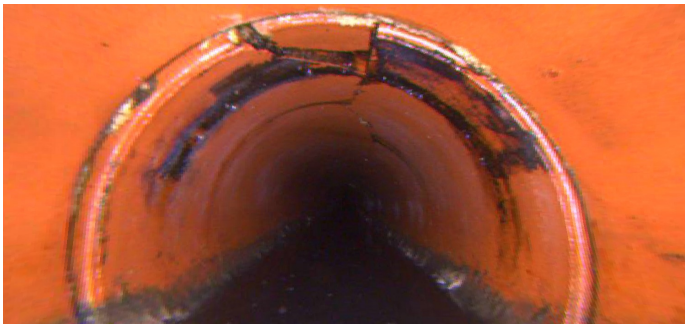
| Position | Code | Observation | Video (sec) | Grade |
|---|---|---|---|---|
| 68.4 | FL | Fracture Longitudinal | 170 | S 3 |

| Code: | FL |
| Description: | Fracture Longitudinal |

| Distance (ft): | 68.4 |
| Structural Grade: | 3 |
| Clock Start/From: | 12 |
| Within 8" of Joint: | YES |

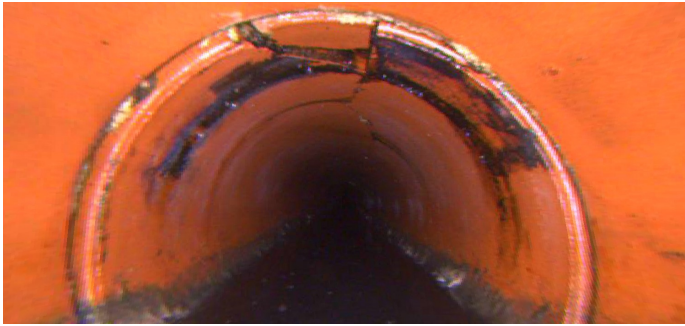
| Position | Code | Observation | Video (sec) | Grade |
|---|---|---|---|---|
| 68.4 | IS | Infil Stain | 181 | NA |

Code: **IS**
Description: **Infil Stain**

Distance (ft): **68.4**
Structural Grade: **0**
O&M Grade: **0**
Clock Start/From: **8**
Clock To: **4**
1st Value:
2nd Value:
Value Percent:
Continuous Index:
Within 8" of Joint: **YES**
Remarks:

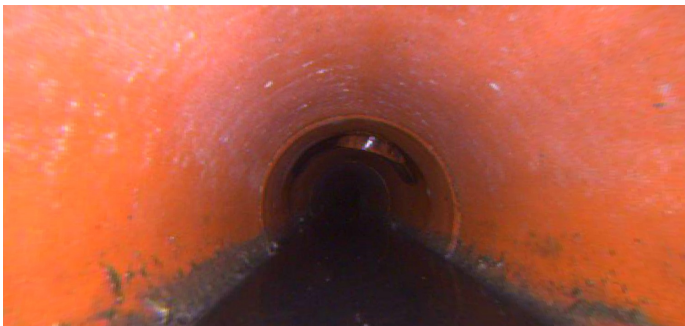
Code: **TF**
Description: **Tap Factory**

Distance (ft): **92.4**
Structural Grade: **0**
O&M Grade: **0**
Clock Start/From: **12**
Clock To:
1st Value: **4.000**
2nd Value:
Value Percent:
Continuous Index:
Within 8" of Joint:
Remarks:

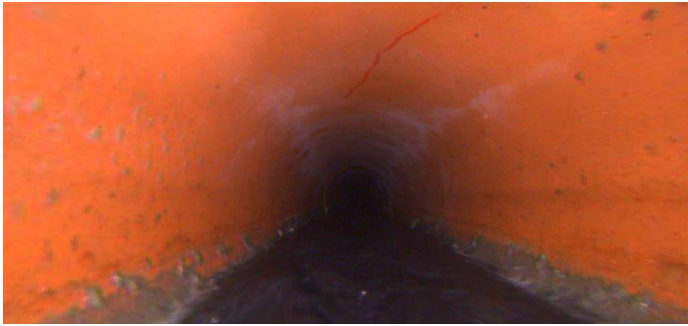
| Code: | MSA |
| Description: | Abandoned Survey |
| Distance (ft): | 101.3 |
| Remarks: | camera stopped |
