Profile/Photo Observation Report

Street:	HOWARD ST	Flow Control:	Not Controlled
City:	Hobart, IN	Year Renewed:	
Location:	Light Highway	Tape/Media #:	
Purpose:	Routine Assessment	Dia/Height:	12"
Use:	Sanitary	Material:	VCP
Drain Area:	NA	Lining:	
Category:	NA		
Comment:

Location Details:		Direction of Survey:	Upstream
US MH:	M-103-028	DS MH:	M-103-029
		Total Length Surveyed (ft):	46.8

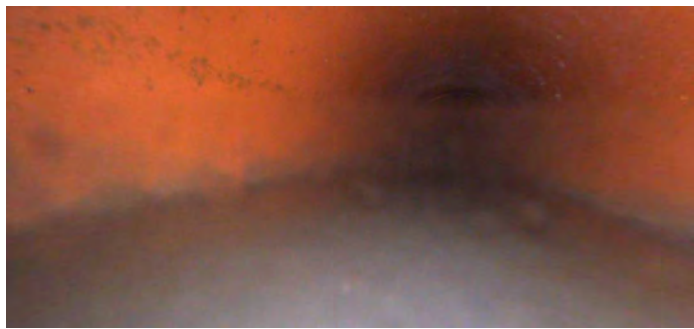
Code: **AMH**
Description: **Manhole**

Distance (ft): **.0**
Structural Grade: **0**
O&M Grade: **0**
Clock Start/From:
Clock To:
1st Value:
2nd Value:
Value Percent:
Continuous Index:
Within 8" of Joint: **NO**
Remarks: **M-103-029**

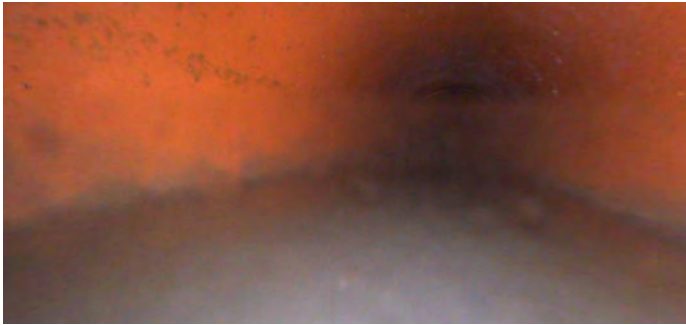
Code:	MWL
Description:	Water Level

Distance (ft):	.0
Structural Grade:	0
O&M Grade:	0
Clock Start/From:	
Clock To:	
1st Value:	
2nd Value:	
Value Percent:	5.000
Continuous Index:	
Within 8" of Joint:	NO
Remarks:

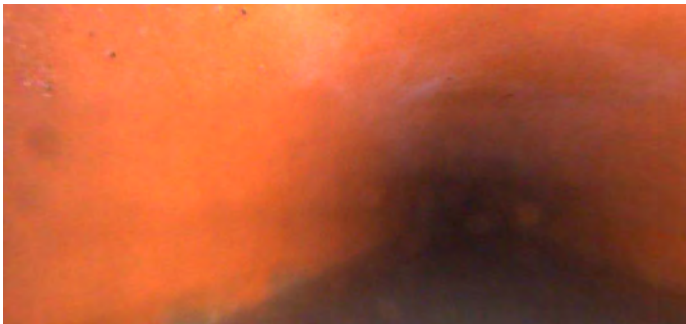
Code:	MSA
Description:	Abandoned Survey

Distance (ft):	46.8
Structural Grade:	0
O&M Grade:	0
Clock Start/From:	
Clock To:	
1st Value:	
2nd Value:	
Value Percent:	
Continuous Index:	
Within 8" of Joint:	NO
Remarks:	camera stopped
