Profile/Photo Observation Report

Street:	Dell St	Flow Control:	Not Controlled
City:	Hobart, IN	Year Renewed:	
Location:	Light Highway	Tape/Media #:	
Purpose:	Routine Assessment	Dia/Height:	12"
Use:	Sanitary	Material:	VCP
Drain Area:	NA	Lining:	
Category:	NA		
Comment:

Location Details:		Direction of Survey:	Upstream
US MH:	M-103-028	DS MH:	M-103-029
		Total Length Surveyed (ft):	46.8

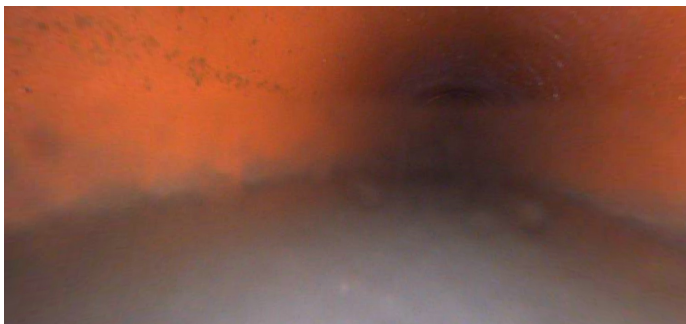
Code: **AMH**
Description: **Manhole**

Distance (ft): **.0**
Structural Grade: **0**
O&M Grade: **0**
Clock Start/From:
Clock To:
1st Value:
2nd Value:
Value Percent:
Continuous Index:
Within 8" of Joint: **NO**
Remarks: **M-103-029**

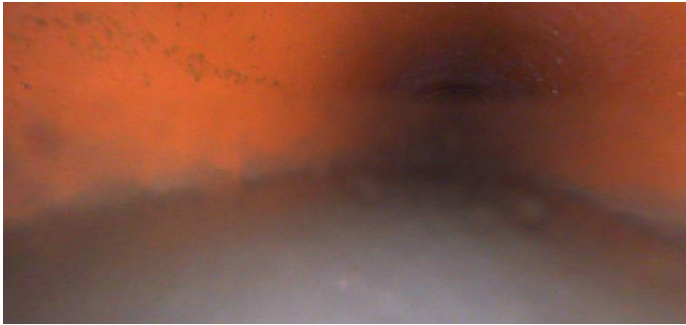
Code:	MWL
Description:	Water Level

Distance (ft):	.0
Structural Grade:	0
O&M Grade:	0
Clock Start/From:	
Clock To:	
1st Value:	
2nd Value:	
Value Percent:	5.000
Continuous Index:	
Within 8" of Joint:	NO
Remarks:

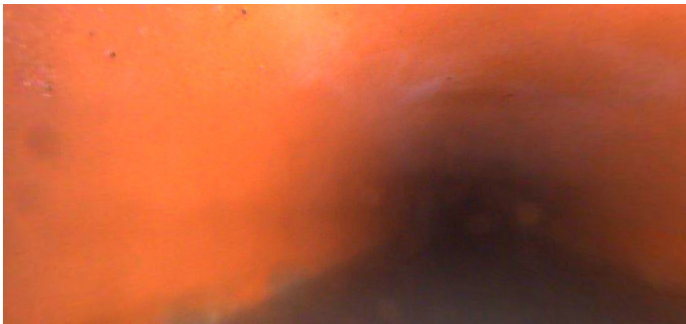
Code:	MSA
Description:	Abandoned Survey

Distance (ft):	46.8
Structural Grade:	0
O&M Grade:	0
Clock Start/From:	
Clock To:	
1st Value:	
2nd Value:	
Value Percent:	
Continuous Index:	
Within 8" of Joint:	NO
Remarks:	camera stopped
