## Profile/Photo Observation Report

Street:	<b>FOXCROFT STREET</b>	Flow Control:	<b>Not Controlled</b>
City:	<b>Hobart, IN</b>	Year Renewed:	
Location:	<b>Light Highway</b>	Tape/Media #:	
Purpose:	<b>Routine Assessment</b>	Dia/Height:	<b>10"</b>
Use:	<b>Sanitary</b>	Material:	<b>VCP</b>
Drain Area:	<b>NA</b>	Lining:	
Category:	<b>NA</b>		
Comment:	<b>P_C at 27 ft unknown obstruction</b>		
Location Details:		Direction of Survey:	<b>Upstream</b>
US MH:	<b>M-507-003</b>	DS MH:	<b>M-507-019A</b>
		Total Length Surveyed (ft):	<b>27.9</b>

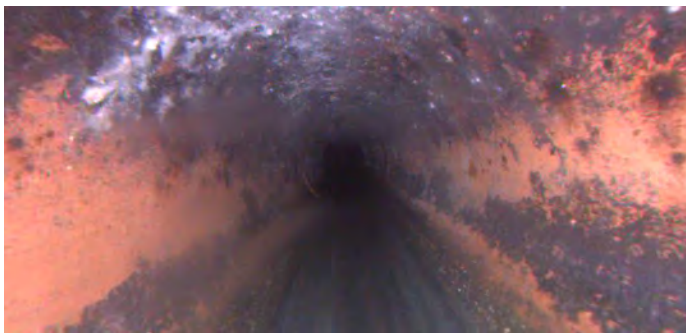
Code: **DAZ**  
Description: **Deposits Attached Other**

Distance (ft): **.0**  
Structural Grade: **0**  
O&M Grade: **2**  
Clock Start/From: **8**  
Clock To: **4**  
1st Value:  
2nd Value:  
Value Percent: **5.000**  
Continuous Index: **S01**  
Within 8" of Joint: **NO**  
Remarks:

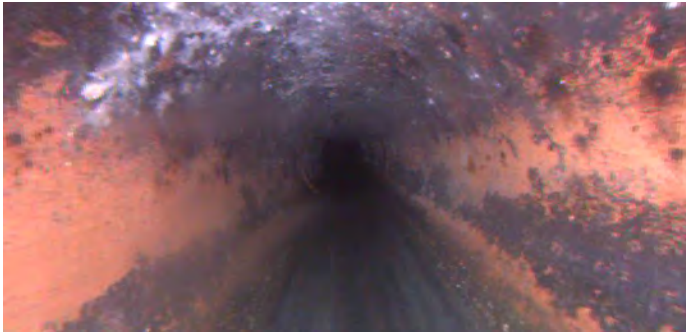
Code:	<b>AMH</b>
Description:	<b>Manhole</b>

Distance (ft):	<b>.0</b>
Structural Grade:	<b>0</b>
O&M Grade:	<b>0</b>
Clock Start/From:	
Clock To:	
1st Value:	
2nd Value:	
Value Percent:	
Continuous Index:	
Within 8" of Joint:	<b>NO</b>
Remarks:	<b>M-507-019A</b>

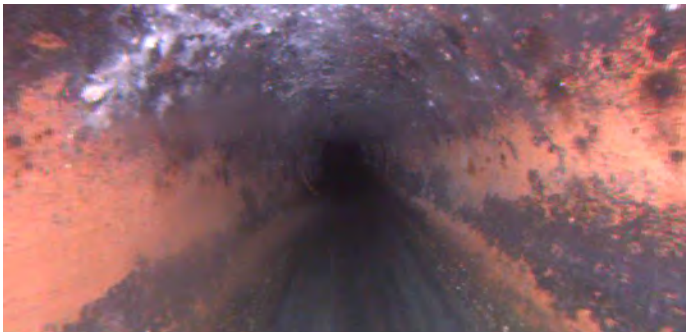
Code:	<b>MWL</b>
Description:	<b>Water Level</b>

Distance (ft):	<b>.0</b>
Structural Grade:	<b>0</b>
O&M Grade:	<b>0</b>
Clock Start/From:	
Clock To:	
1st Value:	
2nd Value:	
Value Percent:	<b>5.000</b>
Continuous Index:	
Within 8" of Joint:	<b>NO</b>
Remarks:

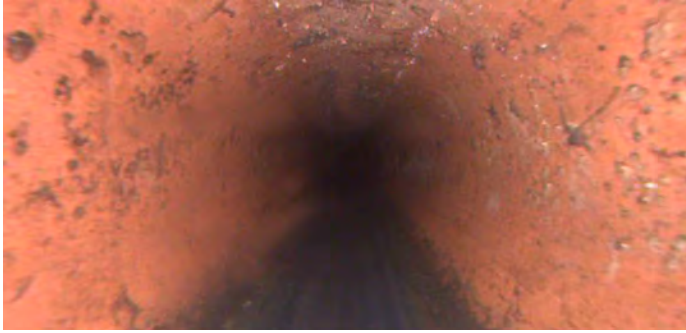
Code: **DAZ**  
Description: **Deposits Attached Other**

Distance (ft): **8.7**  
Structural Grade: **0**  
O&M Grade: **2**  
Clock Start/From: **8**  
Clock To: **4**  
1st Value:  
2nd Value:  
Value Percent: **5.000**  
Continuous Index: **F01**  
Within 8" of Joint: **NO**  
Remarks:

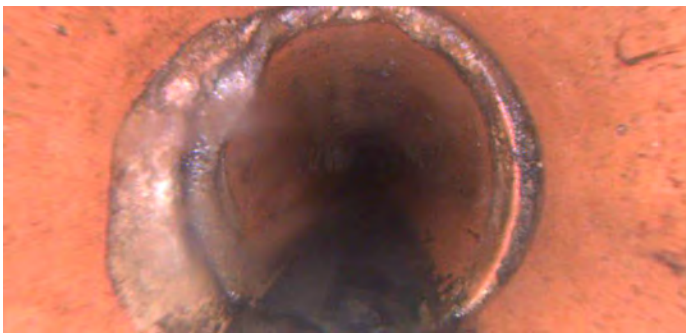
Code: **DAE**  
Description: **Deposits Attached Encrustation**

Distance (ft): **17.7**  
Structural Grade: **0**  
O&M Grade: **2**  
Clock Start/From: **8**  
Clock To: **4**  
1st Value:  
2nd Value:  
Value Percent: **5.000**  
Continuous Index:  
Within 8" of Joint: **YES**  
Remarks:

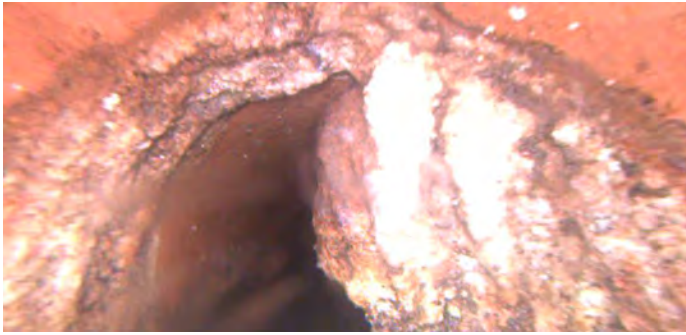
Code: **DAE**  
Description: **Deposits Attached Encrustation**

Distance (ft): **27.7**  
Structural Grade: **0**  
O&M Grade: **5**  
Clock Start/From: **8**  
Clock To: **4**  
1st Value:  
2nd Value:  
Value Percent: **60.000**  
Continuous Index:  
Within 8" of Joint: **YES**  
Remarks:

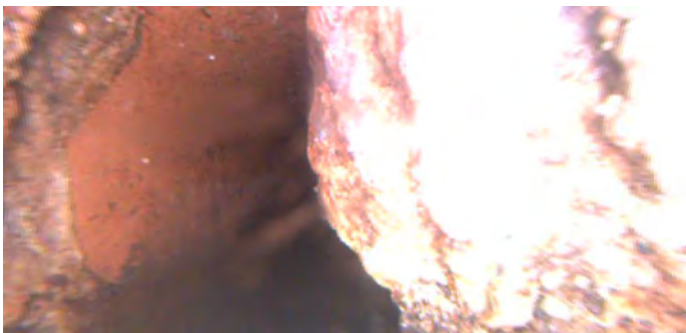
Code: **MSA**  
Description: **Abandoned Survey**

Distance (ft): **27.9**  
Structural Grade: **0**  
O&M Grade: **0**  
Clock Start/From:  
Clock To:  
1st Value:  
2nd Value:  
Value Percent:  
Continuous Index:  
Within 8" of Joint: **NO**  
Remarks: **blockage**
