Profile/Photo Observation Report

Street:	FOXCROFT STREET	Flow Control:	Not Controlled
City:	Hobart, IN	Year Renewed:	
Location:	Light Highway	Tape/Media #:	
Purpose:	Routine Assessment	Dia/Height:	12"
Use:	Sanitary	Material:	VCP
Drain Area:	NA	Lining:	
Category:	NA		
Comment:	R_M at 25 ft debris .		
Location Details:		Direction of Survey:	Upstream
US MH:	M-507-006	DS MH:	M-507-019A
		Total Length Surveyed (ft):	27.0

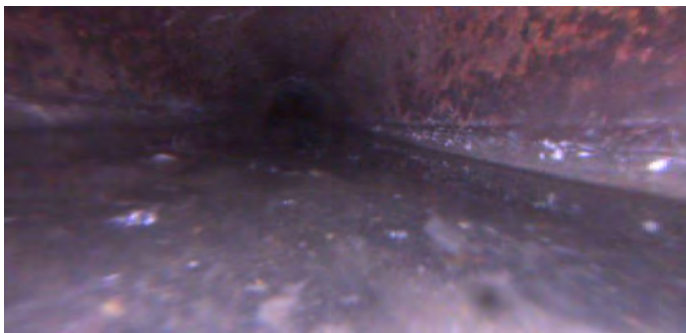
Code: **AMH**
Description: **Manhole**

Distance (ft): **.0**
Structural Grade: **0**
O&M Grade: **0**
Clock Start/From:
Clock To:
1st Value:
2nd Value:
Value Percent:
Continuous Index:
Within 8" of Joint: **NO**
Remarks: **M-507-019A**

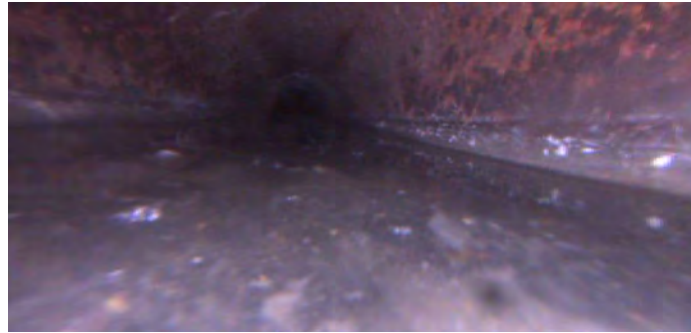
Code: **MWL**
Description: **Water Level**

Distance (ft): **.0**
Structural Grade: **0**
O&M Grade: **0**
Clock Start/From:
Clock To:
1st Value:
2nd Value:
Value Percent: **5.000**
Continuous Index:
Within 8" of Joint: **NO**
Remarks:

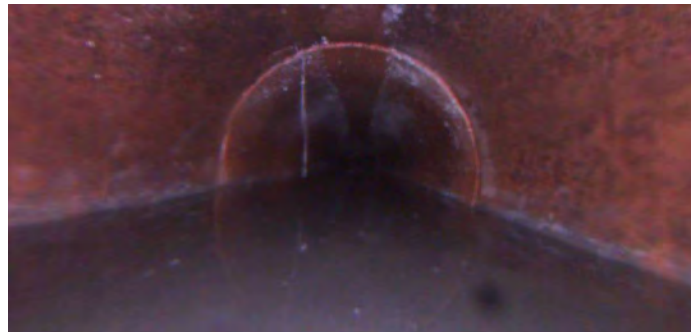
Code: **RFJ**
Description: **Roots Fine Joint**

Distance (ft): **10.1**
Structural Grade: **0**
O&M Grade: **1**
Clock Start/From: **11**
Clock To:
1st Value:
2nd Value:
Value Percent:
Continuous Index:
Within 8" of Joint: **YES**
Remarks:

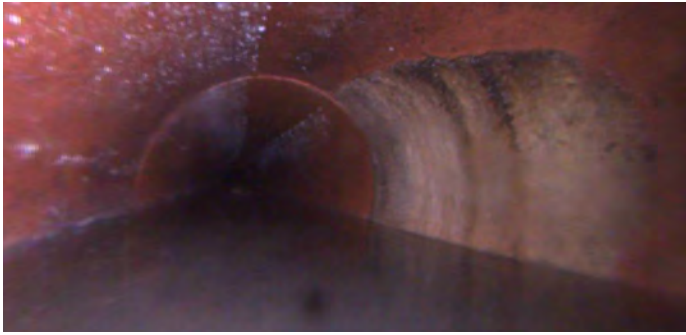
Code: **FL**
Description: **Fracture Longitudinal**

Distance (ft): **16.1**
Structural Grade: **3**
O&M Grade: **0**
Clock Start/From: **1**
Clock To:
1st Value:
2nd Value:
Value Percent:
Continuous Index:
Within 8" of Joint: **YES**
Remarks:

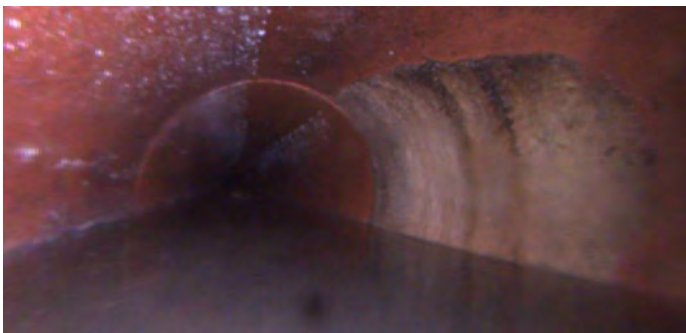
Code: **IS**
Description: **Infil Stain**

Distance (ft): **16.1**
Structural Grade: **0**
O&M Grade: **0**
Clock Start/From: **1**
Clock To: **4**
1st Value:
2nd Value:
Value Percent:
Continuous Index:
Within 8" of Joint: **YES**
Remarks:
