## Profile/Photo Observation Report

| Street: | <b>W 38TH AV</b> | Flow Control: | <b>Not Controlled</b> |
| City: | <b>Hobart, IN</b> | Year Renewed: | |

| US MH: | <b>M-103-030</b> | DS MH: | <b>M-103-031</b> |

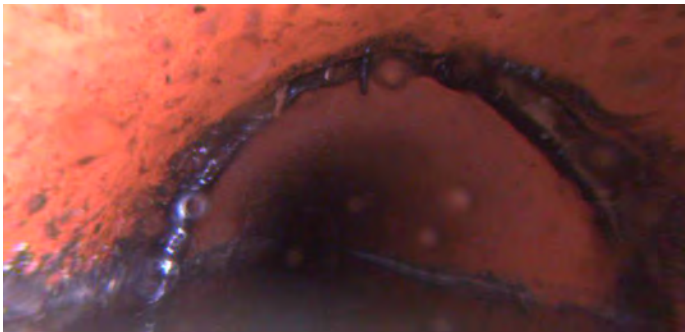
| Code: | <b>ID</b> |
| Description: | <b>Infil Dripper</b> |

| Distance (ft): | <b>2.9</b> |
| O&M Grade: | <b>3</b> |
| Clock Start/From: | <b>11</b> |
| Clock To: | <b>1</b> |
| Within 8" of Joint: | <b>YES</b> |

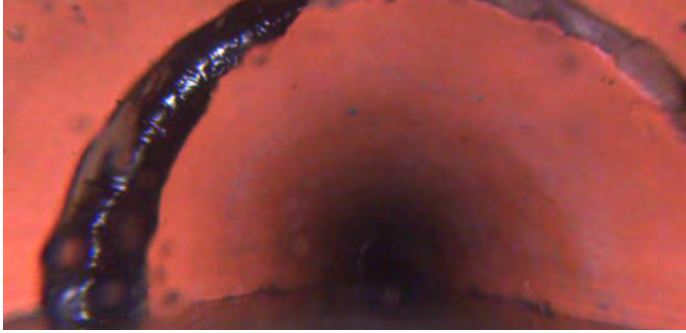
Code: **IW**  
Description: **Infil Weeper**

Distance (ft): **7.9**  
Structural Grade: **0**  
O&M Grade: **2**  
Clock Start/From: **8**  
Clock To: **12**  
1st Value:  
2nd Value:  
Value Percent:  
Continuous Index:  
Within 8" of Joint: **YES**  
Remarks:

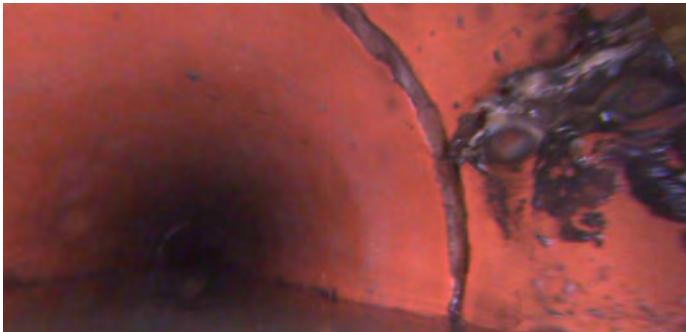
Code: **DAGS**  
Description: **Deposits Attached Grease**

Distance (ft): **7.9**  
Structural Grade: **0**  
O&M Grade: **2**  
Clock Start/From: **3**  
Clock To:  
1st Value:  
2nd Value:  
Value Percent: **5.000**  
Continuous Index:  
Within 8" of Joint: **NO**  
Remarks:

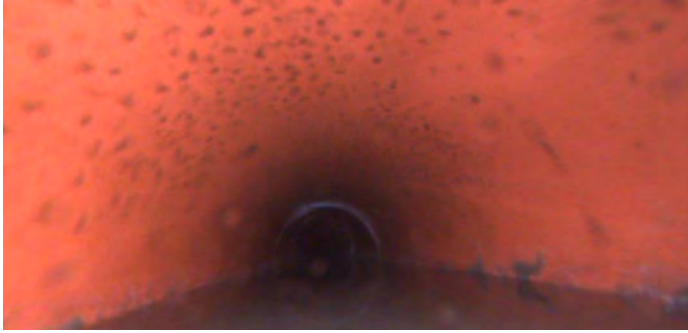
| Code: | MSA |
| Description: | Abandoned Survey |
| Distance (ft): | 50.4 |
| Remarks: | DEBRIS UNDER WATER |
