Profile/Photo Observation Report

Street:	E 38th Ave	Flow Control:	Not Controlled
City:	Hobart, IN	Year Renewed:	
Location:	Other	Tape/Media #:	
Purpose:	Not Known	Dia/Height:	12"
Use:	Sanitary	Material:	PVC
Drain Area:	NA	Lining:	
Category:	NA		
Comment:

Location Details:		Direction of Survey:	Upstream
US MH:	M-103-030	DS MH:	M-103-031
		Total Length Surveyed (ft):	50.4

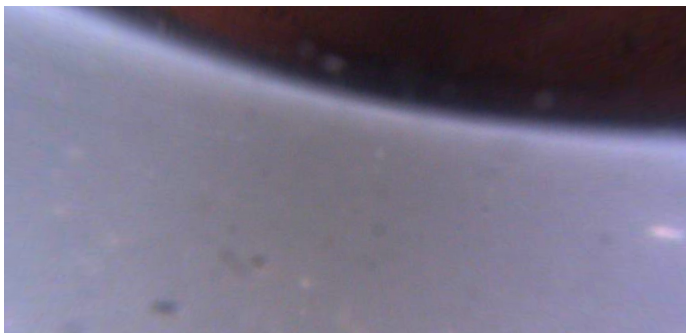
Code: **AMH**
Description: **Manhole**

Distance (ft): **.0**
Structural Grade: **0**
O&M Grade: **0**
Clock Start/From:
Clock To:
1st Value:
2nd Value:
Value Percent:
Continuous Index:
Within 8" of Joint: **NO**
Remarks: **M-103-031**

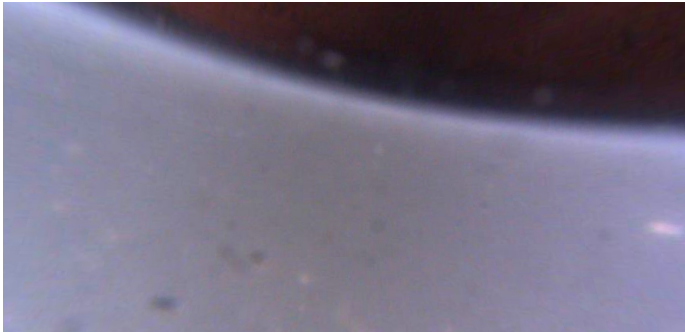
Code:	MWL
Description:	Water Level

Distance (ft):	.0
Structural Grade:	0
O&M Grade:	0
Clock Start/From:	
Clock To:	
1st Value:	
2nd Value:	
Value Percent:	60.000
Continuous Index:	
Within 8" of Joint:	NO
Remarks:

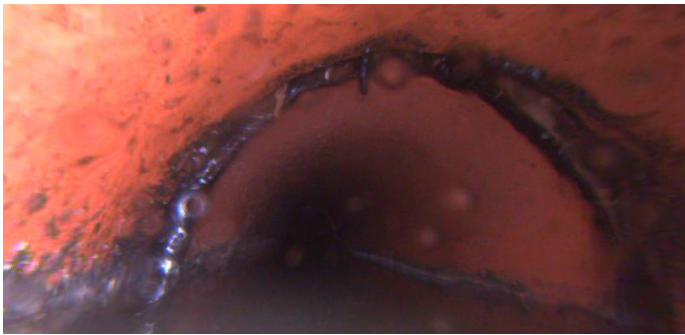
Code:	ID
Description:	Infil Dripper

Distance (ft):	2.9
Structural Grade:	0
O&M Grade:	3
Clock Start/From:	11
Clock To:	1
1st Value:	
2nd Value:	
Value Percent:	
Continuous Index:	
Within 8" of Joint:	YES
Remarks:

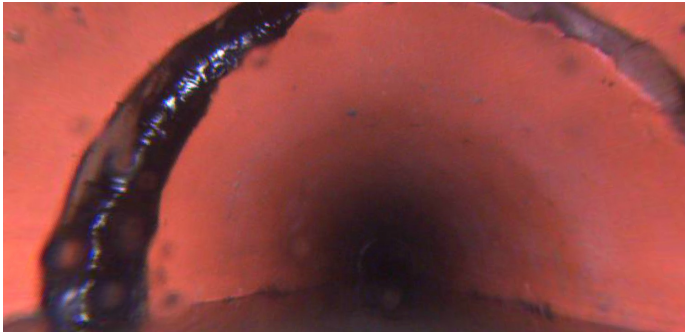
Code: **IW**
Description: **Infil Weeper**

Distance (ft): **7.9**
Structural Grade: **0**
O&M Grade: **2**
Clock Start/From: **8**
Clock To: **12**
1st Value:
2nd Value:
Value Percent:
Continuous Index:
Within 8" of Joint: **YES**
Remarks:

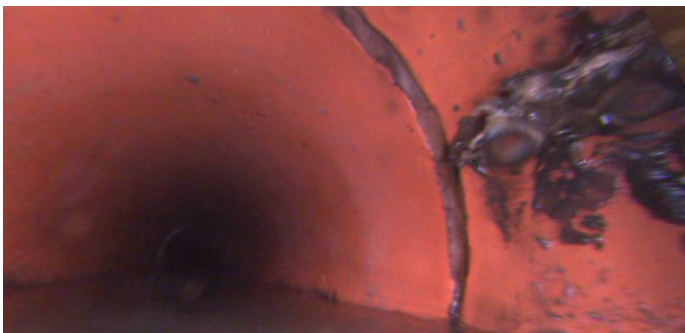
Code: **DAGS**
Description: **Deposits Attached Grease**

Distance (ft): **7.9**
Structural Grade: **0**
O&M Grade: **2**
Clock Start/From: **3**
Clock To:
1st Value:
2nd Value:
Value Percent: **5.000**
Continuous Index:
Within 8" of Joint: **NO**
Remarks:

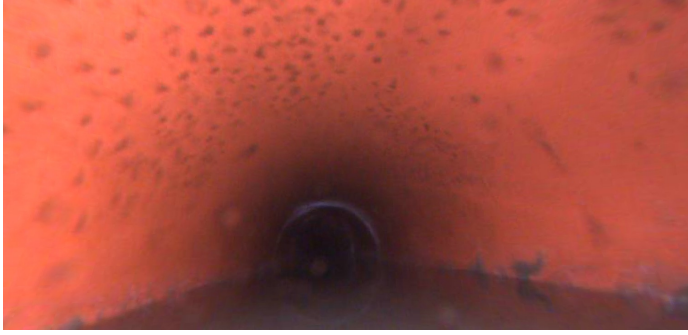
Code:	MSA
Description:	Abandoned Survey
Distance (ft):	50.4
Structural Grade:	0
O&M Grade:	0
Clock Start/From:	
Clock To:	
1st Value:	
2nd Value:	
Value Percent:	
Continuous Index:	
Within 8" of Joint:	NO
Remarks:	DEBRIS UNDER WATER
