Profile/Photo Observation Report

Date:	09/03/2021	Weather:		Coding:	PACP 7.0
Pipe Length (ft):	475.0	Owner:	City of Hobart	Pre Clean:	No Pre-Cleaning
P.O.#:	YES502259	Surveyor:	S. Bucklin	PSR:	UNK41ST AVE_M-504-12
Customer:	City of Hobart	Clean Date:		Shape:	C

Street:	42nd Avenue	Flow Control:	Not Controlled
City:	Hobart, IN	Year Renewed:	
Location:	Alley	Tape/Media #:	
Purpose:	Routine Assessment	Dia/Height:	12"
Use:	Sanitary Sewage Pipe	Material:	VCP
Drain Area:		Lining:	
Category:	NA

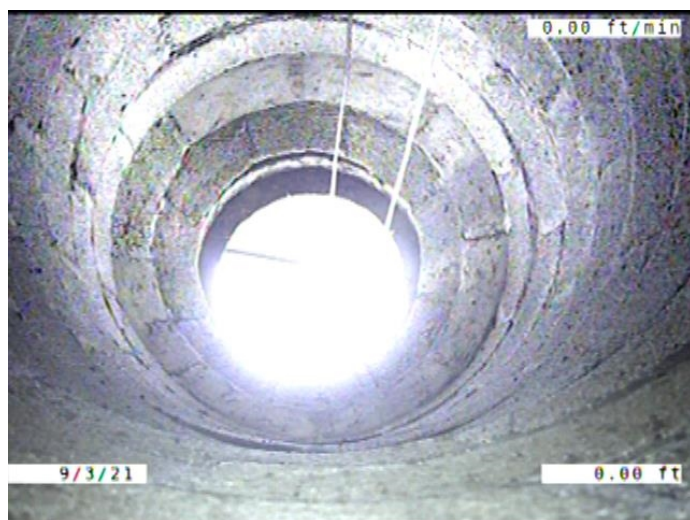
Code: **AMH**
 Description: **Manhole**

Distance (ft): **.0**
 Structural Grade: **0**
 O&M Grade: **0**
 Clock Start/From:
 Clock To:
 1st Value:
 2nd Value:
 Value Percent:
 Continuous Index:
 Within 8" of Joint: **NO**
 Remarks: **M-504-122**

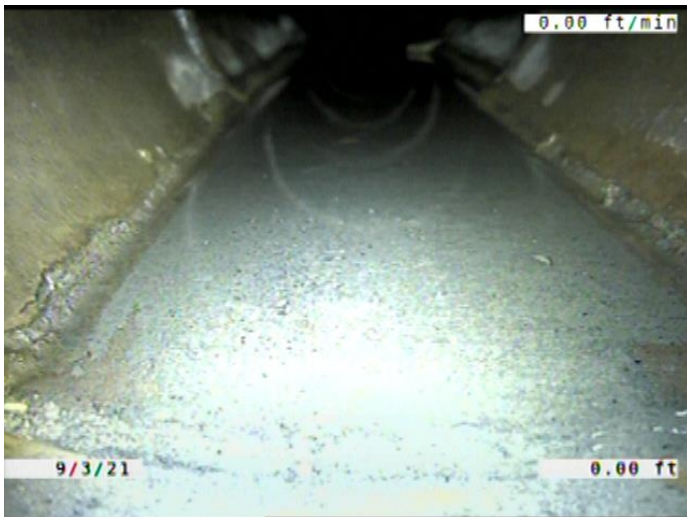
Code: **DSF**
Description: **Deposits Settled Fine**

Distance (ft): **.0**
Structural Grade: **0**
O&M Grade: **2**
Clock Start/From: **5**
Clock To: **7**
1st Value:
2nd Value:
Value Percent: **5.000**
Continuous Index: **S01**
Within 8" of Joint: **YES**
Remarks:

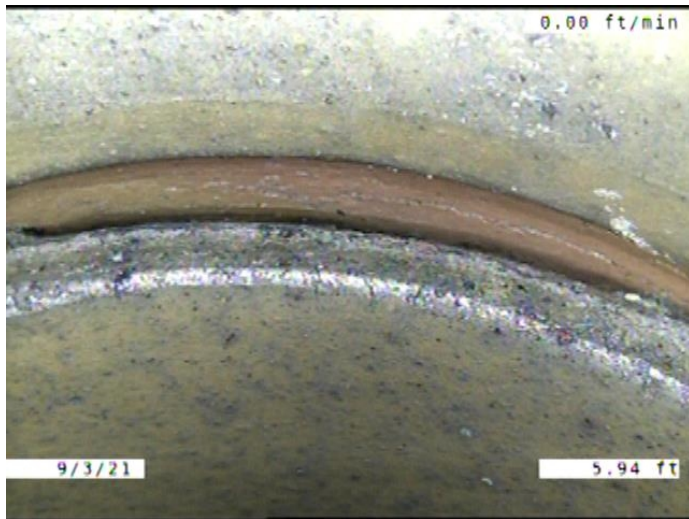
Code: **JOM**
 Description: **Joint Offset Medium**

Distance (ft): **5.9**
 Structural Grade: **3**
 O&M Grade: **0**
 Clock Start/From:
 Clock To:
 1st Value:
 2nd Value:
 Value Percent:
 Continuous Index:
 Within 8" of Joint: **NO**
 Remarks:

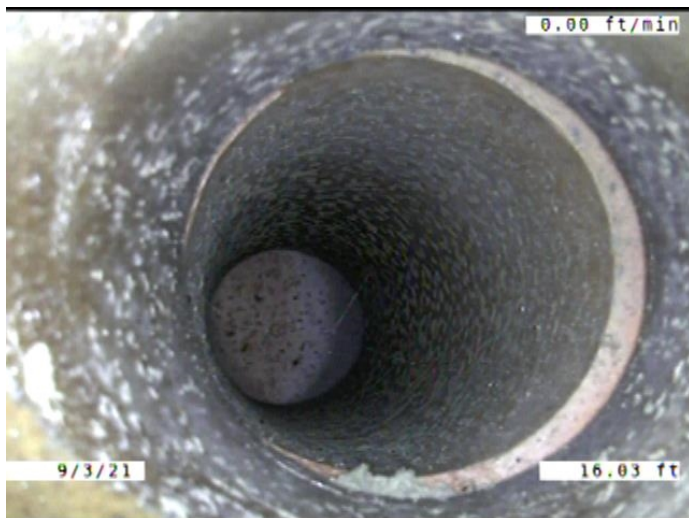
Code: **TFC**
 Description: **Tap Factory Capped**

Distance (ft): **16.0**
 Structural Grade: **0**
 O&M Grade: **0**
 Clock Start/From: **11**
 Clock To:
 1st Value: **6.000**
 2nd Value:
 Value Percent:
 Continuous Index:
 Within 8" of Joint: **YES**
 Remarks:

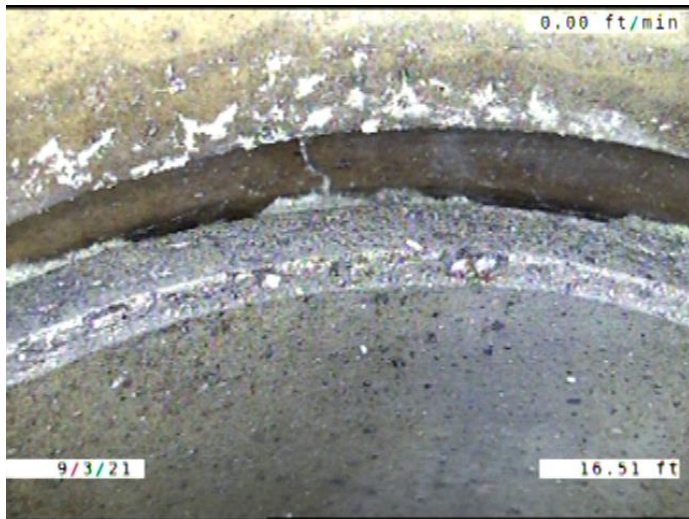
Code: **JOM**
 Description: **Joint Offset Medium**

Distance (ft): **16.5**
 Structural Grade: **3**
 O&M Grade: **0**
 Clock Start/From:
 Clock To:
 1st Value:
 2nd Value:
 Value Percent:
 Continuous Index:
 Within 8" of Joint: **NO**
 Remarks:

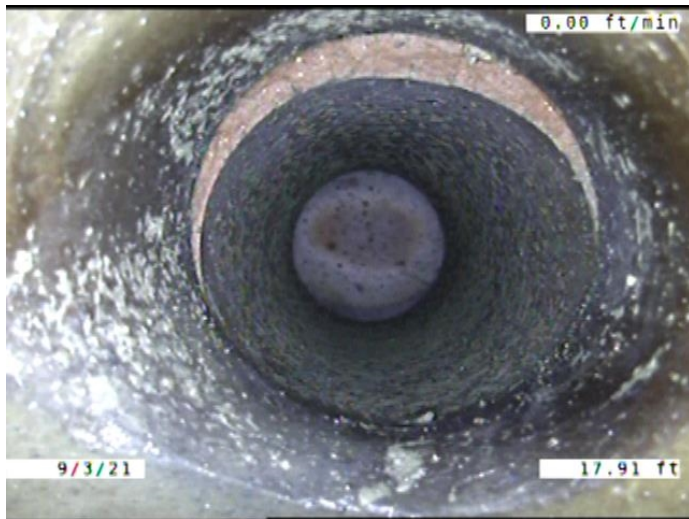
Code: **TFC**
 Description: **Tap Factory Capped**

Distance (ft): **17.9**
 Structural Grade: **0**
 O&M Grade: **0**
 Clock Start/From: **12**
 Clock To:
 1st Value: **6.000**
 2nd Value:
 Value Percent:
 Continuous Index:
 Within 8" of Joint: **YES**
 Remarks:

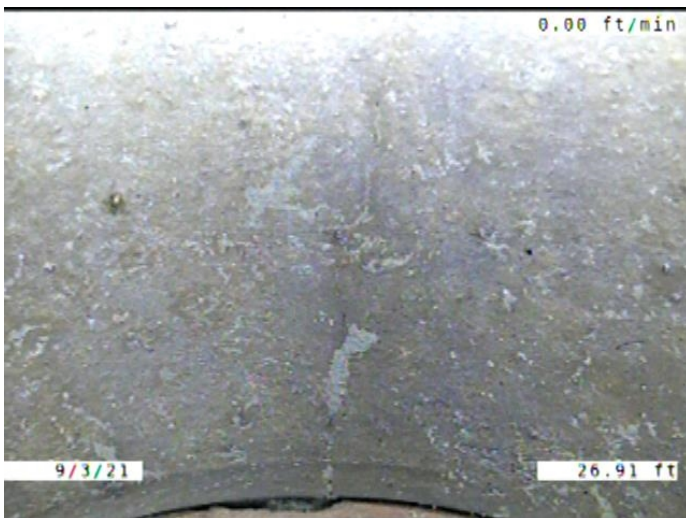
Code: **CL**
 Description: **Crack Longitudinal**

Distance (ft): **26.9**
 Structural Grade: **2**
 O&M Grade: **0**
 Clock Start/From: **12**
 Clock To:
 1st Value:
 2nd Value:
 Value Percent:
 Continuous Index:
 Within 8" of Joint: **YES**
 Remarks:

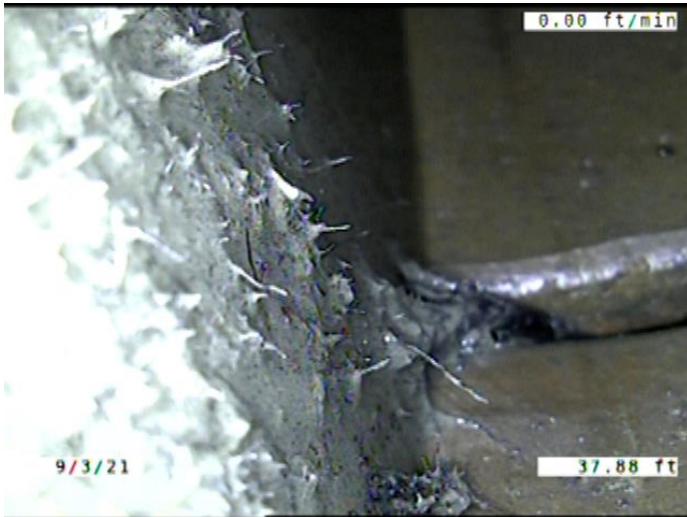
Code: **RMJ**
 Description: **Roots Medium Joint**

Distance (ft): **37.9**
 Structural Grade: **0**
 O&M Grade: **3**
 Clock Start/From: **4**
 Clock To: **8**
 1st Value:
 2nd Value:
 Value Percent: **10.000**
 Continuous Index:
 Within 8" of Joint: **YES**
 Remarks:

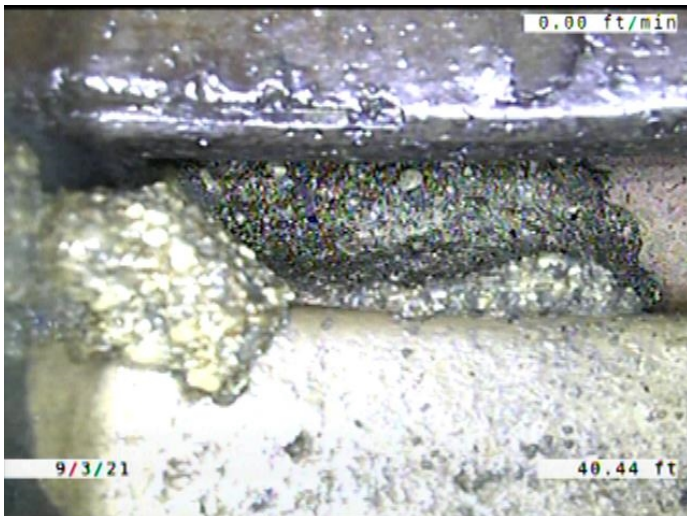
Code: **DAE**
 Description: **Deposits Attached Encrustation**

Distance (ft): **40.4**
 Structural Grade: **0**
 O&M Grade: **2**
 Clock Start/From: **3**
 Clock To:
 1st Value:
 2nd Value:
 Value Percent: **5.000**
 Continuous Index:
 Within 8" of Joint: **YES**
 Remarks:

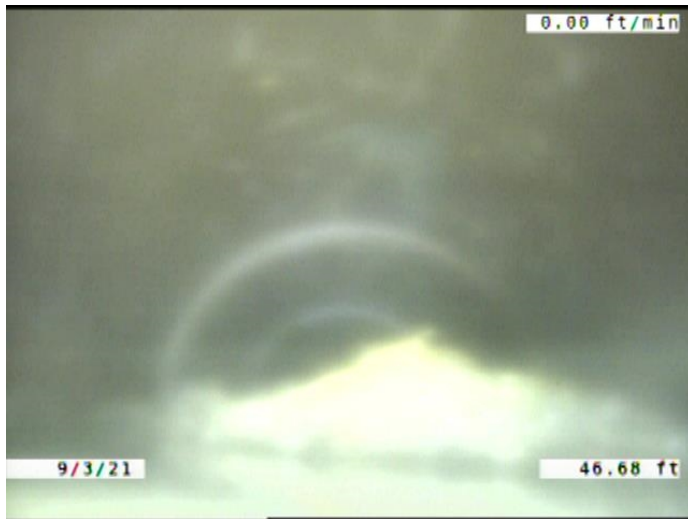
Code: **DSF**
 Description: **Deposits Settled Fine**

Distance (ft): **46.7**
 Structural Grade: **0**
 O&M Grade: **3**
 Clock Start/From: **4**
 Clock To: **8**
 1st Value:
 2nd Value:
 Value Percent: **20.000**
 Continuous Index:
 Within 8" of Joint: **YES**
 Remarks:

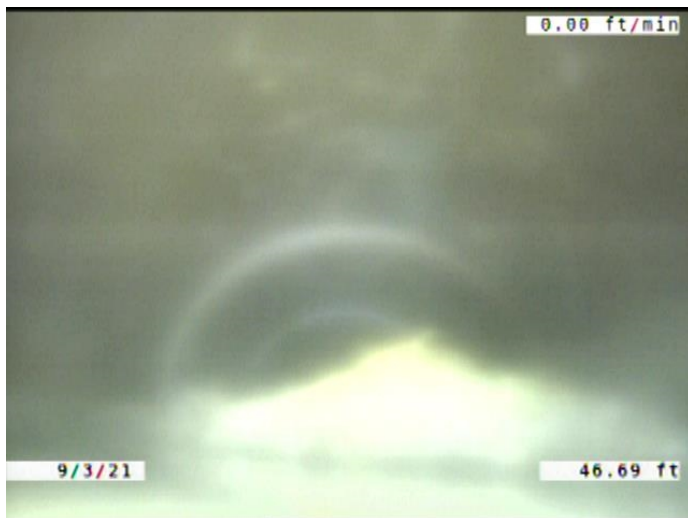
Code: **MSA**
 Description: **Miscellaneous Survey Abandoned**

Distance (ft): **46.7**
 Structural Grade: **0**
 O&M Grade: **0**
 Clock Start/From:
 Clock To:
 1st Value:
 2nd Value:
 Value Percent:
 Continuous Index:
 Within 8" of Joint: **NO**
 Remarks: **CAMERA CANT MAKE IT PAST ROOTS AND DEBRIS**
