Profile/Photo Observation Report

Date:	11/04/2021	Weather:		Coding:	PACP 7.0
Pipe Length (ft):	75.0	Owner:	City of Hobart	Pre Clean:	No Pre-Cleaning
P.O.#:	YES502259	Surveyor:	S. Bucklin	PSR:	
Customer:	City of Hobart	Clean Date:		Shape:	C

Street:	West 2nd Street	Flow Control:	Not Controlled
City:	Hobart, IN	Year Renewed:	
Location:		Tape/Media #:	
Purpose:	Routine Assessment	Dia/Height:	6"
Use:	Sanitary Sewage Pipe	Material:	PVC
Drain Area:		Lining:	None
Category:	NA		
Comment:			
Location Details:		Direction of Survey:	Upstream
US MH:	UNK S WILSON ST	DS MH:	M-405-065
		Total Length Surveyed (ft):	68.8

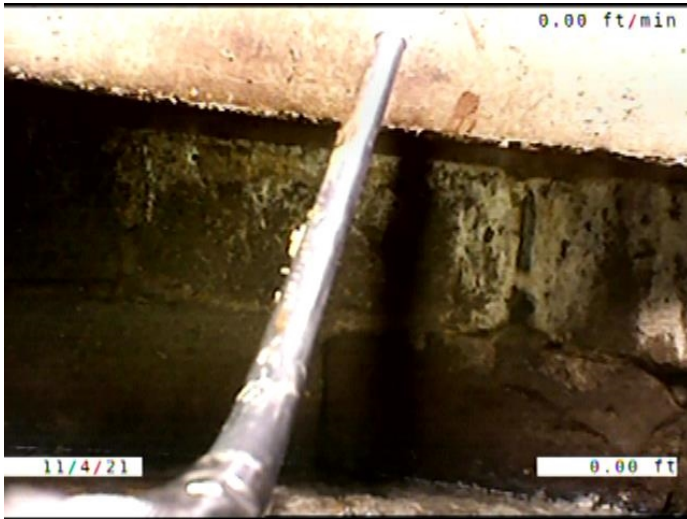
Code: **AMH**
 Description: **Manhole**

Distance (ft): **.0**
 Structural Grade: **0**
 O&M Grade: **0**
 Clock Start/From:
 Clock To:
 1st Value:
 2nd Value:
 Value Percent:
 Continuous Index:
 Within 8" of Joint: **NO**
 Remarks: **M-405-065**

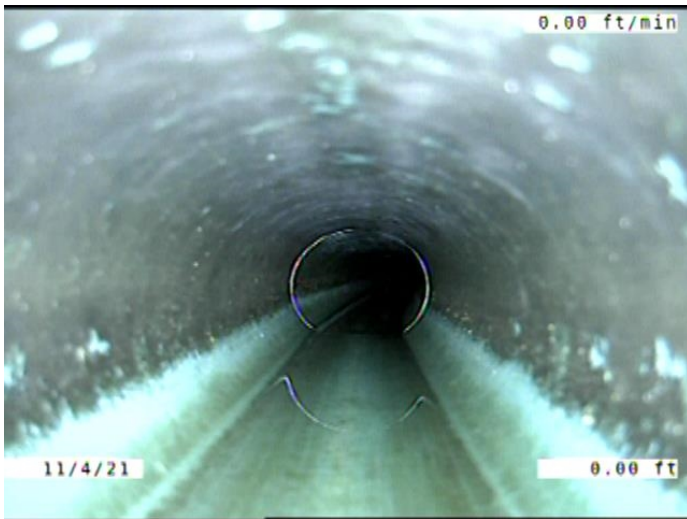
Code: **MWL**
 Description: **Miscellaneous Water Level**

Distance (ft): **.0**
 Structural Grade: **0**
 O&M Grade: **0**
 Clock Start/From:
 Clock To:
 1st Value:
 2nd Value:
 Value Percent: **5.000**
 Continuous Index:
 Within 8" of Joint: **NO**
 Remarks:

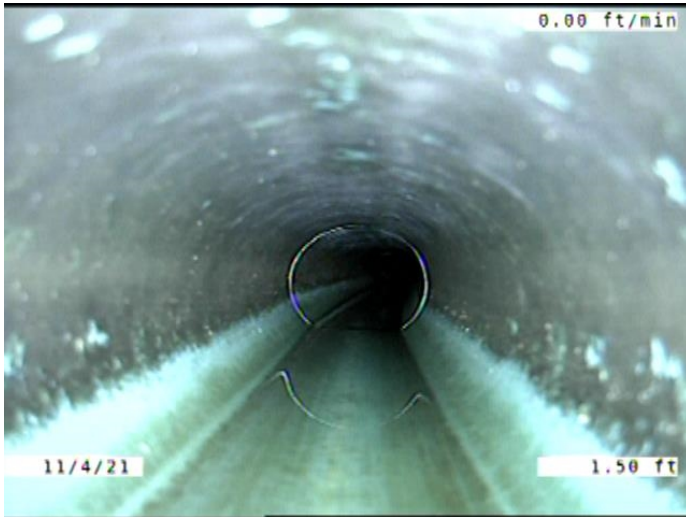
Code: **MGO**
 Description: **Miscellaneous General Observation**

Distance (ft): **1.5**
 Structural Grade: **0**
 O&M Grade: **0**
 Clock Start/From:
 Clock To:
 1st Value:
 2nd Value:
 Value Percent:
 Continuous Index:
 Within 8" of Joint: **NO**
 Remarks: **DROP INTO THE MANHOLE. HAD TO START IN THE PIPE.**

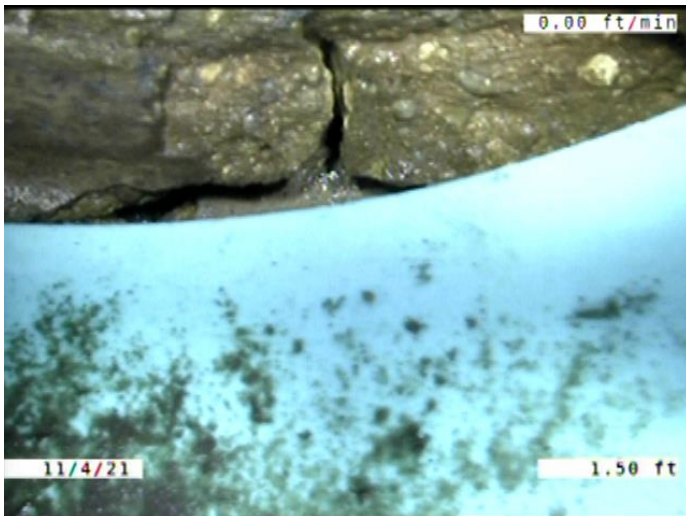
Code: **JOMD**
 Description: **Joint Offset Medium Defective**

Distance (ft): **1.5**
 Structural Grade: **3**
 O&M Grade: **0**
 Clock Start/From:
 Clock To:
 1st Value:
 2nd Value:
 Value Percent:
 Continuous Index:
 Within 8" of Joint: **NO**
 Remarks:

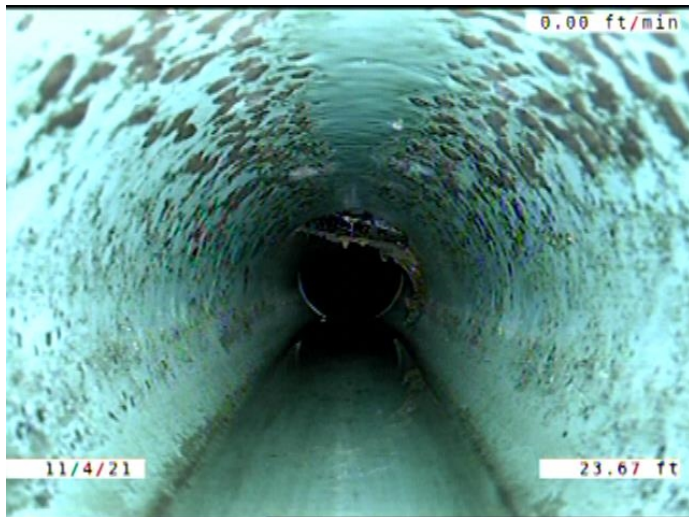
Code: **MWLS**
 Description: **Miscellaneous Water Level Sag**

Distance (ft): **23.7**
 Structural Grade: **2**
 O&M Grade: **0**
 Clock Start/From:
 Clock To:
 1st Value:
 2nd Value:
 Value Percent: **5.000**
 Continuous Index: **S01**
 Within 8" of Joint: **NO**
 Remarks:

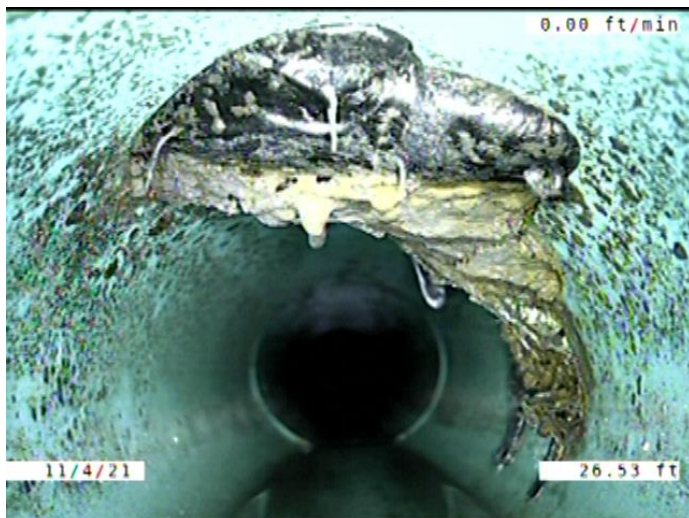
Code: **DAE**
 Description: **Deposits Attached Encrustation**

Distance (ft): **26.5**
 Structural Grade: **0**
 O&M Grade: **3**
 Clock Start/From: **11**
 Clock To: **4**
 1st Value:
 2nd Value:
 Value Percent: **15.000**
 Continuous Index:
 Within 8" of Joint: **NO**
 Remarks:

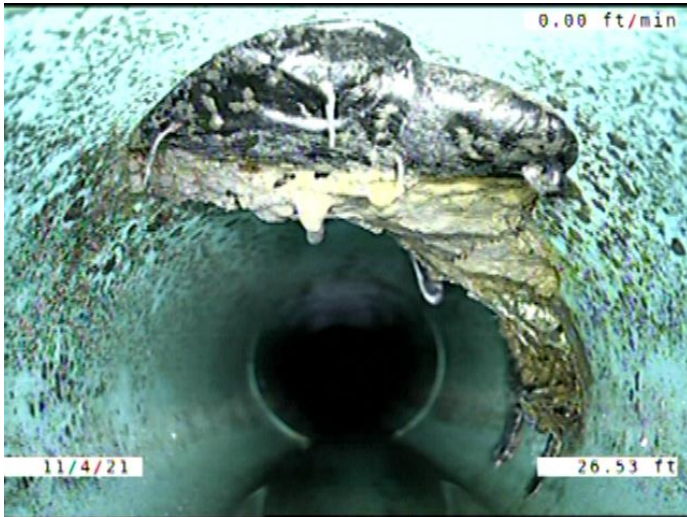
Code: **ISZ**
 Description: **Intruding Sealing Material Other**

Distance (ft): **26.5**
 Structural Grade: **0**
 O&M Grade: **2**
 Clock Start/From: **11**
 Clock To: **5**
 1st Value:
 2nd Value:
 Value Percent: **5.000**
 Continuous Index:
 Within 8" of Joint: **NO**
 Remarks: **SEALER/ TAR**

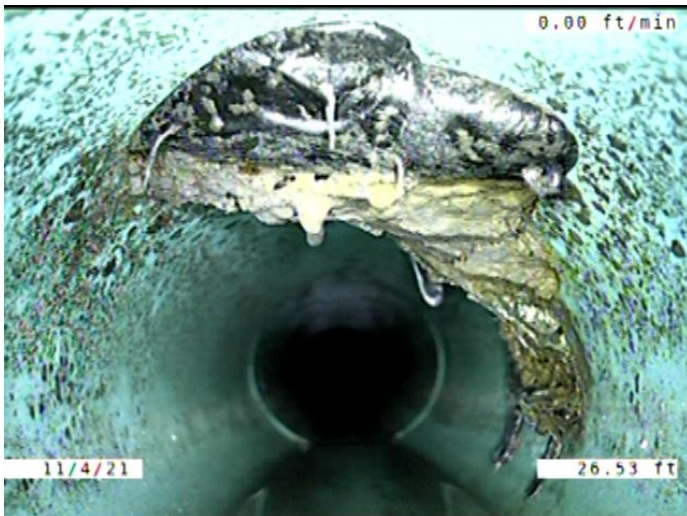
Code: **RPPD**
 Description: **Point Repair Patch Patch Defective**

Distance (ft): **26.5**
 Structural Grade: **4**
 O&M Grade: **0**
 Clock Start/From: **11**
 Clock To: **2**
 1st Value:
 2nd Value:
 Value Percent:
 Continuous Index:
 Within 8" of Joint: **NO**
 Remarks: **Hole or abandoned tap filled with sealant. DAE leaking through.**

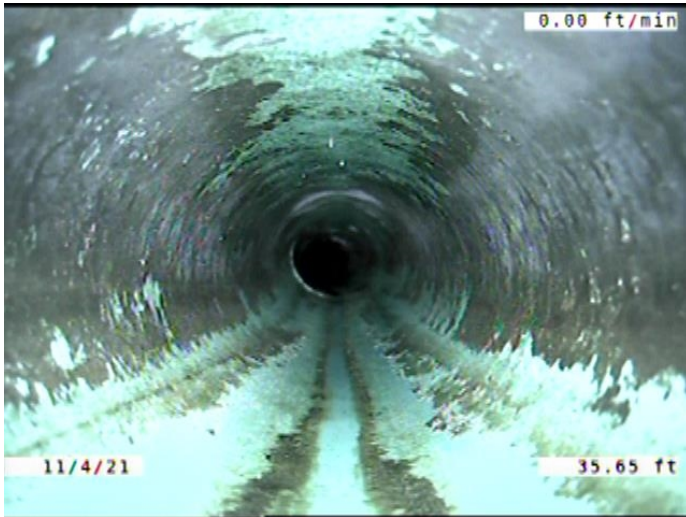
Code: **MWLS**
 Description: **Miscellaneous Water Level Sag**

Distance (ft): **35.6**
 Structural Grade: **2**
 O&M Grade: **0**
 Clock Start/From:
 Clock To:
 1st Value:
 2nd Value:
 Value Percent: **5.000**
 Continuous Index: **F01**
 Within 8" of Joint: **NO**
 Remarks:

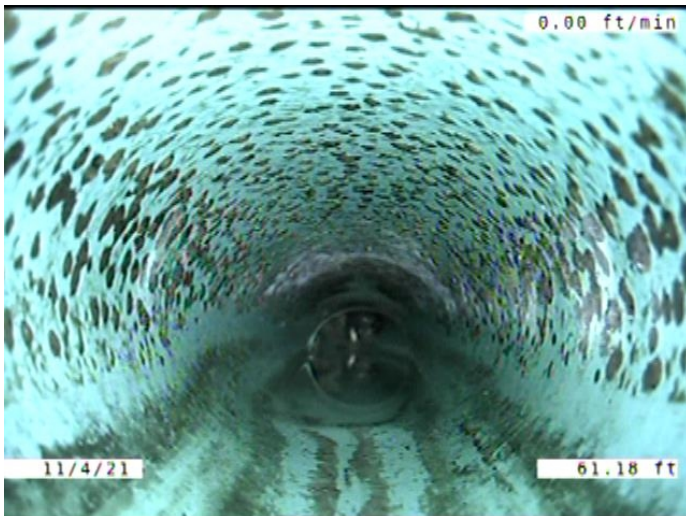
Code: **LD**
 Description: **Line Down**

Distance (ft): **61.2**
 Structural Grade: **0**
 O&M Grade: **1**
 Clock Start/From:
 Clock To:
 1st Value:
 2nd Value:
 Value Percent: **10.000**
 Continuous Index:
 Within 8" of Joint: **NO**
 Remarks:

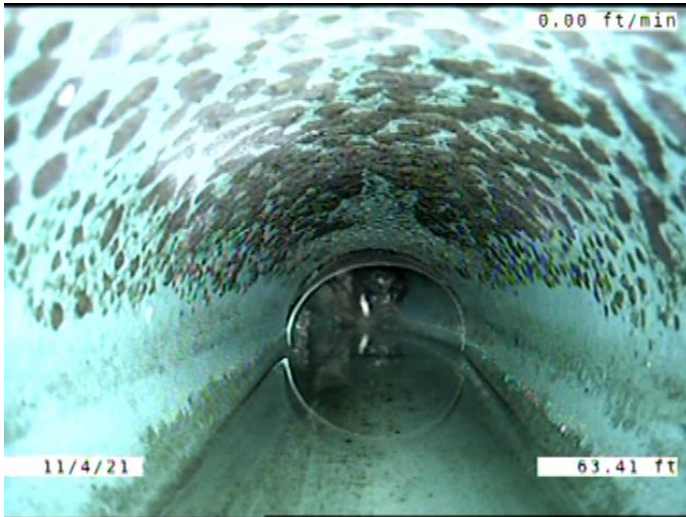
Code: **MWLS**
 Description: **Miscellaneous Water Level Sag**

Distance (ft): **63.4**
 Structural Grade: **2**
 O&M Grade: **0**
 Clock Start/From:
 Clock To:
 1st Value:
 2nd Value:
 Value Percent: **10.000**
 Continuous Index:
 Within 8" of Joint: **NO**
 Remarks:

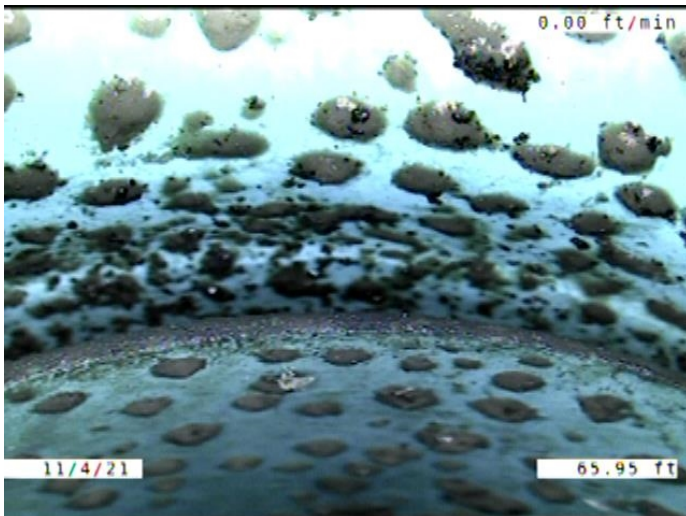
Code: **JOMD**
 Description: **Joint Offset Medium Defective**

Distance (ft): **66.0**
 Structural Grade: **3**
 O&M Grade: **0**
 Clock Start/From:
 Clock To:
 1st Value:
 2nd Value:
 Value Percent:
 Continuous Index:
 Within 8" of Joint: **NO**
 Remarks:

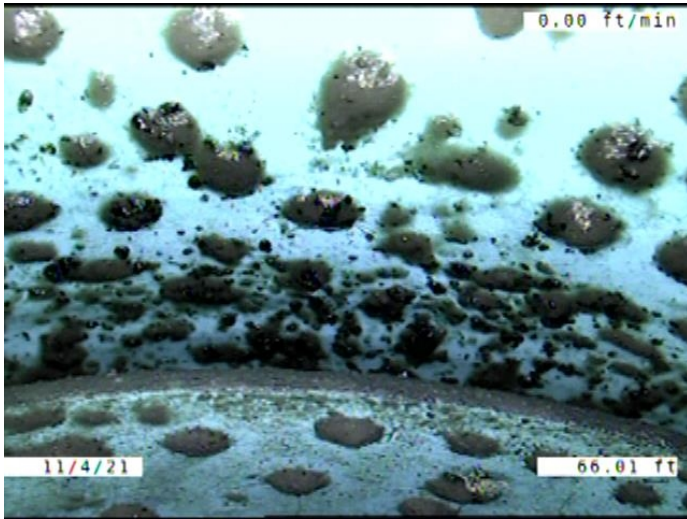
Code: **JAM**
 Description: **Joint Angular Medium**

Distance (ft): **66.0**
 Structural Grade: **3**
 O&M Grade: **0**
 Clock Start/From:
 Clock To:
 1st Value:
 2nd Value:
 Value Percent:
 Continuous Index:
 Within 8" of Joint: **NO**
 Remarks:

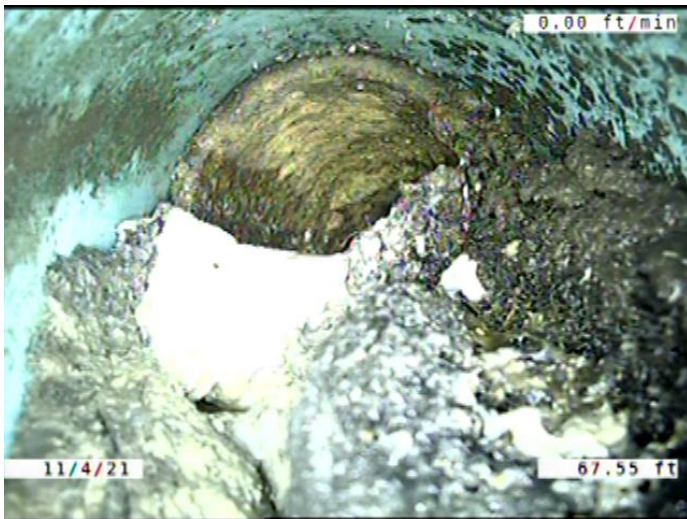
Code: **RMC**
 Description: **Roots Medium Connection**

Distance (ft): **67.5**
 Structural Grade: **0**
 O&M Grade: **3**
 Clock Start/From: **2**
 Clock To: **8**
 1st Value:
 2nd Value:
 Value Percent: **50.000**
 Continuous Index:
 Within 8" of Joint: **NO**
 Remarks:

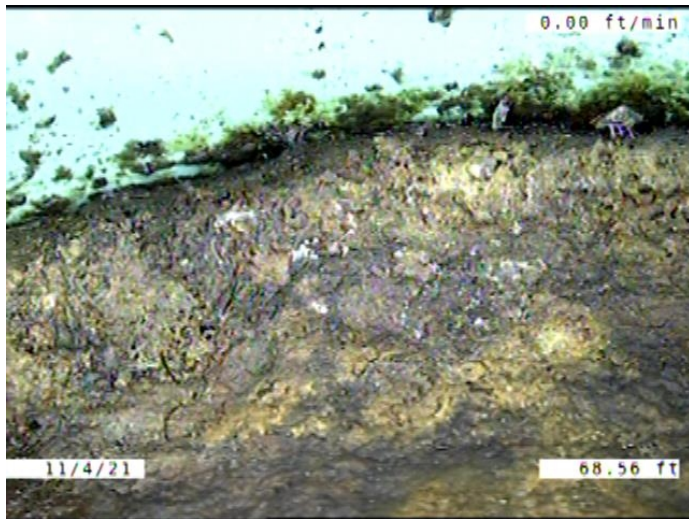
Code: **MMC**
 Description: **Miscellaneous Material Change**

Distance (ft): **68.6**
 Structural Grade: **0**
 O&M Grade: **0**
 Clock Start/From:
 Clock To:
 1st Value:
 2nd Value:
 Value Percent:
 Continuous Index:
 Within 8" of Joint: **NO**
 Remarks: **PVC TO CAST IRON**

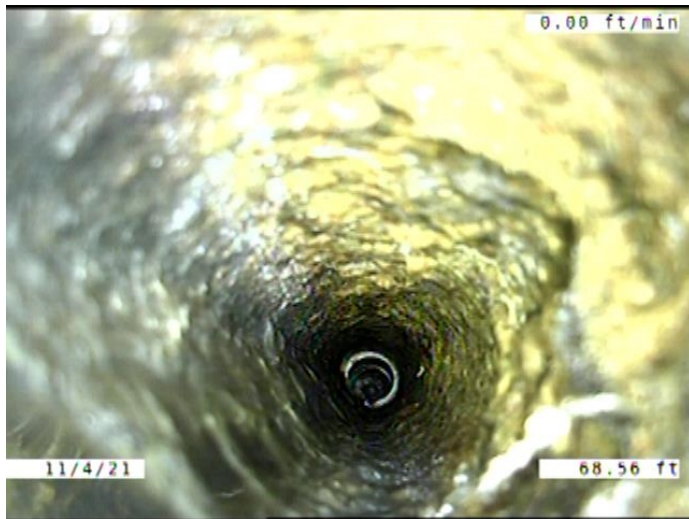
Code: **MSC**
 Description: **Miscellaneous Shape/Size Change**

Distance (ft): **68.6**
 Structural Grade: **0**
 O&M Grade: **0**
 Clock Start/From:
 Clock To:
 1st Value: **4.000**
 2nd Value:
 Value Percent:
 Continuous Index:
 Within 8" of Joint: **NO**
 Remarks:

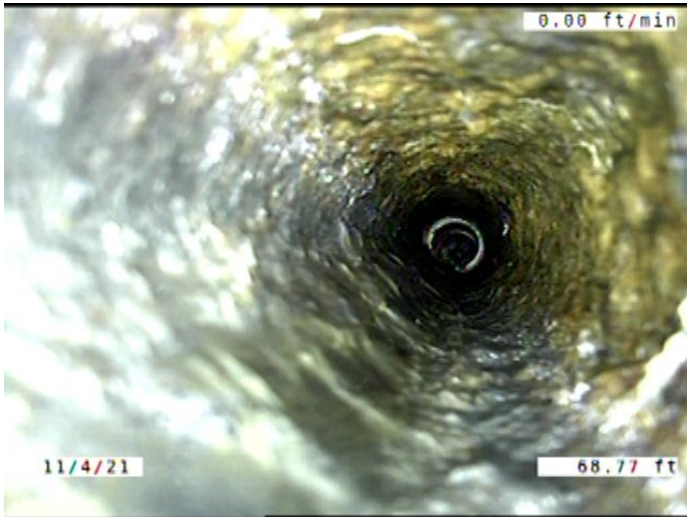
Code:	MSA
Description:	Miscellaneous Survey Abandoned
Distance (ft):	68.8
Structural Grade:	0
O&M Grade:	0
Clock Start/From:	
Clock To:	
1st Value:	
2nd Value:	
Value Percent:	
Continuous Index:	
Within 8" of Joint:	NO
Remarks:	CAMERA CANT FIT INTO 4" PIPE
