Profile/Photo Observation Report

Date:	11/10/2021	Weather:		Coding:	PACP 7.0
Pipe Length (ft):	163.5	Owner:	City of Hobart	Pre Clean:	Heavy Cleaning
P.O.#:	YES502259	Surveyor:	Steven Bucklin	PSR:	
Customer:	City of Hobart, IN (Red	Clean Date:	11/10/2021	Shape:	C

Street:	West Home Avenue	Flow Control:	Not Controlled
City:	City of Hobart	Year Renewed:	
Location:	Local rural streets with light traffic, t	Tape/Media #:	
Purpose:	Routine Assessment	Dia/Height:	10"
Use:	Sanitary Sewage Pipe	Material:	VCP
Drain Area:		Lining:	None
Category:	NA		
Comment:			
Location Details:		Direction of Survey:	Downstream
US MH:	UNK W HOME AVE	DS MH:	M-604-058
		Total Length Surveyed (ft):	163.5

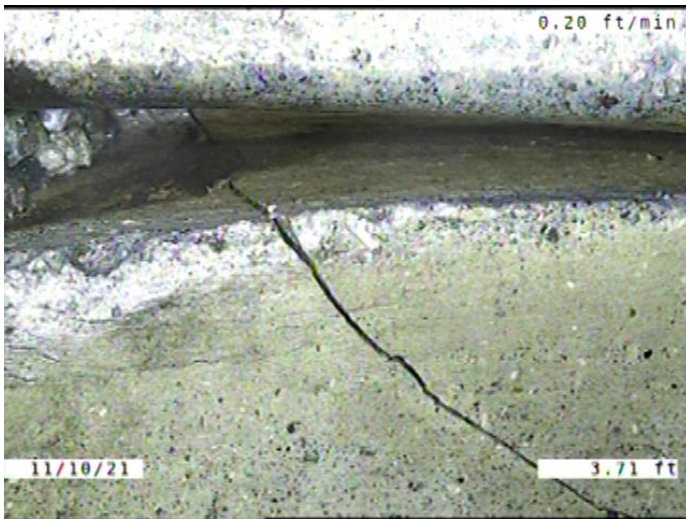
Code: **FS**
 Description: **Fracture Spiral**

Distance (ft): **3.7**
 Structural Grade: **3**
 O&M Grade: **0**
 Clock Start/From: **8**
 Clock To: **1**
 1st Value:
 2nd Value:
 Value Percent:
 Continuous Index:
 Within 8" of Joint: **YES**
 Remarks:

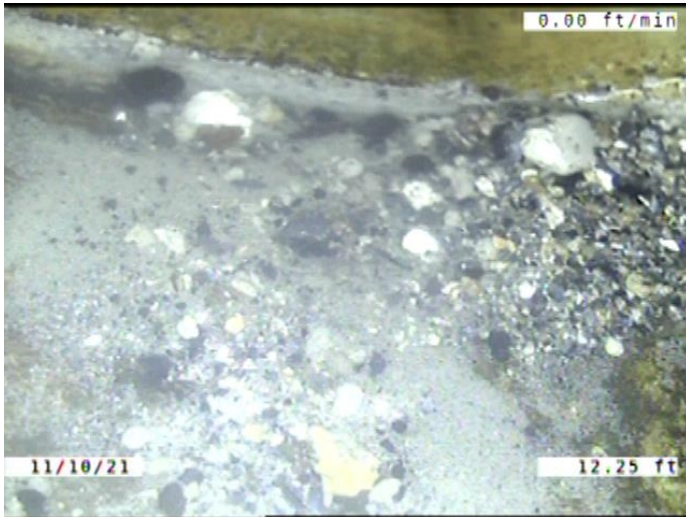
Code: **DSF**
Description: **Deposits Settled Fine**

Distance (ft): **12.3**
Structural Grade: **0**
O&M Grade: **2**
Clock Start/From: **5**
Clock To: **7**
1st Value:
2nd Value:
Value Percent: **5.000**
Continuous Index: **S01**
Within 8" of Joint: **YES**
Remarks:

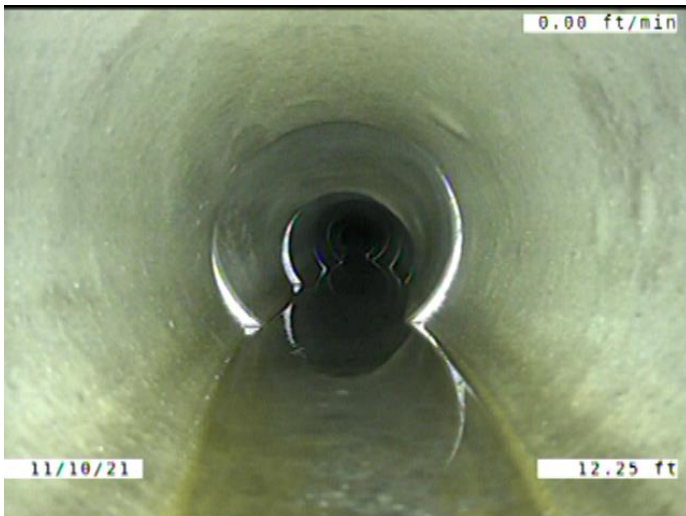
Code: **MWLS**
Description: **Miscellaneous Water Level Sag**

Distance (ft): **12.3**
Structural Grade: **2**
O&M Grade: **0**
Clock Start/From:
Clock To:
1st Value:
2nd Value:
Value Percent: **5.000**
Continuous Index: **S02**
Within 8" of Joint: **NO**
Remarks:

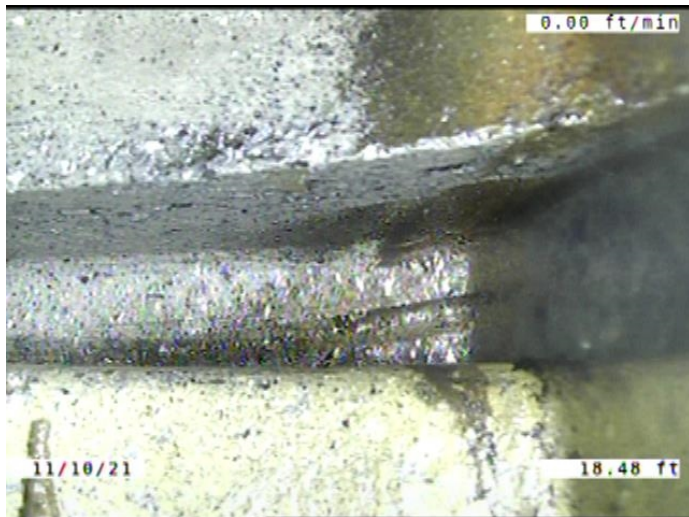
Code: **JAM**
 Description: **Joint Angular Medium**

Distance (ft): **18.5**
 Structural Grade: **3**
 O&M Grade: **0**
 Clock Start/From:
 Clock To:
 1st Value:
 2nd Value:
 Value Percent:
 Continuous Index:
 Within 8" of Joint: **NO**
 Remarks:

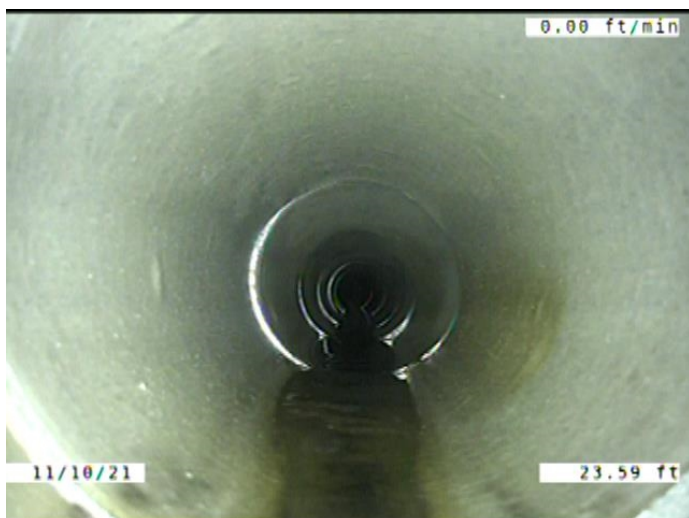
Code: **MWLS**
 Description: **Miscellaneous Water Level Sag**

Distance (ft): **23.6**
 Structural Grade: **2**
 O&M Grade: **0**
 Clock Start/From:
 Clock To:
 1st Value:
 2nd Value:
 Value Percent: **5.000**
 Continuous Index: **F02**
 Within 8" of Joint: **NO**
 Remarks:

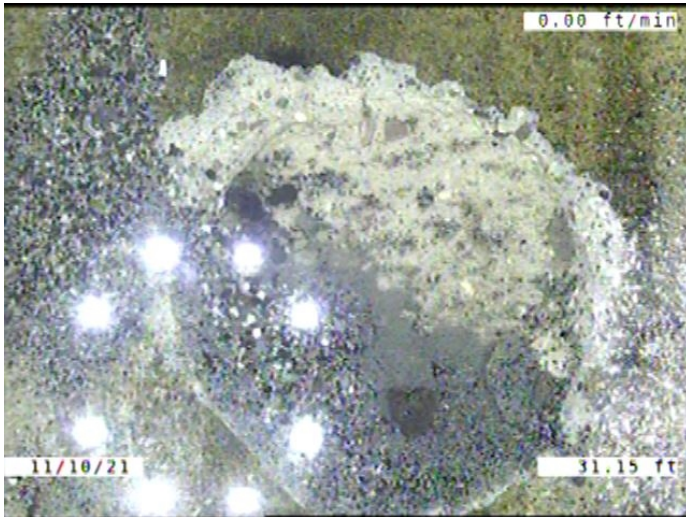
Code: **SSS**
Description: **Surface Damage Surface Spalling**

Distance (ft): **31.1**
Structural Grade: **2**
O&M Grade: **0**
Clock Start/From: **5**
Clock To: **6**
1st Value:
2nd Value:
Value Percent:
Continuous Index:
Within 8" of Joint: **YES**
Remarks:

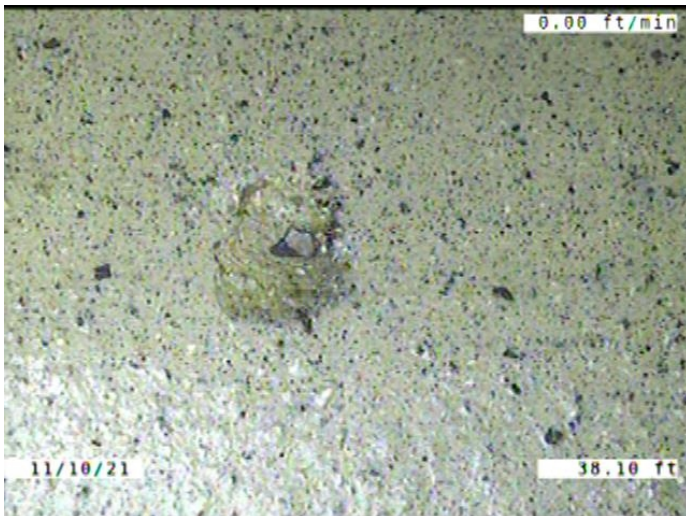
Code: **SSS**
Description: **Surface Damage Surface Spalling**

Distance (ft): **38.1**
Structural Grade: **2**
O&M Grade: **0**
Clock Start/From: **3**
Clock To:
1st Value:
2nd Value:
Value Percent:
Continuous Index:
Within 8" of Joint: **NO**
Remarks:

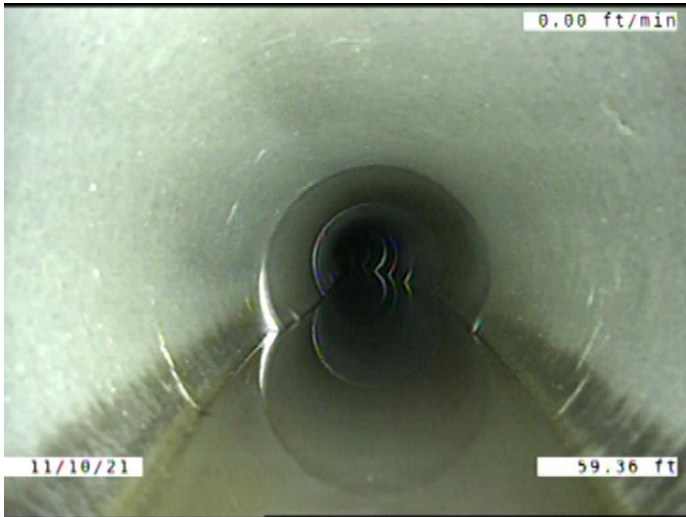
Code: **MWLS**
Description: **Miscellaneous Water Level Sag**

Distance (ft): **59.4**
Structural Grade: **2**
O&M Grade: **0**
Clock Start/From:
Clock To:
1st Value:
2nd Value:
Value Percent: **10.000**
Continuous Index: **S03**
Within 8" of Joint: **NO**
Remarks:

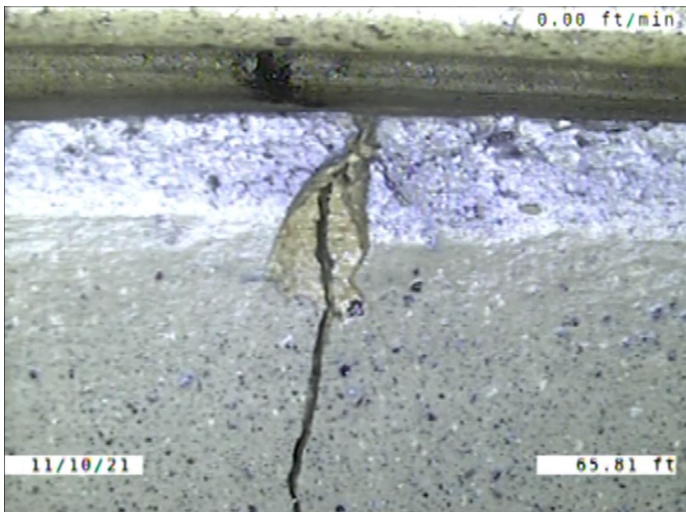
Code: **SSS**
Description: **Surface Damage Surface Spalling**

Distance (ft): **65.8**
Structural Grade: **2**
O&M Grade: **0**
Clock Start/From: **10**
Clock To:
1st Value:
2nd Value:
Value Percent:
Continuous Index:
Within 8" of Joint: **YES**
Remarks:

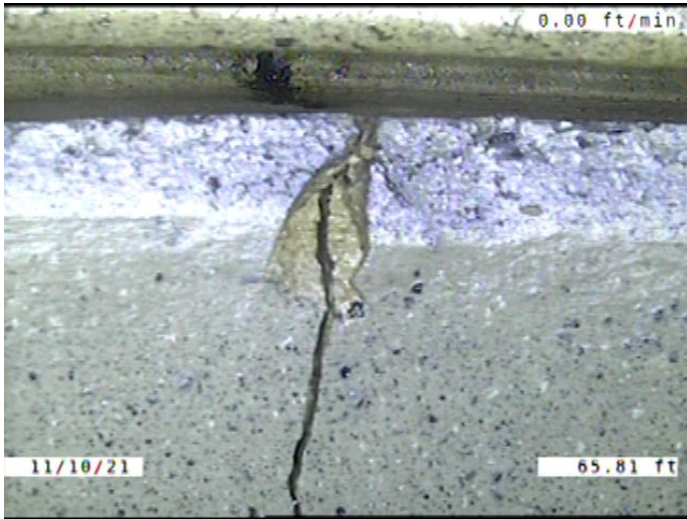
Code: **FM**
Description: **Fracture Multiple**

Distance (ft): **65.8**
Structural Grade: **4**
O&M Grade: **0**
Clock Start/From: **9**
Clock To: **10**
1st Value:
2nd Value:
Value Percent:
Continuous Index:
Within 8" of Joint: **YES**
Remarks:

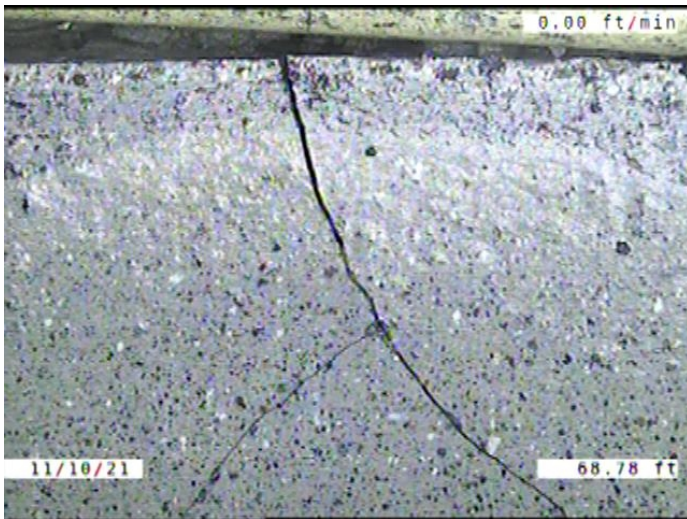
Code: **FM**
Description: **Fracture Multiple**

Distance (ft): **68.8**
Structural Grade: **4**
O&M Grade: **0**
Clock Start/From: **12**
Clock To: **2**
1st Value:
2nd Value:
Value Percent:
Continuous Index:
Within 8" of Joint: **YES**
Remarks:

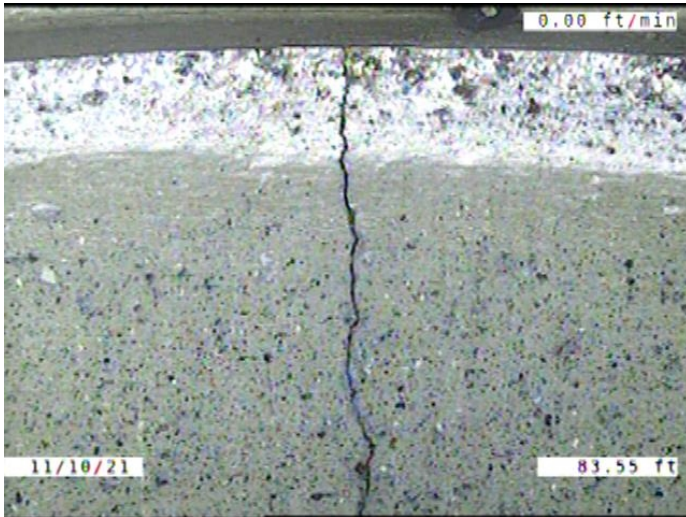
Code: **CL**
 Description: **Crack Longitudinal**

Distance (ft): **83.5**
 Structural Grade: **2**
 O&M Grade: **0**
 Clock Start/From: **12**
 Clock To:
 1st Value:
 2nd Value:
 Value Percent:
 Continuous Index:
 Within 8" of Joint: **YES**
 Remarks:

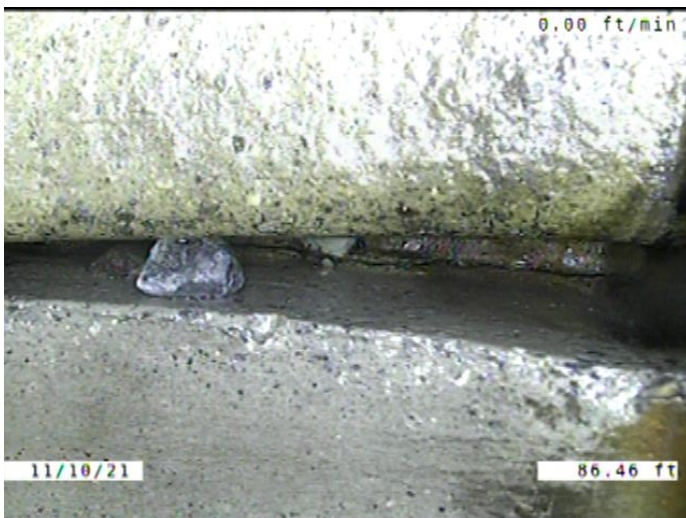
Code: **FS**
 Description: **Fracture Spiral**

Distance (ft): **86.5**
 Structural Grade: **3**
 O&M Grade: **0**
 Clock Start/From: **2**
 Clock To: **3**
 1st Value:
 2nd Value:
 Value Percent:
 Continuous Index:
 Within 8" of Joint: **YES**
 Remarks:

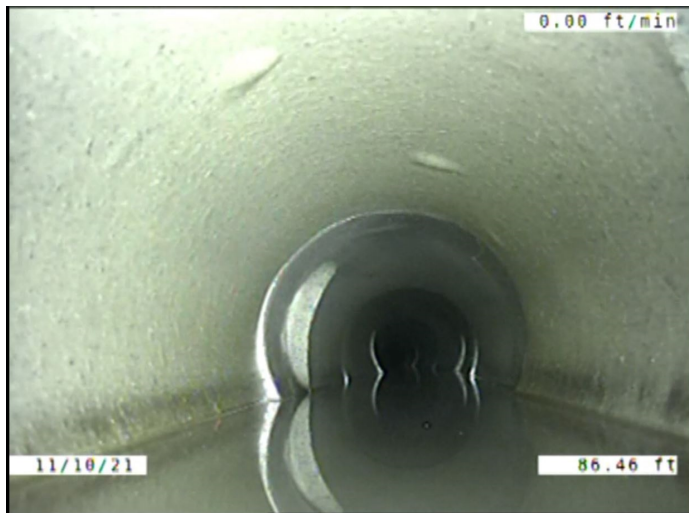
Code: **SZ**
 Description: **Surface Damage Other**

Distance (ft): **86.5**
 Structural Grade: **0**
 O&M Grade: **0**
 Clock Start/From: **10**
 Clock To: **2**
 1st Value:
 2nd Value:
 Value Percent:
 Continuous Index:
 Within 8" of Joint: **NO**
 Remarks: **Indentations, Factory Defect**

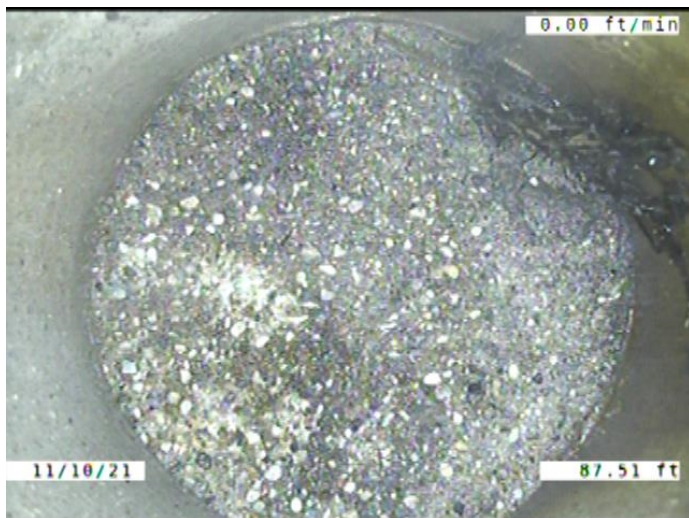
Code: **TFC**
 Description: **Tap Factory Capped**

Distance (ft): **87.5**
 Structural Grade: **0**
 O&M Grade: **0**
 Clock Start/From: **2**
 Clock To:
 1st Value: **4.000**
 2nd Value:
 Value Percent:
 Continuous Index:
 Within 8" of Joint: **YES**
 Remarks: **ROOTS GROWING AROUND THE CAP. CAP LOOKS TO BE LEAKING**

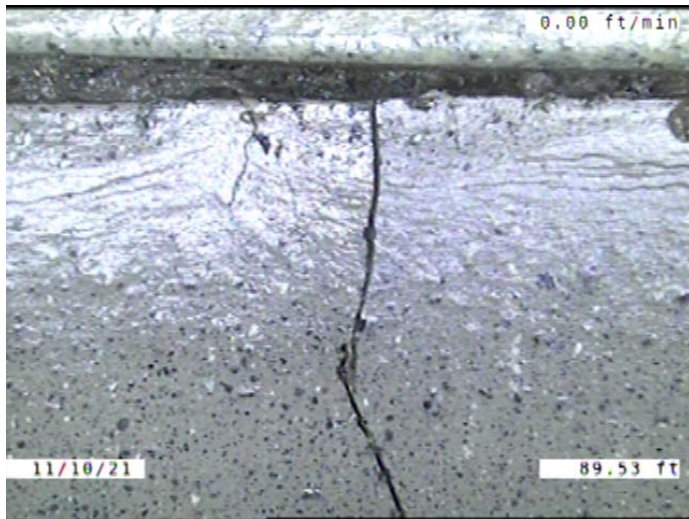
Code: **FM**
 Description: **Fracture Multiple**

Distance (ft): **89.5**
 Structural Grade: **4**
 O&M Grade: **0**
 Clock Start/From: **1**
 Clock To: **2**
 1st Value:
 2nd Value:
 Value Percent:
 Continuous Index:
 Within 8" of Joint: **YES**
 Remarks:

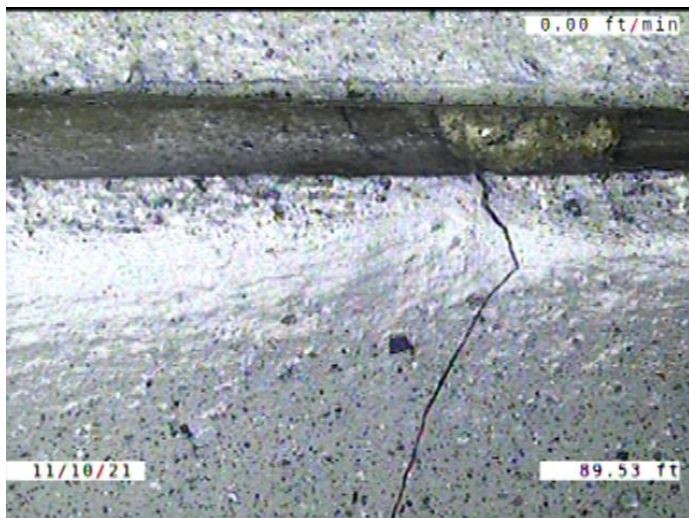
Code: **FS**
 Description: **Fracture Spiral**

Distance (ft): **89.5**
 Structural Grade: **3**
 O&M Grade: **0**
 Clock Start/From: **11**
 Clock To: **12**
 1st Value:
 2nd Value:
 Value Percent:
 Continuous Index:
 Within 8" of Joint: **YES**
 Remarks:

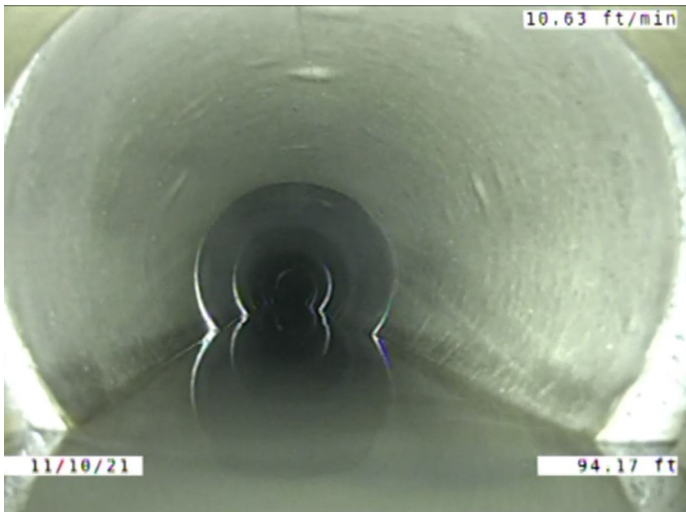
Code: **SZ**
 Description: **Surface Damage Other**

Distance (ft): **94.2**
 Structural Grade: **0**
 O&M Grade: **0**
 Clock Start/From: **10**
 Clock To: **2**
 1st Value:
 2nd Value:
 Value Percent:
 Continuous Index: **S10**
 Within 8" of Joint: **NO**
 Remarks: **Indentations, Factory Defect**

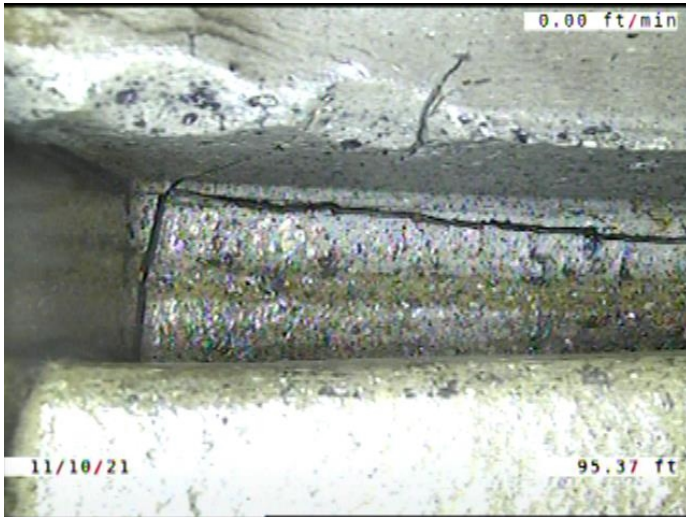
Code: **FM**
Description: **Fracture Multiple**

Distance (ft): **95.4**
Structural Grade: **4**
O&M Grade: **0**
Clock Start/From: **9**
Clock To: **3**
1st Value:
2nd Value:
Value Percent:
Continuous Index: **S04**
Within 8" of Joint: **YES**
Remarks:

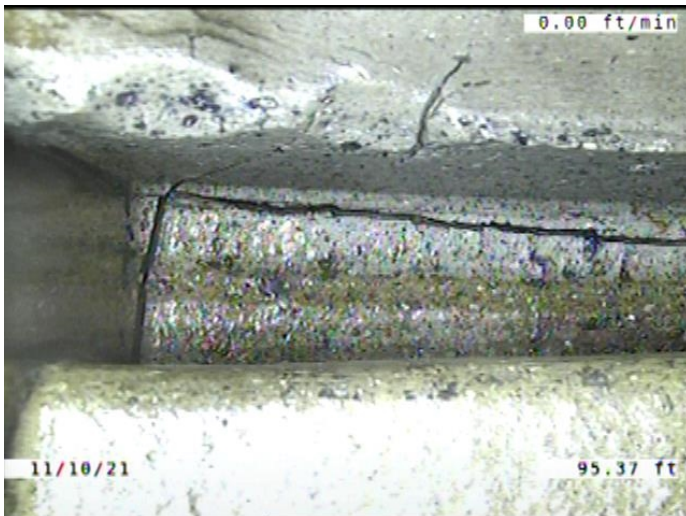
Code: **JAM**
Description: **Joint Angular Medium**

Distance (ft): **95.4**
Structural Grade: **3**
O&M Grade: **0**
Clock Start/From:
Clock To:
1st Value:
2nd Value:
Value Percent:
Continuous Index:
Within 8" of Joint: **NO**
Remarks:

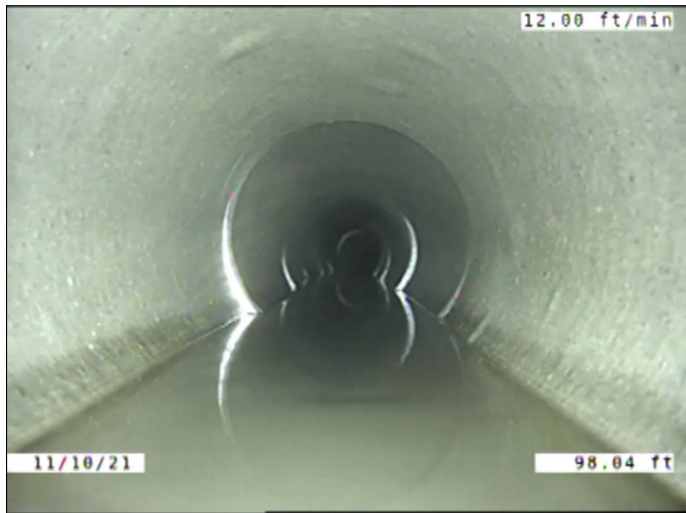
Code:	SZ
Description:	Surface Damage Other
Distance (ft):	98.0
Structural Grade:	0
O&M Grade:	0
Clock Start/From:	10
Clock To:	2
1st Value:	
2nd Value:	
Value Percent:	
Continuous Index:	F10
Within 8" of Joint:	NO
Remarks:	Indentations, Factory Defect

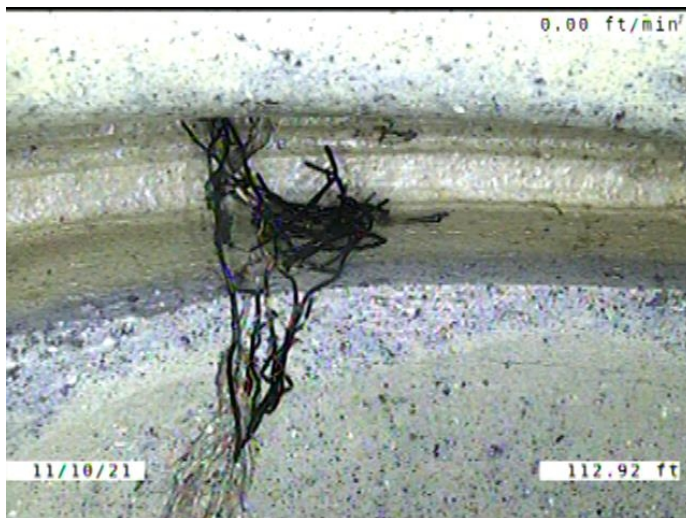
Code:	RFJ
Description:	Roots Fine Joint
Distance (ft):	112.9
Structural Grade:	0
O&M Grade:	1
Clock Start/From:	9
Clock To:	11
1st Value:	
2nd Value:	
Value Percent:	
Continuous Index:	
Within 8" of Joint:	YES
Remarks:

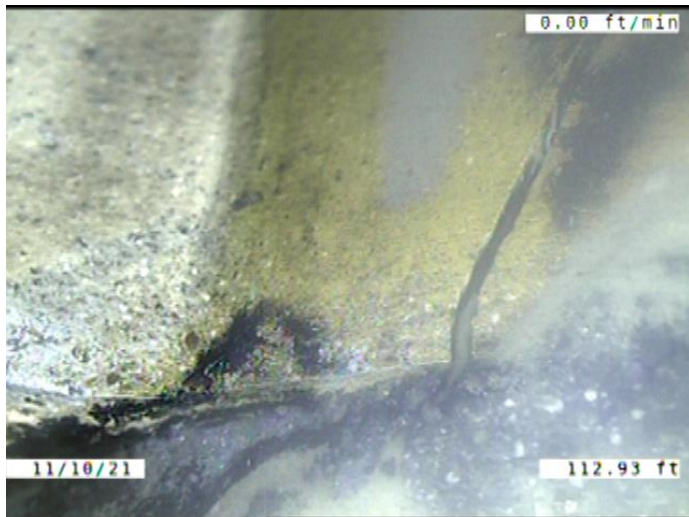
Code: **B**
 Description: **Broken**

Distance (ft): **112.9**
 Structural Grade: **4**
 O&M Grade: **0**
 Clock Start/From: **12**
 Clock To: **12**
 1st Value:
 2nd Value:
 Value Percent:
 Continuous Index:
 Within 8" of Joint: **YES**
 Remarks:

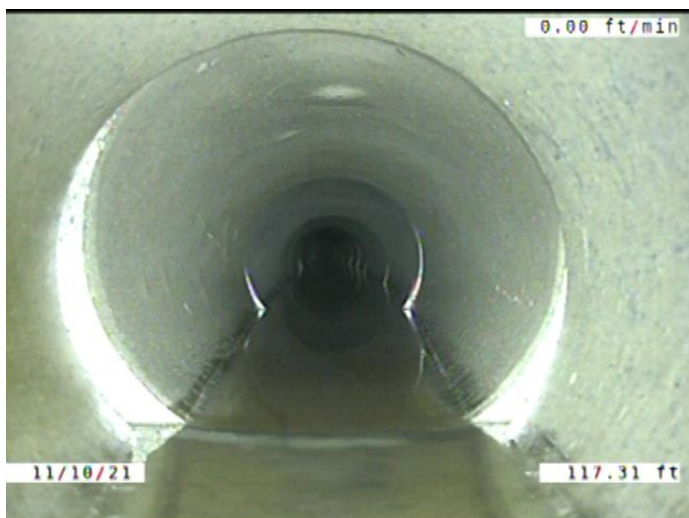
Code: **MWLS**
 Description: **Miscellaneous Water Level Sag**

Distance (ft): **117.3**
 Structural Grade: **2**
 O&M Grade: **0**
 Clock Start/From:
 Clock To:
 1st Value:
 2nd Value:
 Value Percent: **10.000**
 Continuous Index: **S05**
 Within 8" of Joint: **NO**
 Remarks:

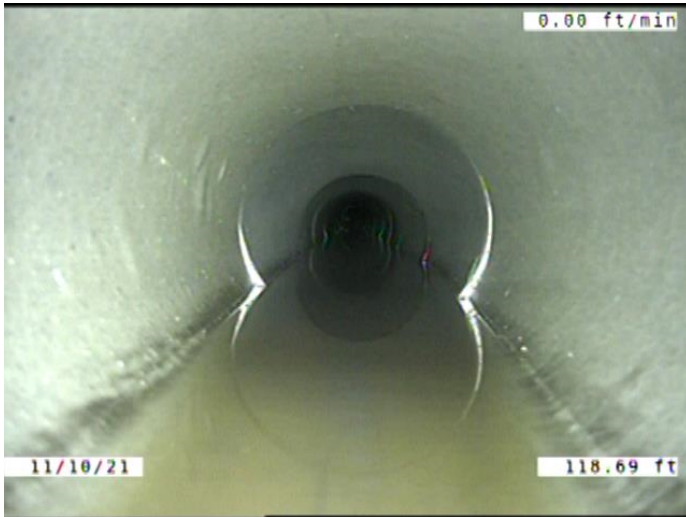
Code: **FM**
Description: **Fracture Multiple**

Distance (ft): **118.7**
Structural Grade: **4**
O&M Grade: **0**
Clock Start/From: **9**
Clock To: **3**
1st Value:
2nd Value:
Value Percent:
Continuous Index: **F04**
Within 8" of Joint: **YES**
Remarks:

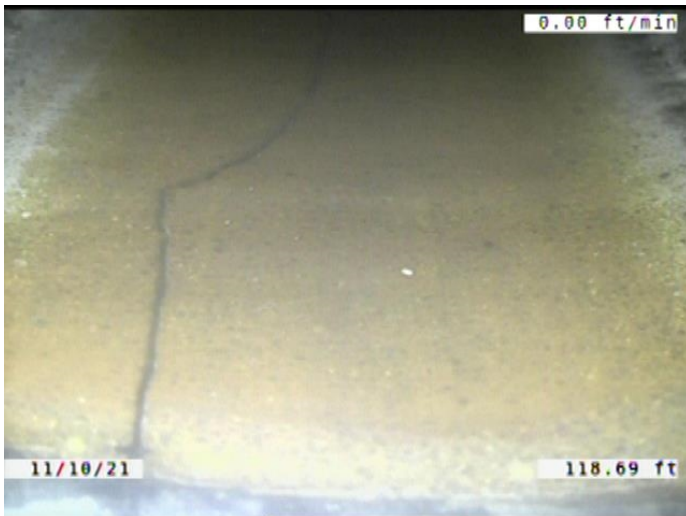
Code: **FM**
Description: **Fracture Multiple**

Distance (ft): **118.7**
Structural Grade: **4**
O&M Grade: **0**
Clock Start/From: **12**
Clock To: **12**
1st Value:
2nd Value:
Value Percent:
Continuous Index:
Within 8" of Joint: **YES**
Remarks:

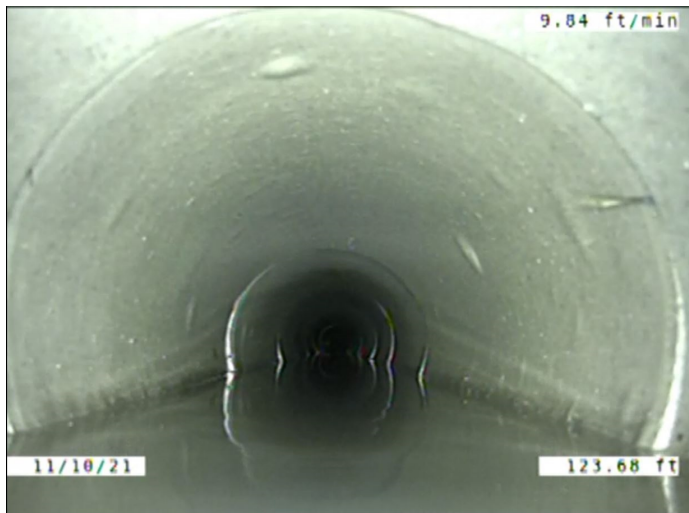
Code: **SZ**
 Description: **Surface Damage Other**

Distance (ft): **123.7**
 Structural Grade: **0**
 O&M Grade: **0**
 Clock Start/From: **9**
 Clock To: **3**
 1st Value:
 2nd Value:
 Value Percent:
 Continuous Index:
 Within 8" of Joint: **NO**
 Remarks: **Indentations, Factory Defect**

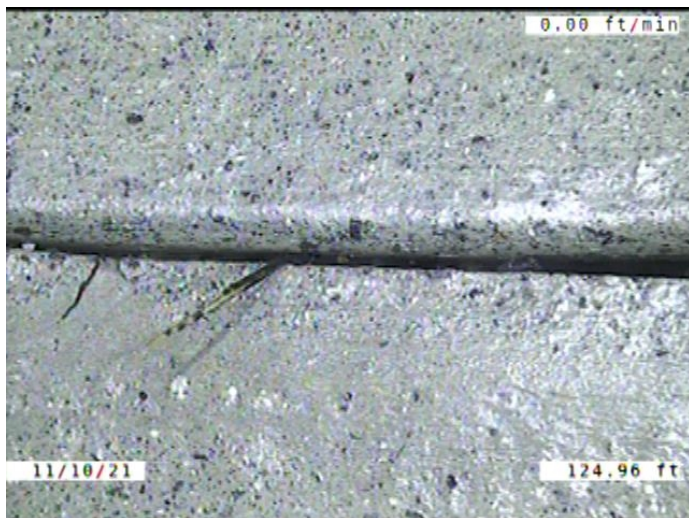
Code: **RFJ**
 Description: **Roots Fine Joint**

Distance (ft): **125.0**
 Structural Grade: **0**
 O&M Grade: **1**
 Clock Start/From: **2**
 Clock To:
 1st Value:
 2nd Value:
 Value Percent:
 Continuous Index:
 Within 8" of Joint: **YES**
 Remarks:

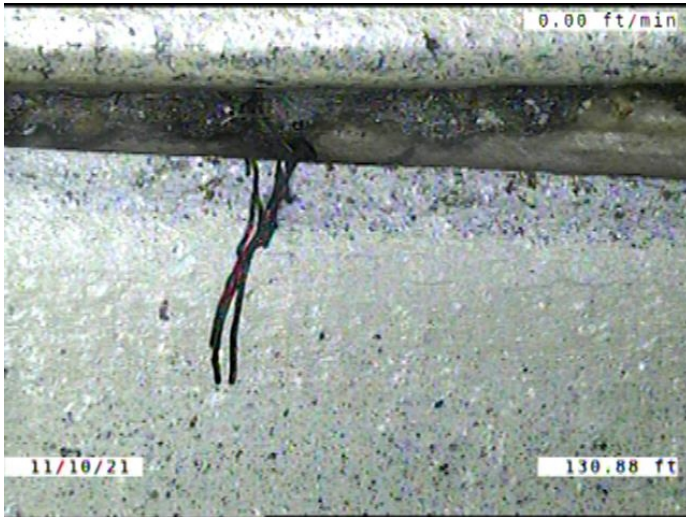
Code: **RFJ**
Description: **Roots Fine Joint**

Distance (ft): **130.9**
Structural Grade: **0**
O&M Grade: **1**
Clock Start/From: **10**
Clock To:
1st Value:
2nd Value:
Value Percent:
Continuous Index:
Within 8" of Joint: **YES**
Remarks:

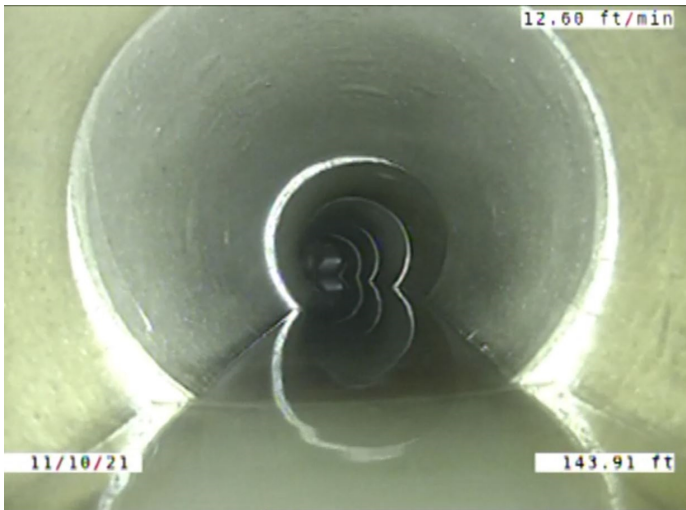
Code: **CM**
Description: **Crack Multiple**

Distance (ft): **143.9**
Structural Grade: **3**
O&M Grade: **0**
Clock Start/From: **8**
Clock To: **4**
1st Value:
2nd Value:
Value Percent:
Continuous Index:
Within 8" of Joint: **YES**
Remarks:

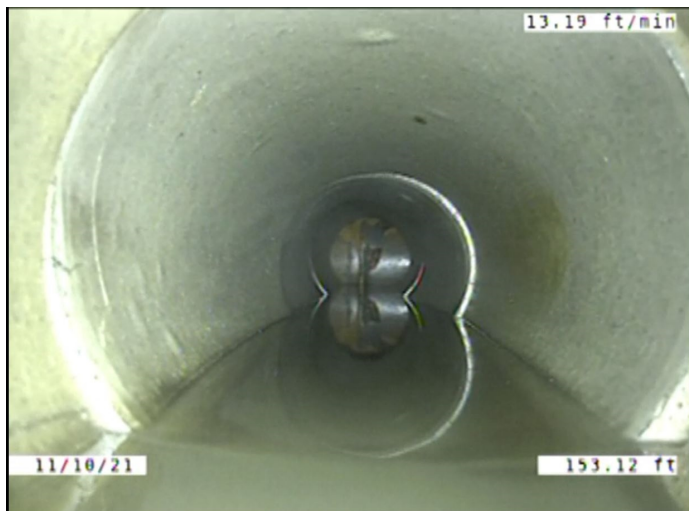
Code: **CM**
Description: **Crack Multiple**

Distance (ft): **153.1**
Structural Grade: **3**
O&M Grade: **0**
Clock Start/From: **8**
Clock To: **10**
1st Value:
2nd Value:
Value Percent:
Continuous Index:
Within 8" of Joint: **YES**
Remarks:

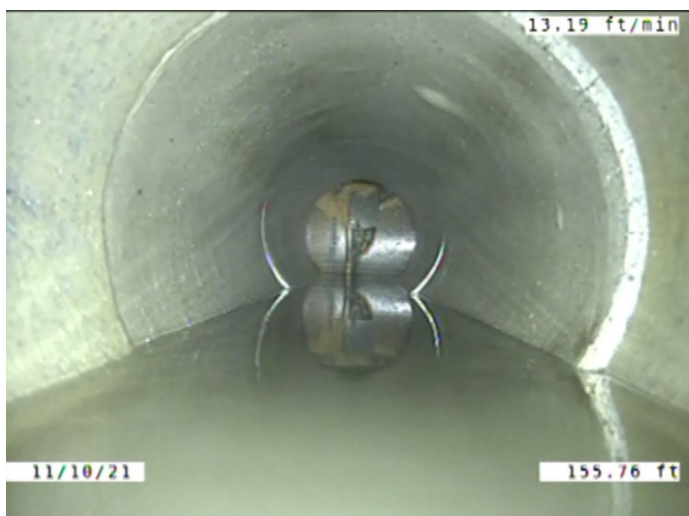
Code: **CL**
Description: **Crack Longitudinal**

Distance (ft): **155.8**
Structural Grade: **2**
O&M Grade: **0**
Clock Start/From: **2**
Clock To:
1st Value:
2nd Value:
Value Percent:
Continuous Index:
Within 8" of Joint: **YES**
Remarks:

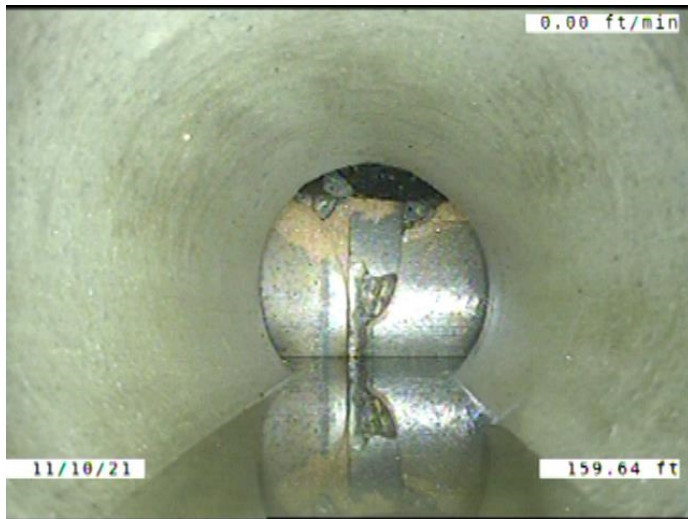
Code: **MWLS**
 Description: **Miscellaneous Water Level Sag**

Distance (ft): **159.6**
 Structural Grade: **2**
 O&M Grade: **0**
 Clock Start/From:
 Clock To:
 1st Value:
 2nd Value:
 Value Percent: **10.000**
 Continuous Index: **F03**
 Within 8" of Joint: **NO**
 Remarks:

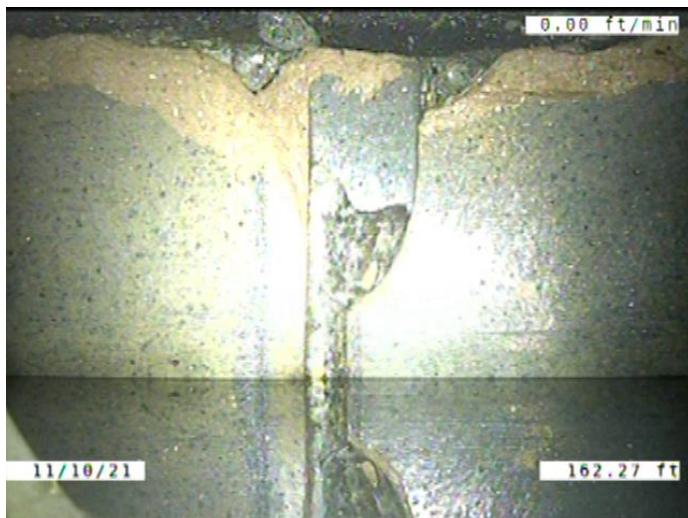
Code: **DSF**
 Description: **Deposits Settled Fine**

Distance (ft): **162.3**
 Structural Grade: **0**
 O&M Grade: **2**
 Clock Start/From: **5**
 Clock To: **7**
 1st Value:
 2nd Value:
 Value Percent: **5.000**
 Continuous Index: **F01**
 Within 8" of Joint: **YES**
 Remarks:

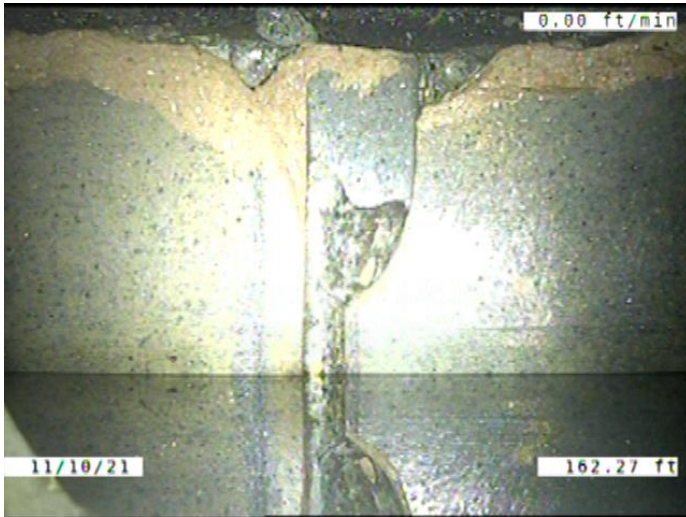
Code: **MWLS**
 Description: **Miscellaneous Water Level Sag**

Distance (ft): **162.3**
 Structural Grade: **2**
 O&M Grade: **0**
 Clock Start/From:
 Clock To:
 1st Value:
 2nd Value:
 Value Percent: **10.000**
 Continuous Index: **F05**
 Within 8" of Joint: **NO**
 Remarks:
