Profile/Photo Observation Report

Street:	FOXCROFT STREET	Flow Control:	Not Controlled
City:	Hobart, IN	Year Renewed:	
Location:	Yard	Tape/Media #:	
Purpose:	Routine Assessment	Dia/Height:	12"
Use:	Sanitary	Material:	VCP
Drain Area:	NA	Lining:	
Category:	NA		
Comment:	R_M at 8 ft nothing visible rocks in the tracks		
Location Details:		Direction of Survey:	Downstream
US MH:	M-507-011	DS MH:	M-507-019A
		Total Length Surveyed (ft):	9.4

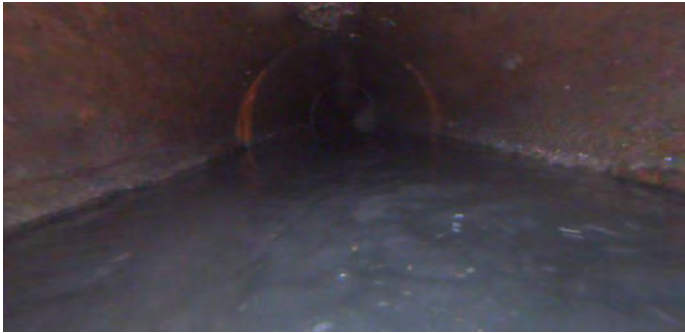
Code:	MWL
Description:	Water Level

Distance (ft):	.0
Structural Grade:	0
O&M Grade:	0
Clock Start/From:	
Clock To:	
1st Value:	
2nd Value:	
Value Percent:	5.000
Continuous Index:	
Within 8" of Joint:	NO
Remarks:

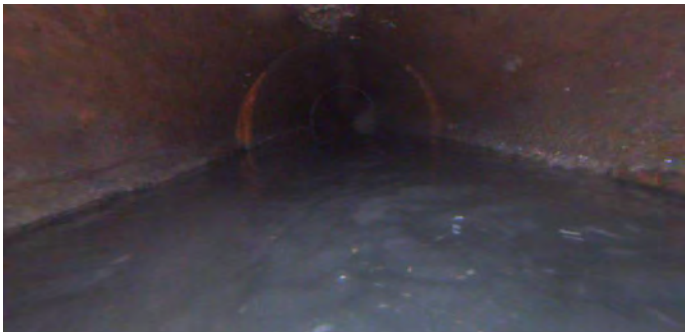
Code:	IS
Description:	Infil Stain

Distance (ft):	.0
Structural Grade:	0
O&M Grade:	0
Clock Start/From:	8
Clock To:	12
1st Value:	
2nd Value:	
Value Percent:	
Continuous Index:	
Within 8" of Joint:	YES
Remarks:

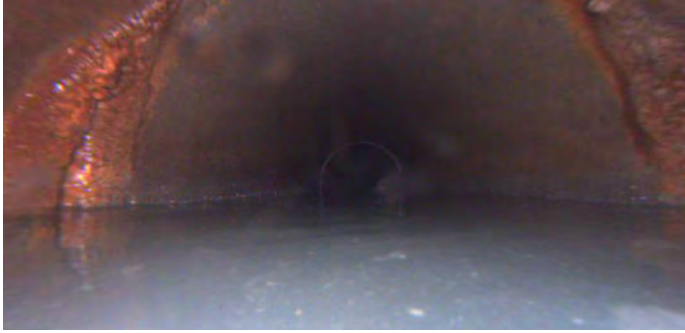
Code: **DAE**
Description: **Deposits Attached Encrustation**

Distance (ft): **2.2**
Structural Grade: **0**
O&M Grade: **2**
Clock Start/From: **8**
Clock To: **4**
1st Value:
2nd Value:
Value Percent: **5.000**
Continuous Index:
Within 8" of Joint: **YES**
Remarks:

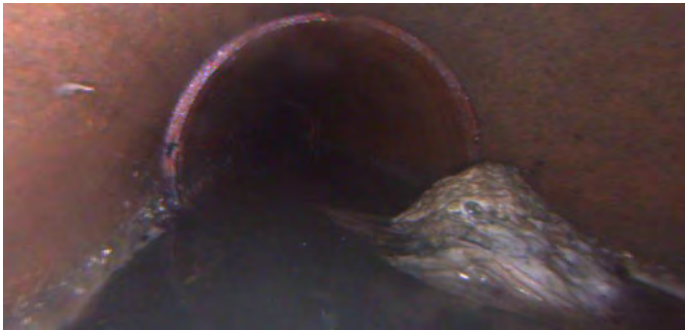
Code: **DSZ**
Description: **Deposits Settled Other**

Distance (ft): **4.6**
Structural Grade: **0**
O&M Grade: **2**
Clock Start/From: **4**
Clock To:
1st Value:
2nd Value:
Value Percent: **10.000**
Continuous Index:
Within 8" of Joint: **YES**
Remarks: **mixed material**

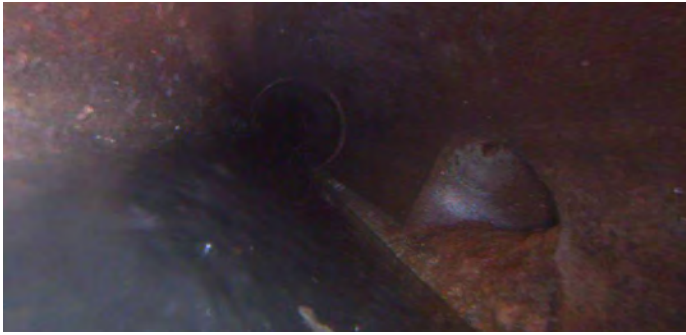
Code: **TFD**
Description: **Tap Factory Defective**

Distance (ft): **9.4**
Structural Grade: **0**
O&M Grade: **2**
Clock Start/From: **3**
Clock To:
1st Value: **4.000**
2nd Value:
Value Percent:
Continuous Index:
Within 8" of Joint:
Remarks: **DAE**

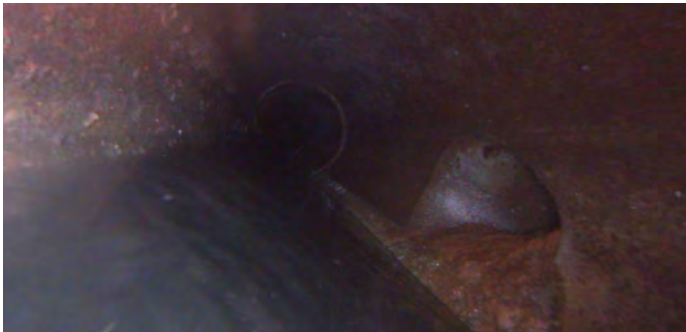
Code: **DAE**
Description: **Deposits Attached Encrustation**

Distance (ft): **9.4**
Structural Grade: **0**
O&M Grade: **2**
Clock Start/From: **3**
Clock To: **4**
1st Value:
2nd Value:
Value Percent: **5.000**
Continuous Index:
Within 8" of Joint: **NO**
Remarks:

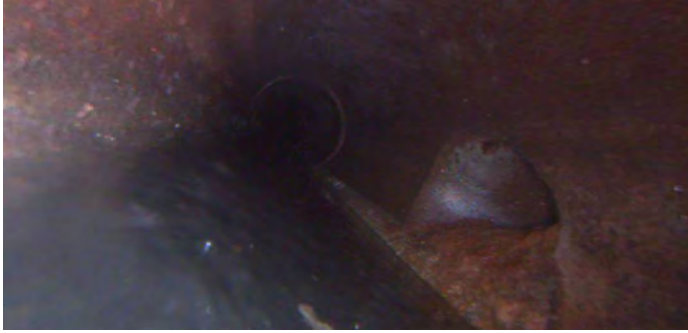
Code:	MSA
Description:	Abandoned Survey
Distance (ft):	9.4
Structural Grade:	0
O&M Grade:	0
Clock Start/From:	
Clock To:	
1st Value:	
2nd Value:	
Value Percent:	
Continuous Index:	
Within 8" of Joint:	NO
Remarks:	camera stopped
