## Profile/Photo Observation Report

Date:	<b>03/28/2018</b>	Weather:		Coding:	<b>PACP 6.0</b>
Pipe Length (ft):	<b>218.0</b>	Owner:	<b>NA</b>	Pre Clean:	<b>No Pre-Cleaning</b>
P.O.#:		Surveyor:	<b>Selasie Honu</b>	PSR:	
Customer:		Clean Date:	<b>01/01/1900</b>	Shape:	<b>C</b>

Street:	<b>FOXCROFT STREET</b>	Flow Control:	<b>Not Controlled</b>
City:	<b>Hobart, IN</b>	Year Renewed:	
Location:	<b>Yard</b>	Tape/Media #:	
Purpose:	<b>Routine Assessment</b>	Dia/Height:	<b>12"</b>
Use:	<b>Sanitary</b>	Material:	<b>VCP</b>
Drain Area:	<b>NA</b>	Lining:	
Category:	<b>NA</b>		
Comment:	<b>P_C at 16 ft debris</b>

Location Details:		Direction of Survey:	<b>Upstream</b>
US MH:	<b>M-507-011</b>	DS MH:	<b>M-507-019A</b>
		Total Length Surveyed (ft):	<b>17.5</b>

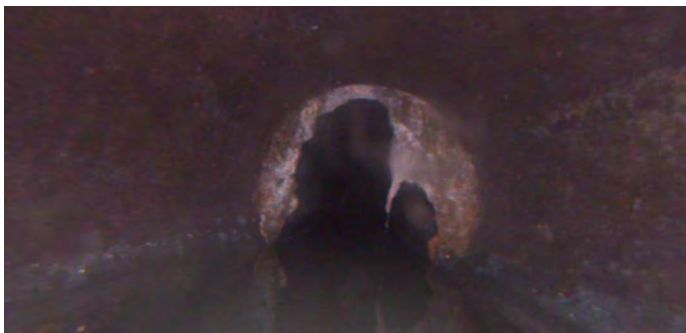
Code: **AMH**  
Description: **Manhole**

Distance (ft): **.0**  
Structural Grade: **0**  
O&M Grade: **0**  
Clock Start/From:  
Clock To:  
1st Value:  
2nd Value:  
Value Percent:  
Continuous Index:  
Within 8" of Joint: **NO**  
Remarks: **M-507-019A**

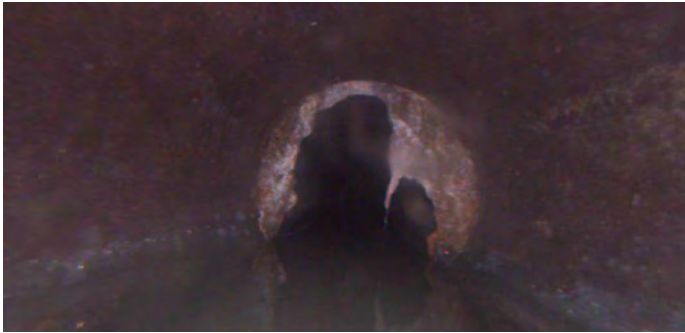
Code:	<b>MWL</b>
Description:	<b>Water Level</b>

Distance (ft):	<b>.0</b>
Structural Grade:	<b>0</b>
O&M Grade:	<b>0</b>
Clock Start/From:	
Clock To:	
1st Value:	
2nd Value:	
Value Percent:	<b>5.000</b>
Continuous Index:	
Within 8" of Joint:	<b>NO</b>
Remarks:

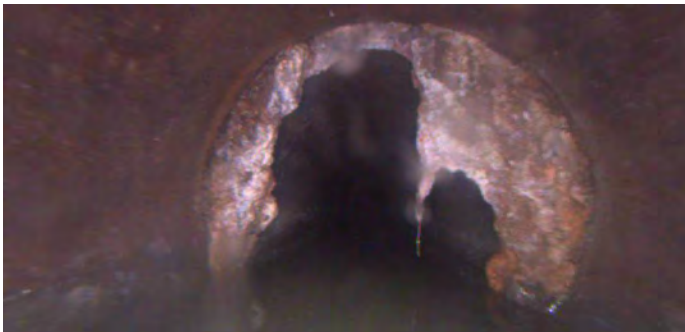
Code:	<b>DAE</b>
Description:	<b>Deposits Attached Encrustation</b>

Distance (ft):	<b>1.4</b>
Structural Grade:	<b>0</b>
O&M Grade:	<b>4</b>
Clock Start/From:	<b>7</b>
Clock To:	<b>5</b>
1st Value:	
2nd Value:	
Value Percent:	<b>25.000</b>
Continuous Index:	
Within 8" of Joint:	<b>YES</b>
Remarks:

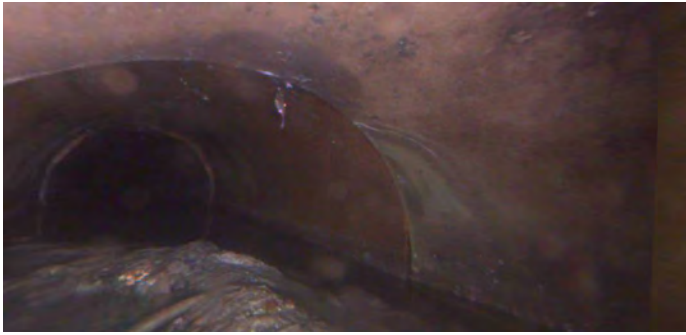
Code: **CS**  
Description: **Crack Spiral**

Distance (ft): **15.3**  
Structural Grade: **2**  
O&M Grade: **0**  
Clock Start/From: **2**  
Clock To: **3**  
1st Value:  
2nd Value:  
Value Percent:  
Continuous Index:  
Within 8" of Joint: **YES**  
Remarks:

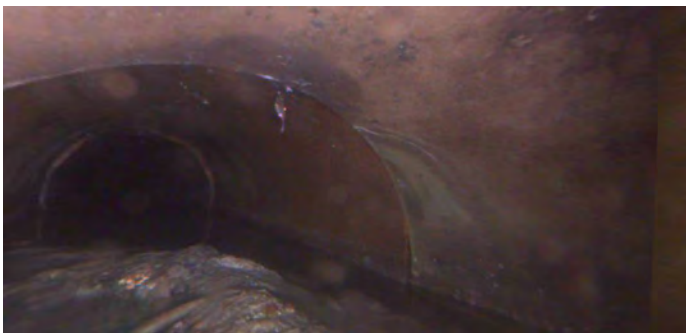
Code: **IW**  
Description: **Infil Weeper**

Distance (ft): **15.3**  
Structural Grade: **0**  
O&M Grade: **2**  
Clock Start/From: **2**  
Clock To: **4**  
1st Value:  
2nd Value:  
Value Percent:  
Continuous Index:  
Within 8" of Joint: **YES**  
Remarks:

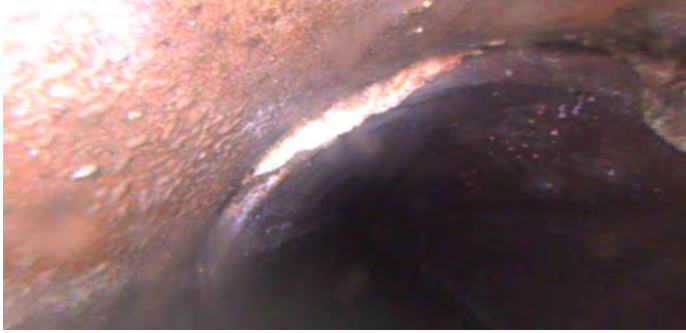
Code:	<b>MSA</b>
Description:	<b>Abandoned Survey</b>
Distance (ft):	<b>17.5</b>
Structural Grade:	<b>0</b>
O&M Grade:	<b>0</b>
Clock Start/From:	
Clock To:	
1st Value:	
2nd Value:	
Value Percent:	
Continuous Index:	
Within 8" of Joint:	<b>NO</b>
Remarks:	<b>camera stopped</b>
