Profile/Photo Observation Report

Street:	FOXCROFT STREET	Flow Control:	Not Controlled
City:	Hobart, IN	Year Renewed:	
Location:	Woods	Tape/Media #:	
Purpose:	Routine Assessment	Dia/Height:	12"
Use:	Sanitary	Material:	VCP
Drain Area:	NA	Lining:	
Category:	NA		
Comment:	F_S_R_M at 1 ft debris		
Location Details:		Direction of Survey:	Upstream
US MH:	M-507-019	DS MH:	M-507-019A
		Total Length Surveyed (ft):	3.0

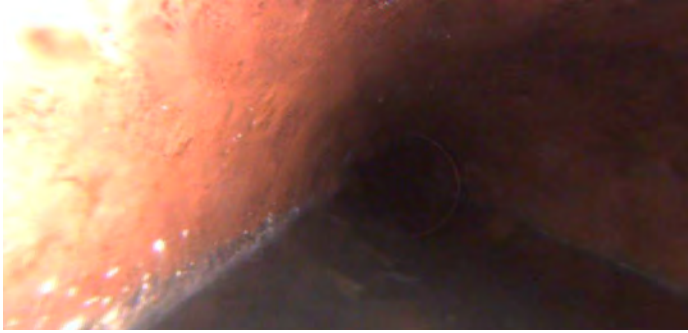
Code:	MSA
Description:	Abandoned Survey
Distance (ft):	3.0
Structural Grade:	0
O&M Grade:	0
Clock Start/From:	
Clock To:	
1st Value:	
2nd Value:	
Value Percent:	
Continuous Index:	
Within 8" of Joint:	NO
Remarks:	camera stopped
