Profile/Photo Observation Report

Date:	03/30/2018	Weather:		Coding:	PACP 6.0
Pipe Length (ft):	361.0	Owner:	NA	Pre Clean:	No Pre-Cleaning
P.O.#:		Surveyor:	JUSTIN GONZALES	PSR:	
Customer:		Clean Date:	01/01/1900	Shape:	C

Street:	FOXCROFT STREET	Flow Control:	Not Controlled
City:	Hobart, IN	Year Renewed:	
Location:	Yard	Tape/Media #:	
Purpose:	Routine Assessment	Dia/Height:	10"
Use:	Sanitary	Material:	PVC
Drain Area:	NA	Lining:	
Category:	NA		
Comment:	M_T_P_C at 425 ft . O_C at 341 ft		
Location Details:		Direction of Survey:	Upstream
US MH:	M-607-075A	DS MH:	M-607-075
		Total Length Surveyed (ft):	426.8

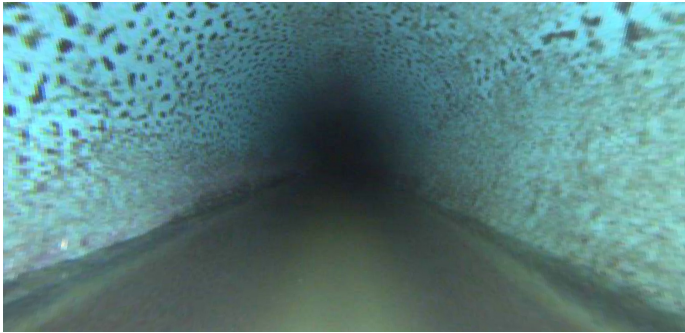
Code:	MWL
Description:	Water Level

Distance (ft):	.0
Structural Grade:	0
O&M Grade:	0
Clock Start/From:	
Clock To:	
1st Value:	
2nd Value:	
Value Percent:	15.000
Continuous Index:	
Within 8" of Joint:	NO
Remarks:

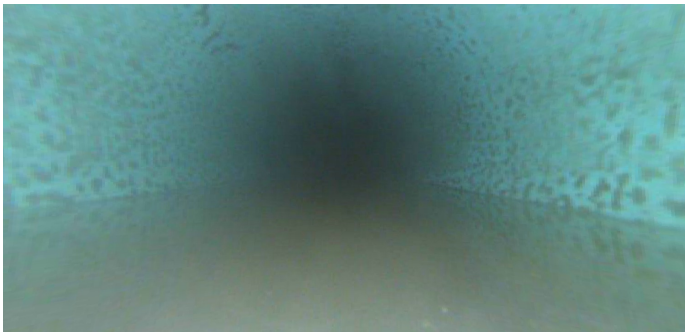
Code:	MGO
Description:	General Observation

Distance (ft):	13.1
Structural Grade:	0
O&M Grade:	0
Clock Start/From:	
Clock To:	
1st Value:	
2nd Value:	
Value Percent:	
Continuous Index:	
Within 8" of Joint:	NO
Remarks:	FOG

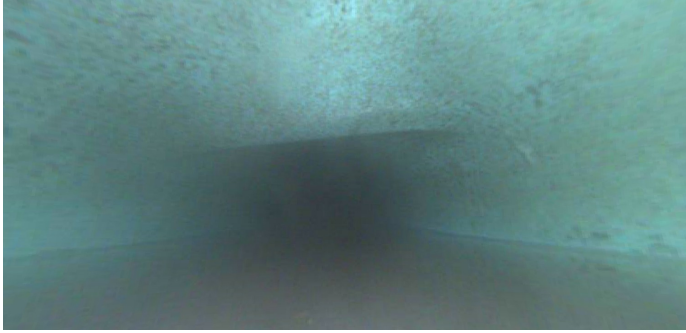
Code: **D**
Description: **Deformed**

Distance (ft): **26.4**
Structural Grade: **4**
O&M Grade: **0**
Clock Start/From:
Clock To:
1st Value:
2nd Value:
Value Percent: **10.000**
Continuous Index:
Within 8" of Joint: **NO**
Remarks:

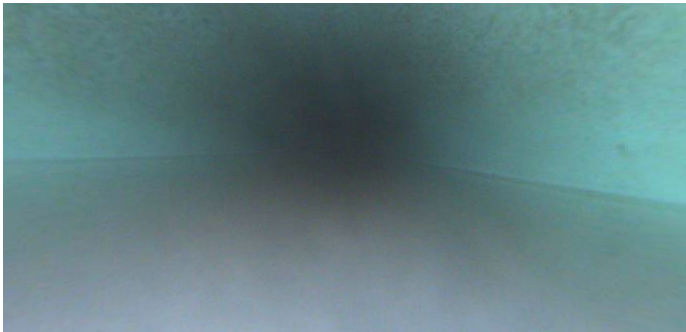
Code: **MWLS**
Description: **Water Level Sag**

Distance (ft): **28.3**
Structural Grade: **2**
O&M Grade: **3**
Clock Start/From:
Clock To:
1st Value:
2nd Value:
Value Percent: **20.000**
Continuous Index:
Within 8" of Joint: **NO**
Remarks:

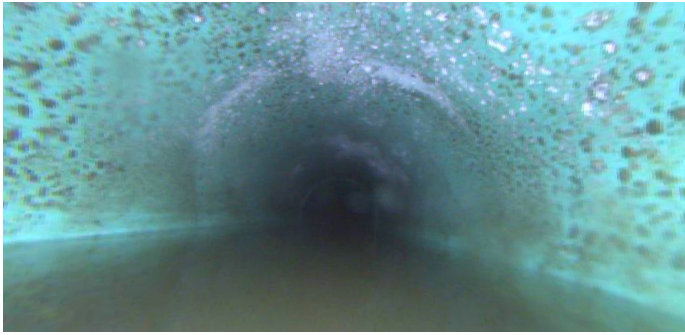
Code: **DAGS**
Description: **Deposits Attached Grease**

Distance (ft): **178.5**
Structural Grade: **0**
O&M Grade: **2**
Clock Start/From: **7**
Clock To: **5**
1st Value:
2nd Value:
Value Percent: **5.000**
Continuous Index:
Within 8" of Joint: **NO**
Remarks:

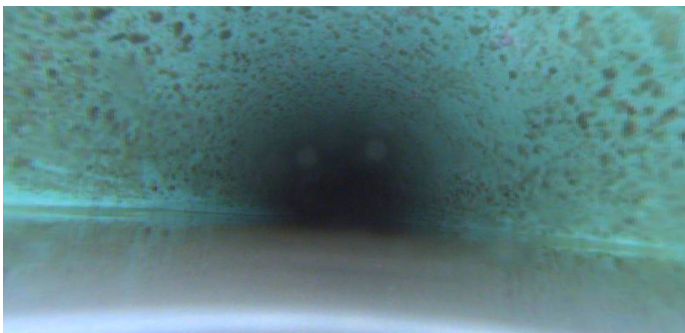
Code: **MWLS**
Description: **Water Level Sag**

Distance (ft): **222.0**
Structural Grade: **3**
O&M Grade: **3**
Clock Start/From:
Clock To:
1st Value:
2nd Value:
Value Percent: **40.000**
Continuous Index: **S01**
Within 8" of Joint: **NO**
Remarks:

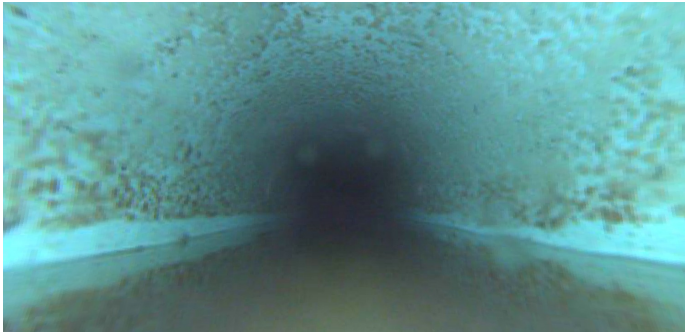
Code: **MWLS**
Description: **Water Level Sag**

Distance (ft): **243.8**
Structural Grade: **3**
O&M Grade: **3**
Clock Start/From:
Clock To:
1st Value:
2nd Value:
Value Percent: **40.000**
Continuous Index: **F01**
Within 8" of Joint: **NO**
Remarks:

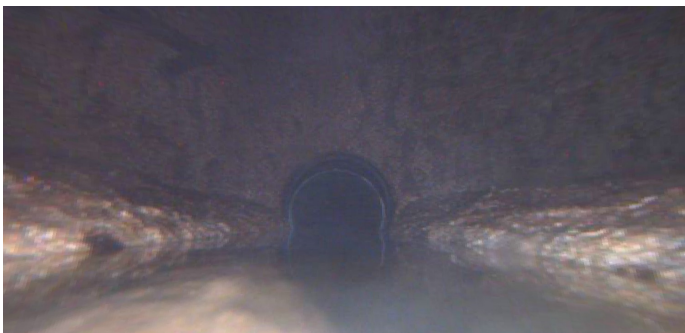
Code: **MGO**
Description: **General Observation**

Distance (ft): **341.3**
Structural Grade: **0**
O&M Grade: **0**
Clock Start/From:
Clock To:
1st Value:
2nd Value:
Value Percent:
Continuous Index:
Within 8" of Joint: **NO**
Remarks: **DSMH**

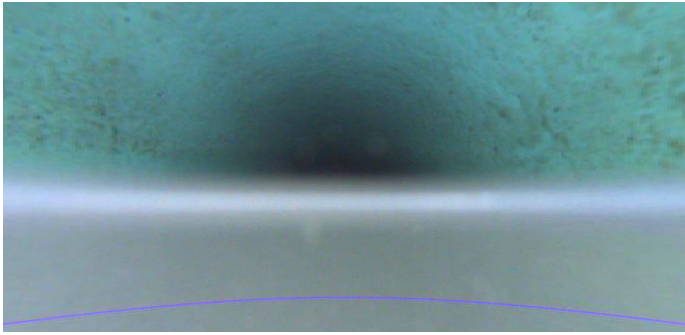
Code: **MWLS**
Description: **Water Level Sag**

Distance (ft): **406.5**
Structural Grade: **3**
O&M Grade: **3**
Clock Start/From:
Clock To:
1st Value:
2nd Value:
Value Percent: **50.000**
Continuous Index:
Within 8" of Joint: **NO**
Remarks:

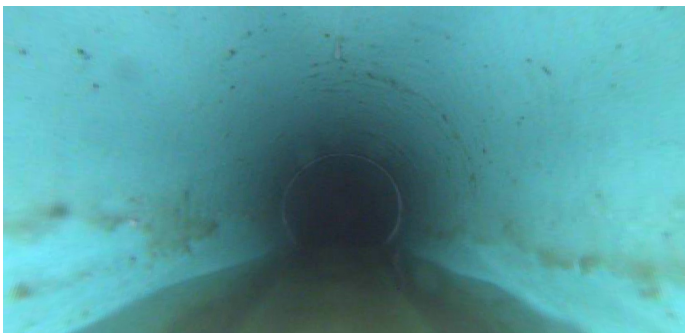
Code: **MSA**
Description: **Abandoned Survey**

Distance (ft): **426.8**
Structural Grade: **0**
O&M Grade: **0**
Clock Start/From:
Clock To:
1st Value:
2nd Value:
Value Percent:
Continuous Index:
Within 8" of Joint: **NO**
Remarks: **ROBOT HAS STOPPED**
