Profile/Photo Observation Report

Date:	03/30/2018	Weather:		Coding:	PACP 6.0
Pipe Length (ft):	128.0	Owner:	NA	Pre Clean:	No Pre-Cleaning
P.O.#:		Surveyor:	Jen Costello	PSR:	
Customer:		Clean Date:	01/01/1900	Shape:	C

Street:	FOXCROFT STREET	Flow Control:	Not Controlled
City:	Hobart, IN	Year Renewed:	
Location:	Yard	Tape/Media #:	
Purpose:	Routine Assessment	Dia/Height:	10"
Use:	Sanitary	Material:	PVC
Drain Area:	NA	Lining:	
Category:	NA		
Comment:	Flow direction

Location Details:		Direction of Survey:	Upstream
US MH:	M-607-075A	DS MH:	M-608-015
		Total Length Surveyed (ft):	128.0

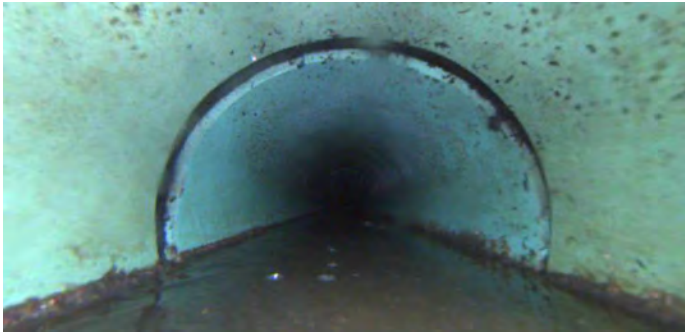
Code:	MWL
Description:	Water Level

Distance (ft):	.0
Structural Grade:	0
O&M Grade:	0
Clock Start/From:	
Clock To:	
1st Value:	
2nd Value:	
Value Percent:	30.000
Continuous Index:	
Within 8" of Joint:	NO
Remarks:

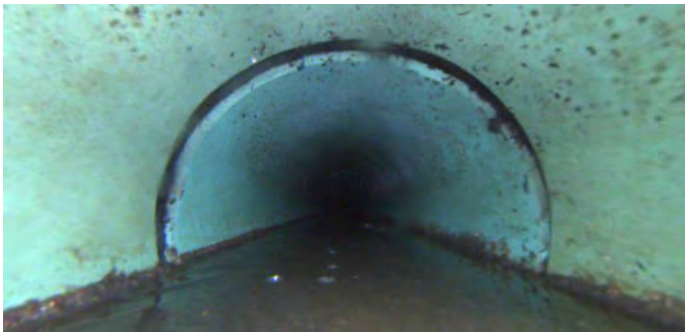
Code:	JOM
Description:	Joint Offset Medium

Distance (ft):	.0
Structural Grade:	1
O&M Grade:	0
Clock Start/From:	
Clock To:	
1st Value:	
2nd Value:	
Value Percent:	
Continuous Index:	
Within 8" of Joint:	NO
Remarks:

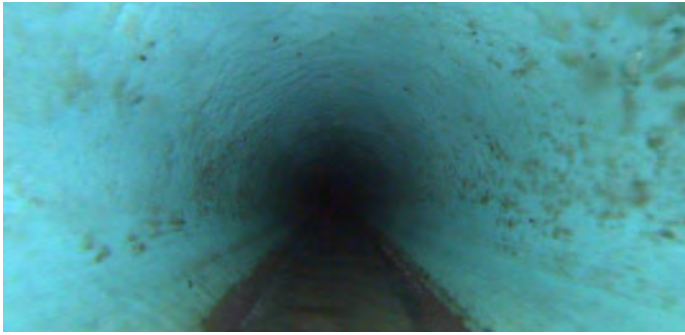
Code: **MWL**
Description: **Water Level**

Distance (ft): **7.0**
Structural Grade: **0**
O&M Grade: **0**
Clock Start/From:
Clock To:
1st Value:
2nd Value:
Value Percent: **5.000**
Continuous Index:
Within 8" of Joint: **NO**
Remarks:

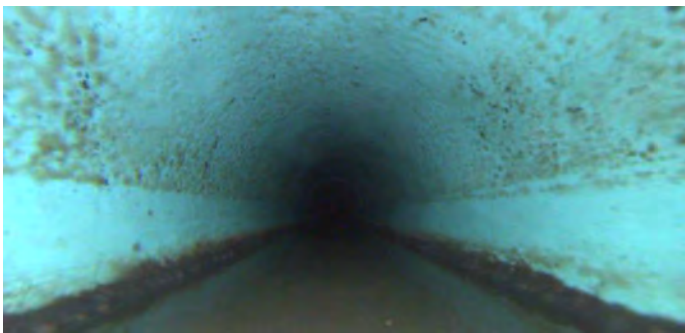
Code: **MWL**
Description: **Water Level**

Distance (ft): **37.6**
Structural Grade: **0**
O&M Grade: **0**
Clock Start/From:
Clock To:
1st Value:
2nd Value:
Value Percent: **20.000**
Continuous Index:
Within 8" of Joint: **NO**
Remarks:

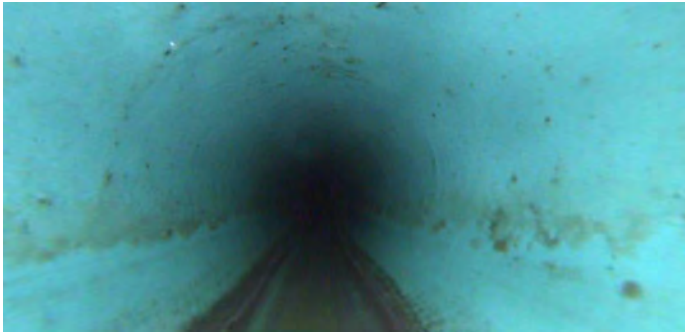
Code: **MWL**
Description: **Water Level**

Distance (ft): **44.0**
Structural Grade: **0**
O&M Grade: **0**
Clock Start/From:
Clock To:
1st Value:
2nd Value:
Value Percent: **5.000**
Continuous Index:
Within 8" of Joint: **NO**
Remarks:

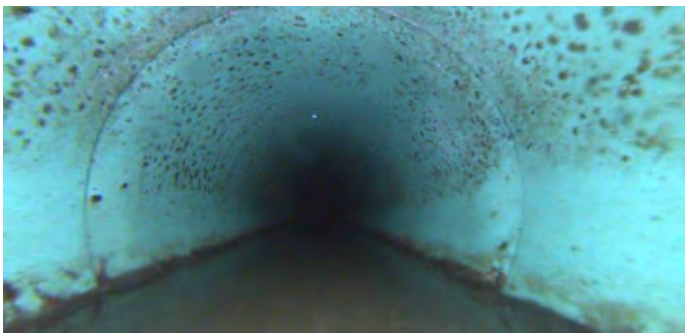
Code: **MWL**
Description: **Water Level**

Distance (ft): **66.3**
Structural Grade: **0**
O&M Grade: **0**
Clock Start/From:
Clock To:
1st Value:
2nd Value:
Value Percent: **20.000**
Continuous Index:
Within 8" of Joint: **NO**
Remarks:

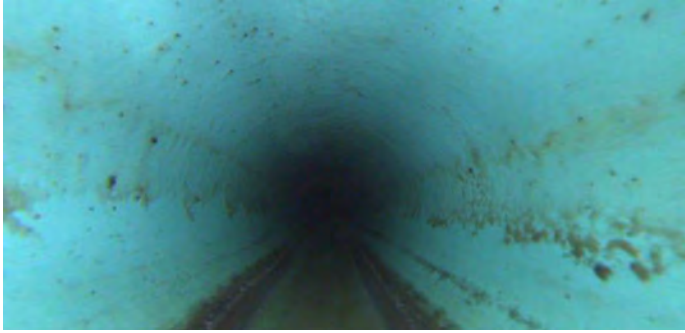
Code: **MWL**
Description: **Water Level**

Distance (ft): **111.5**
Structural Grade: **0**
O&M Grade: **0**
Clock Start/From:
Clock To:
1st Value:
2nd Value:
Value Percent: **5.000**
Continuous Index:
Within 8" of Joint: **NO**
Remarks:

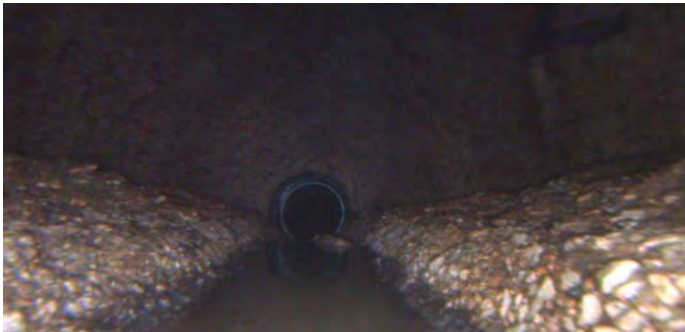
Code: **AMH**
Description: **Manhole**

Distance (ft): **127.8**
Structural Grade: **0**
O&M Grade: **0**
Clock Start/From:
Clock To:
1st Value:
2nd Value:
Value Percent:
Continuous Index:
Within 8" of Joint: **NO**
Remarks: **M-607-075A**
