Profile/Photo Observation Report

Street:	FOXCROFT STREET	Flow Control:	Not Controlled
City:	Hobart, IN	Year Renewed:	
Location:	Yard	Tape/Media #:	
Purpose:	Routine Assessment	Dia/Height:	8"
Use:	Sanitary	Material:	PVC
Drain Area:	NA	Lining:	
Category:	NA		
Comment:	MH M-607-063 DNE

Location Details:		Direction of Survey:	Downstream
US MH:	M-607-075	DS MH:	M-607-067
		Total Length Surveyed (ft):	321.8

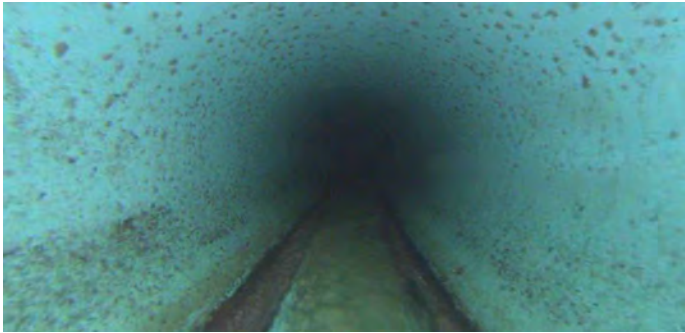
Code:	MWL
Description:	Water Level

Distance (ft):	.0
Structural Grade:	0
O&M Grade:	0
Clock Start/From:	
Clock To:	
1st Value:	
2nd Value:	
Value Percent:	5.000
Continuous Index:	
Within 8" of Joint:	NO
Remarks:

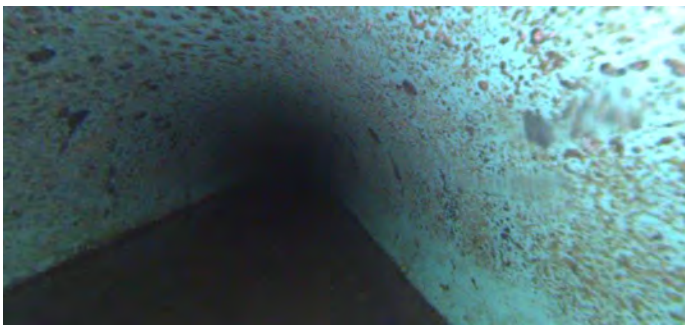
Code:	MWL
Description:	Water Level

Distance (ft):	227.1
Structural Grade:	0
O&M Grade:	0
Clock Start/From:	
Clock To:	
1st Value:	
2nd Value:	
Value Percent:	20.000
Continuous Index:	
Within 8" of Joint:	NO
Remarks:

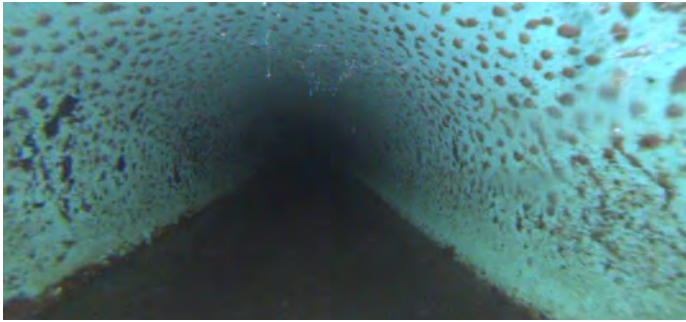
Code: **MWL**
Description: **Water Level**

Distance (ft): **311.5**
Structural Grade: **0**
O&M Grade: **0**
Clock Start/From:
Clock To:
1st Value:
2nd Value:
Value Percent: **30.000**
Continuous Index:
Within 8" of Joint: **NO**
Remarks:

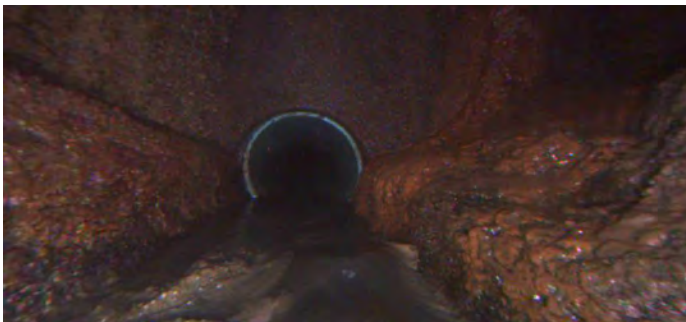
Code: **AMH**
Description: **Manhole**

Distance (ft): **321.8**
Structural Grade: **0**
O&M Grade: **0**
Clock Start/From:
Clock To:
1st Value:
2nd Value:
Value Percent:
Continuous Index:
Within 8" of Joint: **NO**
Remarks: **M-607-067**
