Profile/Photo Observation Report

Street:	Capitol	Flow Control:	Not Controlled
City:	Hobart, IN	Year Renewed:	
Location:	Light Highway	Tape/Media #:	
Purpose:	Maintenance Related	Dia/Height:	12"
Use:	Sanitary	Material:	PVC
Drain Area:	NA	Lining:	Cured in Place
Category:	NA		
Comment:	706-036 doesn't exist.

Location Details:		Direction of Survey:	Downstream
US MH:	M-706-035.5	DS MH:	M-706-037
		Total Length Surveyed (ft):	158.6

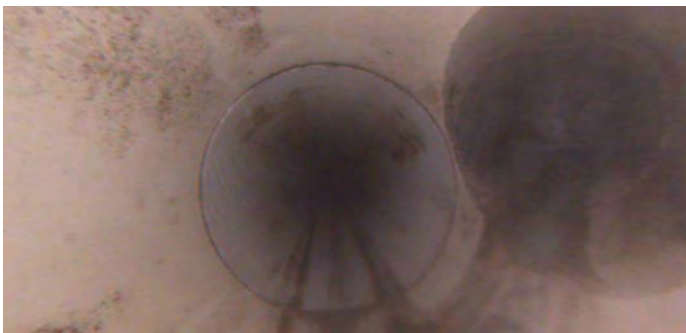
Code: **TF**
Description: **Tap Factory**

Distance (ft): **62.4**
Structural Grade: **0**
O&M Grade: **0**
Clock Start/From: **2**
Clock To:
1st Value: **4.000**
2nd Value:
Value Percent:
Continuous Index:
Within 8" of Joint: **YES**
Remarks:

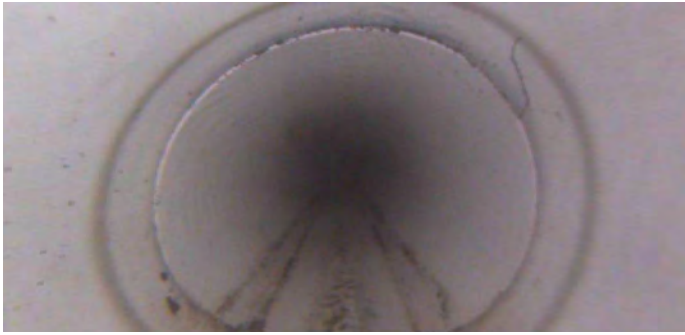
Code: **D**
Description: **Deformed**

Distance (ft): **97.2**
Structural Grade: **4**
O&M Grade: **0**
Clock Start/From:
Clock To:
1st Value:
2nd Value:
Value Percent: **5.000**
Continuous Index:
Within 8" of Joint: **NO**
Remarks:

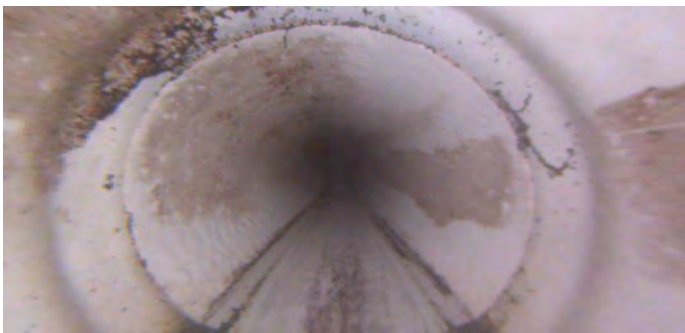
Code: **D**
Description: **Deformed**

Distance (ft): **123.1**
Structural Grade: **4**
O&M Grade: **0**
Clock Start/From:
Clock To:
1st Value:
2nd Value:
Value Percent: **5.000**
Continuous Index:
Within 8" of Joint: **NO**
Remarks:

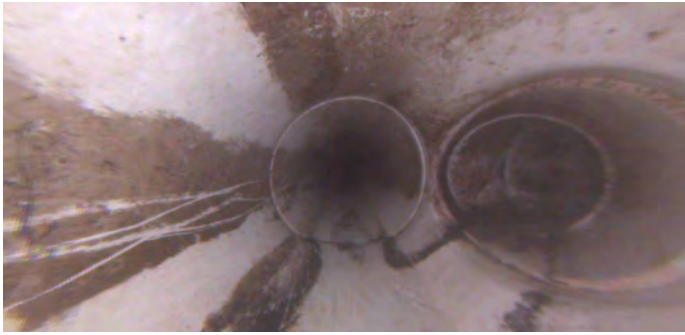
Code: **TF**
Description: **Tap Factory**

Distance (ft): **145.9**
Structural Grade: **0**
O&M Grade: **0**
Clock Start/From: **3**
Clock To:
1st Value: **4.000**
2nd Value:
Value Percent:
Continuous Index:
Within 8" of Joint: **YES**
Remarks:

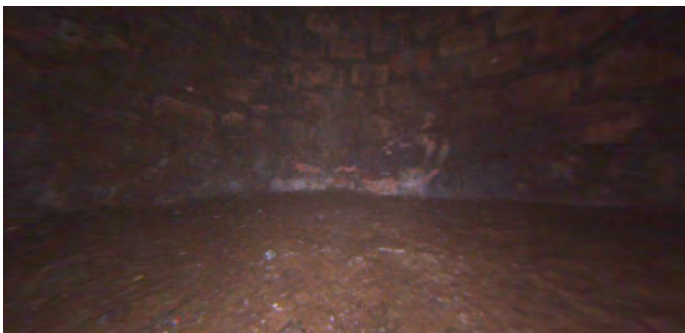
Code: **AMH**
Description: **Manhole**

Distance (ft): **158.6**
Structural Grade: **0**
O&M Grade: **0**
Clock Start/From:
Clock To:
1st Value:
2nd Value:
Value Percent:
Continuous Index:
Within 8" of Joint: **NO**
Remarks: **M-706-037**
