Profile/Photo Observation Report

Street:	Bracken	Flow Control:	Not Controlled
City:	Hobart, IN	Year Renewed:	
Location:	Sidewalk	Tape/Media #:	
Purpose:	Maintenance Related	Dia/Height:	8"
Use:	Sanitary	Material:	PVC
Drain Area:	NA	Lining:	Cured in Place
Category:	NA		
Comment:	Flow direction wrong. New segment.		
Location Details:		Direction of Survey:	Downstream
US MH:	M-709-009	DS MH:	M-708-009-A
		Total Length Surveyed (ft):	133.2

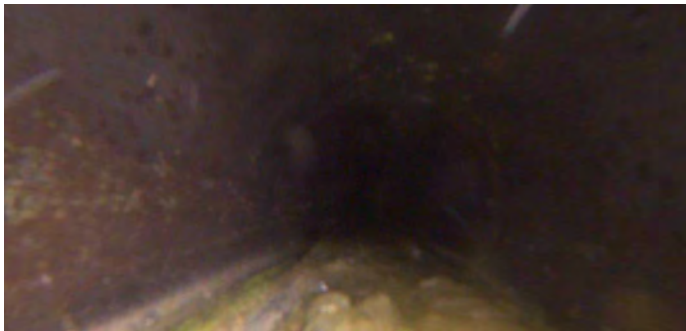
Code: **AMH**
Description: **Manhole**

Distance (ft): **.0**
Structural Grade: **0**
O&M Grade: **0**
Clock Start/From:
Clock To:
1st Value:
2nd Value:
Value Percent:
Continuous Index:
Within 8" of Joint: **NO**
Remarks: **M-709-009**

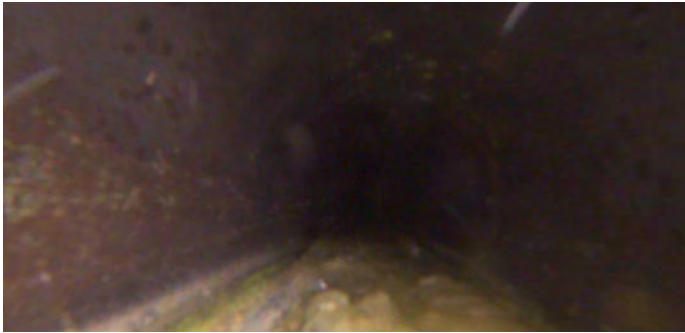
Code:	MWL
Description:	Water Level

Distance (ft):	.0
Structural Grade:	0
O&M Grade:	0
Clock Start/From:	
Clock To:	
1st Value:	
2nd Value:	
Value Percent:	5.000
Continuous Index:	
Within 8" of Joint:	NO
Remarks:

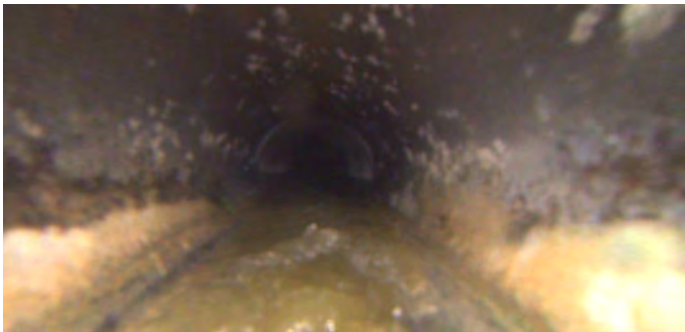
Code:	DAGS
Description:	Deposits Attached Grease

Distance (ft):	12.6
Structural Grade:	0
O&M Grade:	2
Clock Start/From:	8
Clock To:	4
1st Value:	
2nd Value:	
Value Percent:	5.000
Continuous Index:	
Within 8" of Joint:	NO
Remarks:

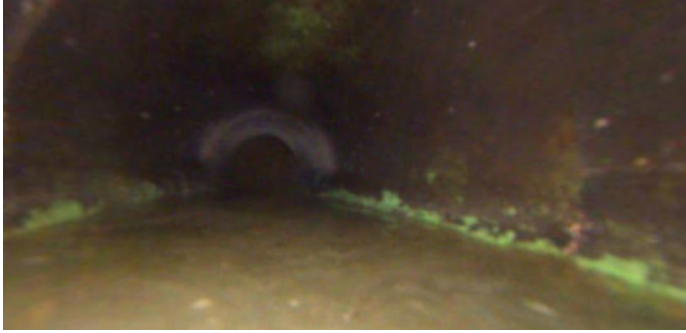
Code: **LL**
Description: **Alignment Left**

Distance (ft): **127.8**
Structural Grade: **0**
O&M Grade: **1**
Clock Start/From:
Clock To:
1st Value:
2nd Value:
Value Percent: **5.000**
Continuous Index:
Within 8" of Joint: **NO**
Remarks:

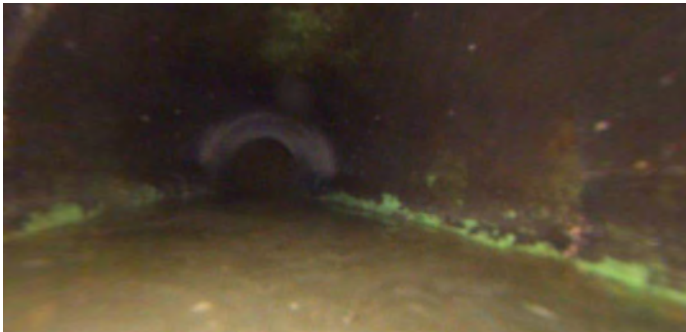
Code: **MWL**
Description: **Water Level**

Distance (ft): **127.8**
Structural Grade: **0**
O&M Grade: **0**
Clock Start/From:
Clock To:
1st Value:
2nd Value:
Value Percent: **20.000**
Continuous Index:
Within 8" of Joint: **NO**
Remarks:

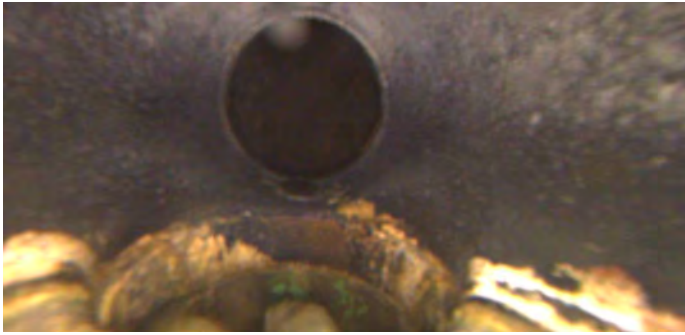
Code: **TF**
Description: **Tap Factory**

Distance (ft): **130.4**
Structural Grade: **0**
O&M Grade: **0**
Clock Start/From: **6**
Clock To:
1st Value: **6.000**
2nd Value:
Value Percent:
Continuous Index:
Within 8" of Joint:
Remarks: **drop connection**

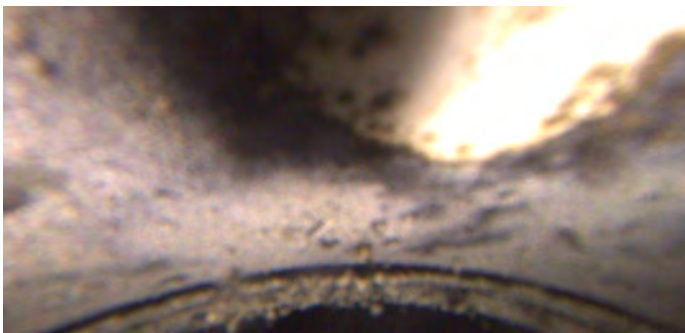
Code: **AMH**
Description: **Manhole**

Distance (ft): **133.2**
Structural Grade: **0**
O&M Grade: **0**
Clock Start/From:
Clock To:
1st Value:
2nd Value:
Value Percent:
Continuous Index:
Within 8" of Joint: **NO**
Remarks: **M-708-009-A in drop connection**
