Profile/Photo Observation Report

Date:	03/23/2018	Weather:		Coding:	PACP 6.0
Pipe Length (ft):	338.6	Owner:	NA	Pre Clean:	Not Known
P.O.#:		Surveyor:	Jen Costello	PSR:	P-203-060-031
Customer:		Clean Date:	01/01/1900	Shape:	C

Street:	W 38TH AVE	Flow Control:	Not Controlled
City:	Hobart, IN	Year Renewed:	
Location:	Other	Tape/Media #:	
Purpose:	Not Known	Dia/Height:	12"
Use:	Sanitary	Material:	PVC
Drain Area:	NA	Lining:	
Category:	NA		
Comment:

Location Details:		Direction of Survey:	Downstream
US MH:	M-103-031	DS MH:	M-203-060
		Total Length Surveyed (ft):	6.4

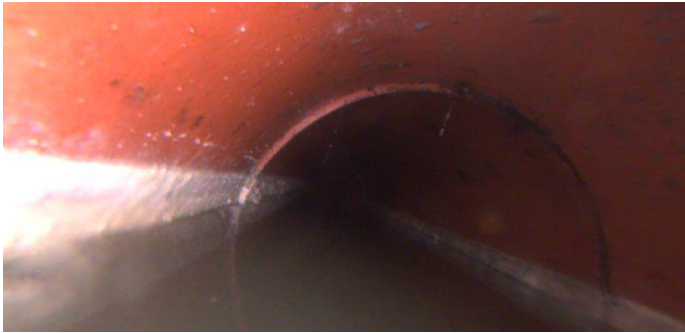
Code:	MWL
Description:	Water Level

Distance (ft):	.0
Structural Grade:	0
O&M Grade:	0
Clock Start/From:	
Clock To:	
1st Value:	
2nd Value:	
Value Percent:	30.000
Continuous Index:	
Within 8" of Joint:	NO
Remarks:

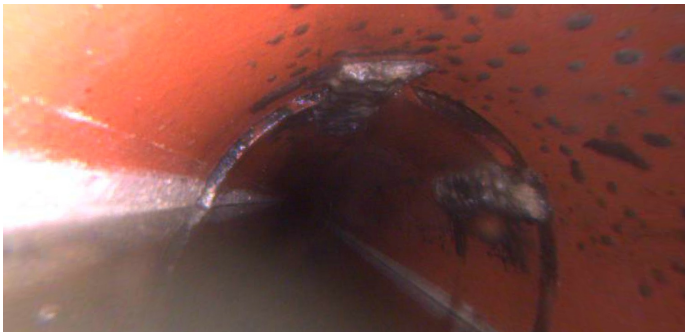
Code:	DAGS
Description:	Deposits Attached Grease

Distance (ft):	6.4
Structural Grade:	0
O&M Grade:	2
Clock Start/From:	8
Clock To:	4
1st Value:	
2nd Value:	
Value Percent:	5.000
Continuous Index:	
Within 8" of Joint:	YES
Remarks:

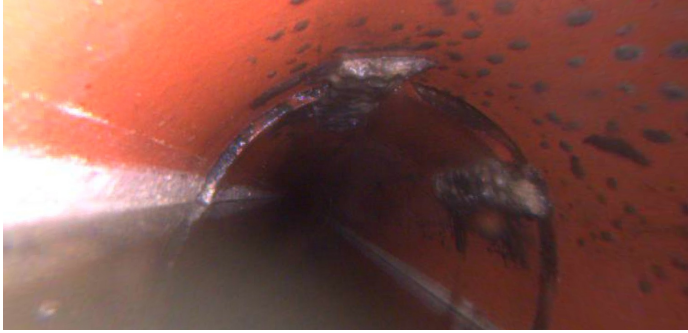
Code:	MSA
Description:	Abandoned Survey
Distance (ft):	6.4
Structural Grade:	0
O&M Grade:	0
Clock Start/From:	
Clock To:	
1st Value:	
2nd Value:	
Value Percent:	
Continuous Index:	
Within 8" of Joint:	NO
Remarks:	overturned
