Profile/Photo Observation Report

Street:	E 38th Ave	Flow Control:	Not Controlled
City:	Hobart, IN	Year Renewed:	
Location:	Other	Tape/Media #:	
Purpose:	Not Known	Dia/Height:	12"
Use:	Sanitary	Material:	PVC
Drain Area:	NA	Lining:	
Category:	NA		
Comment:

Location Details:		Direction of Survey:	Downstream
US MH:	M-103-031	DS MH:	M-203-060
		Total Length Surveyed (ft):	6.4

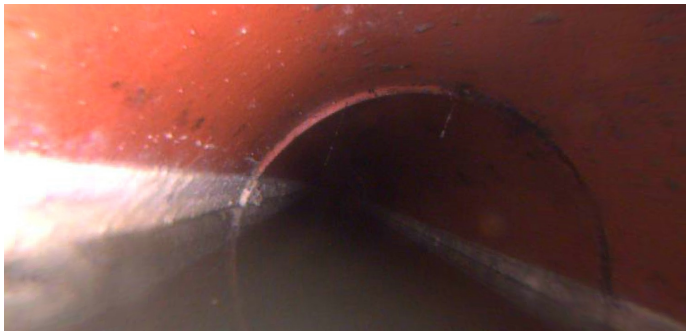
Code: **AMH**
Description: **Manhole**

Distance (ft): **.0**
Structural Grade: **0**
O&M Grade: **0**
Clock Start/From:
Clock To:
1st Value:
2nd Value:
Value Percent:
Continuous Index:
Within 8" of Joint: **NO**
Remarks: **M-103-031**

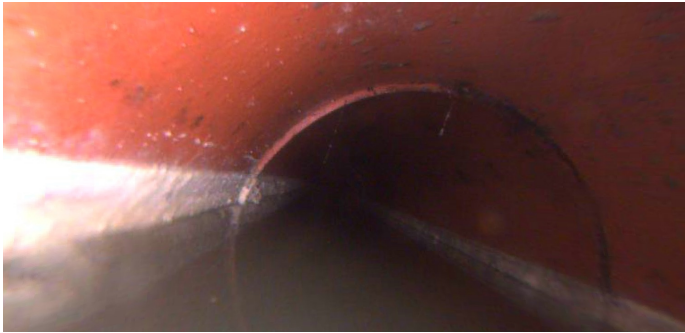
Code:	MWL
Description:	Water Level

Distance (ft):	.0
Structural Grade:	0
O&M Grade:	0
Clock Start/From:	
Clock To:	
1st Value:	
2nd Value:	
Value Percent:	30.000
Continuous Index:	
Within 8" of Joint:	NO
Remarks:

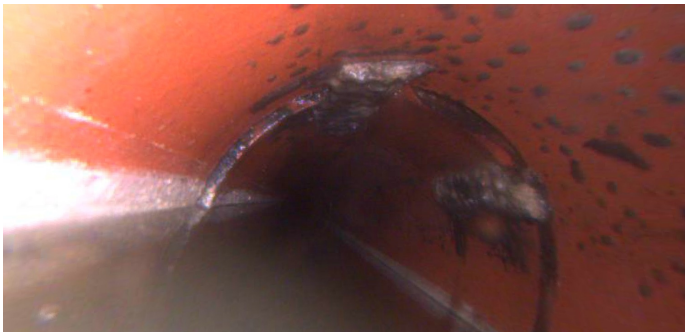
Code:	DAGS
Description:	Deposits Attached Grease

Distance (ft):	6.4
Structural Grade:	0
O&M Grade:	2
Clock Start/From:	8
Clock To:	4
1st Value:	
2nd Value:	
Value Percent:	5.000
Continuous Index:	
Within 8" of Joint:	YES
Remarks:

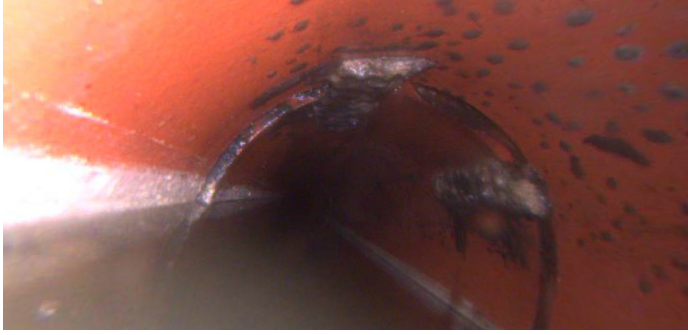
Code:	MSA
Description:	Abandoned Survey
Distance (ft):	6.4
Structural Grade:	0
O&M Grade:	0
Clock Start/From:	
Clock To:	
1st Value:	
2nd Value:	
Value Percent:	
Continuous Index:	
Within 8" of Joint:	NO
Remarks:	overturned
