## Profile/Photo Observation Report

Street:	<b>W 38TH AVE</b>	Flow Control:	<b>Not Controlled</b>
City:	<b>Hobart, IN</b>	Year Renewed:	
Location:	<b>Light Highway</b>	Tape/Media #:	
Purpose:	<b>Not Known</b>	Dia/Height:	<b>12"</b>
Use:	<b>Sanitary</b>	Material:	<b>VCP</b>
Drain Area:	<b>NA</b>	Lining:	
Category:	<b>NA</b>		
Comment:

Location Details:		Direction of Survey:	<b>Downstream</b>
US MH:	<b>M-103-031</b>	DS MH:	<b>M-203-060</b>
		Total Length Surveyed (ft):	<b>12.5</b>

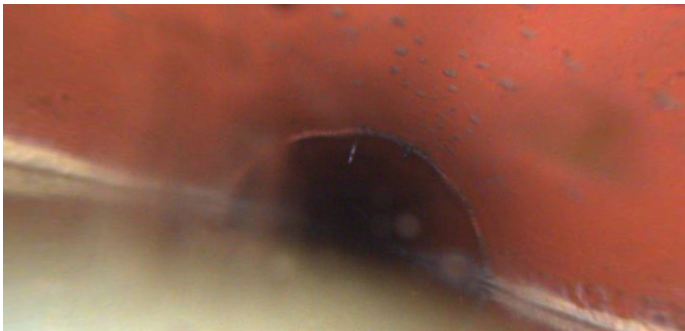
Code: **AMH**  
Description: **Manhole**

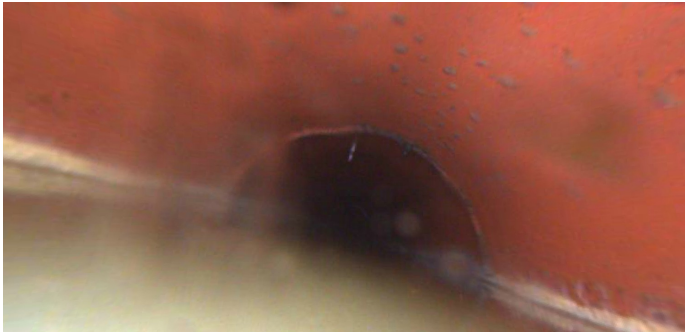
Code:	<b>MWL</b>
Description:	<b>Water Level</b>

Distance (ft):	<b>.0</b>
Structural Grade:	<b>0</b>
O&M Grade:	<b>0</b>
Clock Start/From:	
Clock To:	
1st Value:	
2nd Value:	
Value Percent:	<b>40.000</b>
Continuous Index:	
Within 8" of Joint:	<b>NO</b>
Remarks:

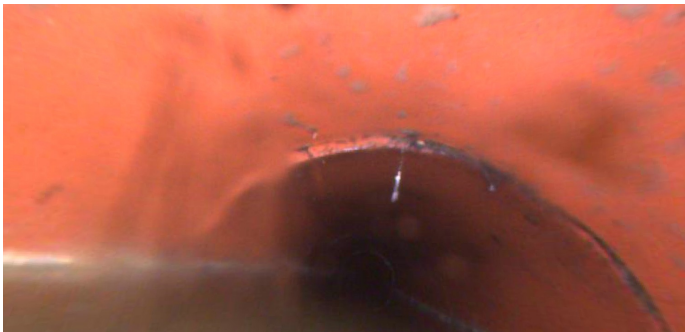
Code:	<b>RFJ</b>
Description:	<b>Roots Fine Joint</b>

Distance (ft):	<b>1.5</b>
Structural Grade:	<b>0</b>
O&M Grade:	<b>1</b>
Clock Start/From:	<b>12</b>
Clock To:	
1st Value:	
2nd Value:	
Value Percent:	
Continuous Index:	
Within 8" of Joint:	<b>YES</b>
Remarks:

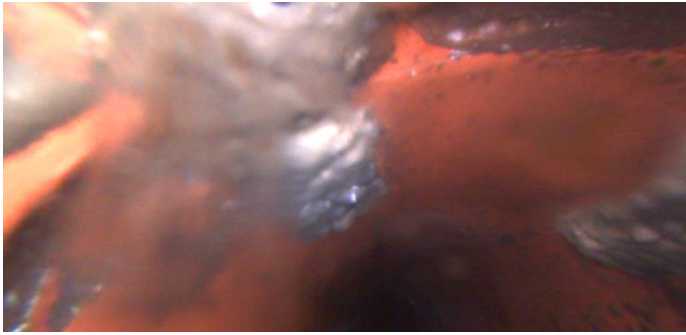
Code: **DAGS**  
Description: **Deposits Attached Grease**

Distance (ft): **6.8**  
Structural Grade: **0**  
O&M Grade: **2**  
Clock Start/From: **10**  
Clock To: **2**  
1st Value:  
2nd Value:  
Value Percent: **5.000**  
Continuous Index:  
Within 8" of Joint: **YES**  
Remarks:

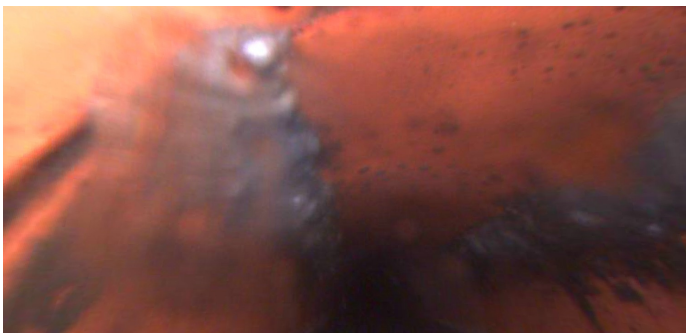
Code: **DAGS**  
Description: **Deposits Attached Grease**

Distance (ft): **11.8**  
Structural Grade: **0**  
O&M Grade: **2**  
Clock Start/From: **11**  
Clock To: **1**  
1st Value:  
2nd Value:  
Value Percent: **5.000**  
Continuous Index:  
Within 8" of Joint: **YES**  
Remarks:

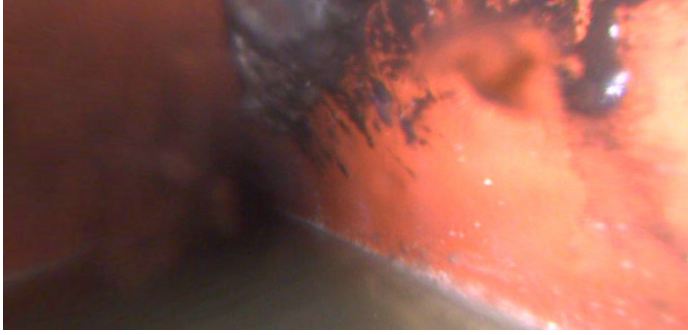
Code:	<b>MSA</b>
Description:	<b>Abandoned Survey</b>
Distance (ft):	<b>12.5</b>
Structural Grade:	<b>0</b>
O&M Grade:	<b>0</b>
Clock Start/From:	
Clock To:	
1st Value:	
2nd Value:	
Value Percent:	
Continuous Index:	
Within 8" of Joint:	<b>NO</b>
Remarks:	<b>debris under water</b>
