Profile/Photo Observation Report

Date:	04/25/2018	Weather:		Coding:	PACP 6.0
Pipe Length (ft):	.0	Owner:	NA	Pre Clean:	Not Known
P.O.#:		Surveyor:	Jen Costello	PSR:	P-203-060-031
Customer:		Clean Date:	01/01/1900	Shape:	C

Location Details:		Direction of Survey:	Downstream
US MH:	M-103-031	DS MH:	M-203-060
		Total Length Surveyed (ft):	338.6

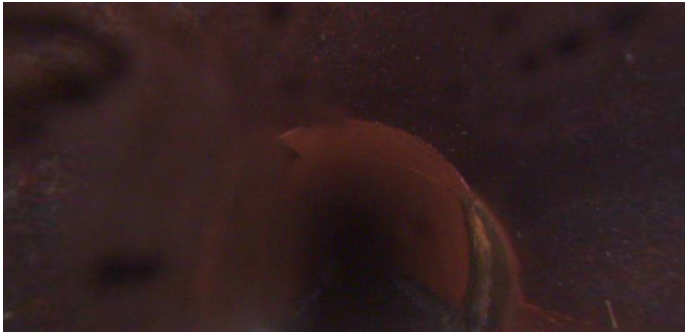
Code:	MWL
Description:	Water Level

Distance (ft):	.0
Structural Grade:	0
O&M Grade:	0
Clock Start/From:	
Clock To:	
1st Value:	
2nd Value:	
Value Percent:	10.000
Continuous Index:	
Within 8" of Joint:	NO
Remarks:

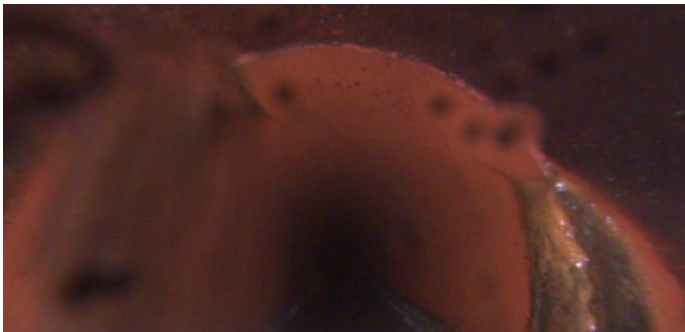
Code:	IW
Description:	Infil Weeper

Distance (ft):	1.6
Structural Grade:	0
O&M Grade:	2
Clock Start/From:	8
Clock To:	4
1st Value:	
2nd Value:	
Value Percent:	
Continuous Index:	
Within 8" of Joint:	YES
Remarks:

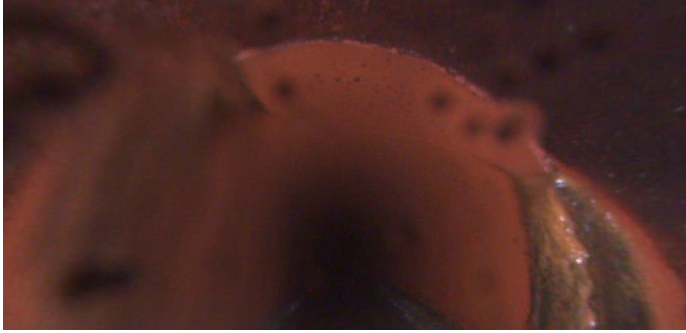
Code: **FC**
Description: **Fracture Circumferential**

Distance (ft): **1.6**
Structural Grade: **2**
O&M Grade: **0**
Clock Start/From: **12**
Clock To: **2**
1st Value:
2nd Value:
Value Percent:
Continuous Index:
Within 8" of Joint: **YES**
Remarks:

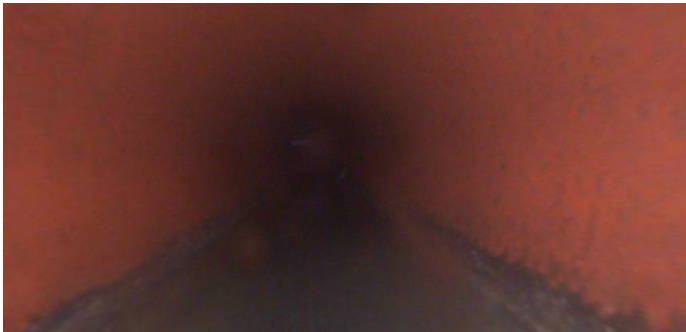
Code: **MGO**
Description: **General Observation**

Distance (ft): **6.4**
Structural Grade: **0**
O&M Grade: **0**
Clock Start/From:
Clock To:
1st Value:
2nd Value:
Value Percent:
Continuous Index:
Within 8" of Joint: **NO**
Remarks: **REAR CAMERA**

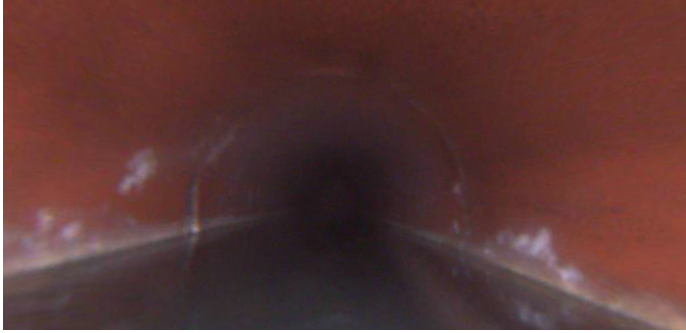
Code: **DAGS**
Description: **Deposits Attached Grease**

Distance (ft): **144.2**
Structural Grade: **0**
O&M Grade: **2**
Clock Start/From: **8**
Clock To: **4**
1st Value:
2nd Value:
Value Percent: **5.000**
Continuous Index: **S01**
Within 8" of Joint: **NO**
Remarks:

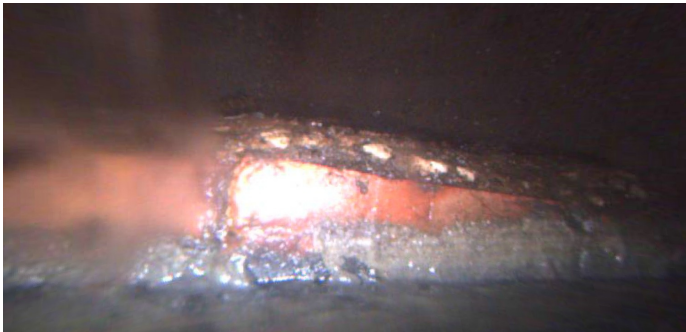
Code: **DAGS**
Description: **Deposits Attached Grease**

Distance (ft): **338.6**
Structural Grade: **0**
O&M Grade: **2**
Clock Start/From: **8**
Clock To: **4**
1st Value:
2nd Value:
Value Percent: **5.000**
Continuous Index: **F01**
Within 8" of Joint: **NO**
Remarks:

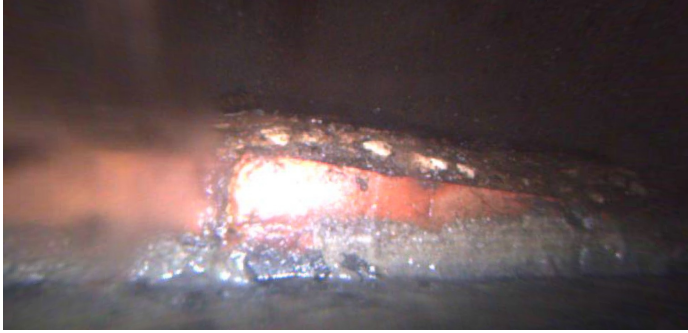
Code:	AMH
Description:	Manhole
Distance (ft):	338.6
Structural Grade:	0
O&M Grade:	0
Clock Start/From:	
Clock To:	
1st Value:	
2nd Value:	
Value Percent:	
Continuous Index:	
Within 8" of Joint:	NO
Remarks:	M-203-060
