Profile/Photo Observation Report

Street:	Summerlin	Flow Control:	Not Controlled
City:	Hobart, IN	Year Renewed:	
Location:	Light Highway	Tape/Media #:	
Purpose:	Not Known	Dia/Height:	12"
Use:	Sanitary	Material:	VCP
Drain Area:	NA	Lining:	
Category:	NA		
Comment:

Location Details:		Direction of Survey:	Downstream
US MH:	M-103-031	DS MH:	M-203-060
		Total Length Surveyed (ft):	338.6

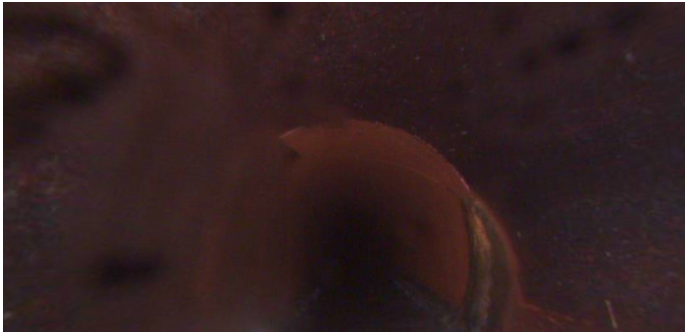
Code:	MWL
Description:	Water Level

Distance (ft):	.0
Structural Grade:	0
O&M Grade:	0
Clock Start/From:	
Clock To:	
1st Value:	
2nd Value:	
Value Percent:	10.000
Continuous Index:	
Within 8" of Joint:	NO
Remarks:

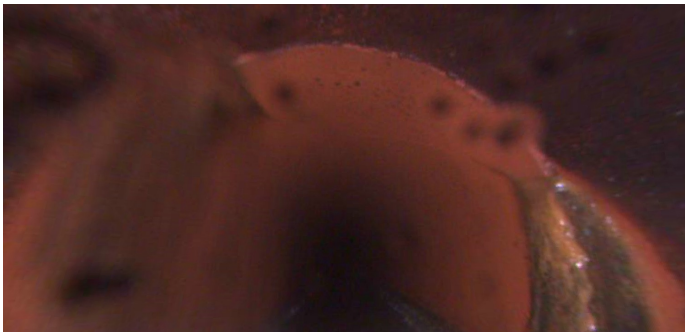
Code:	IW
Description:	Infil Weeper

Distance (ft):	1.6
Structural Grade:	0
O&M Grade:	2
Clock Start/From:	8
Clock To:	4
1st Value:	
2nd Value:	
Value Percent:	
Continuous Index:	
Within 8" of Joint:	YES
Remarks:

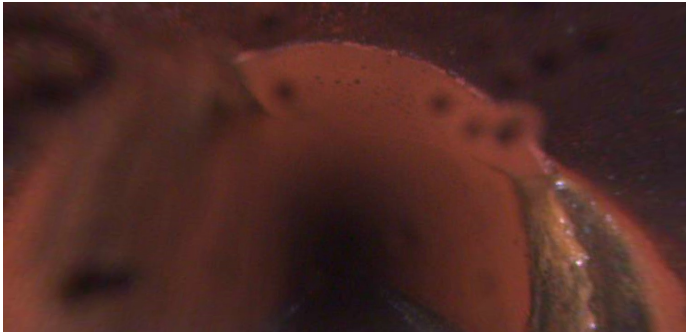
Code: **FC**
Description: **Fracture Circumferential**

Distance (ft): **1.6**
Structural Grade: **2**
O&M Grade: **0**
Clock Start/From: **12**
Clock To: **2**
1st Value:
2nd Value:
Value Percent:
Continuous Index:
Within 8" of Joint: **YES**
Remarks:

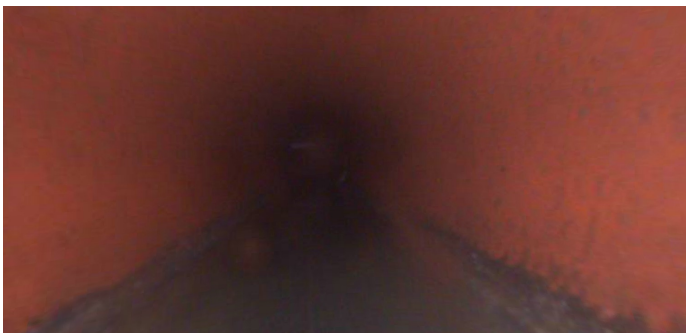
Code: **MGO**
Description: **General Observation**

Distance (ft): **6.4**
Structural Grade: **0**
O&M Grade: **0**
Clock Start/From:
Clock To:
1st Value:
2nd Value:
Value Percent:
Continuous Index:
Within 8" of Joint: **NO**
Remarks: **REAR CAMERA**

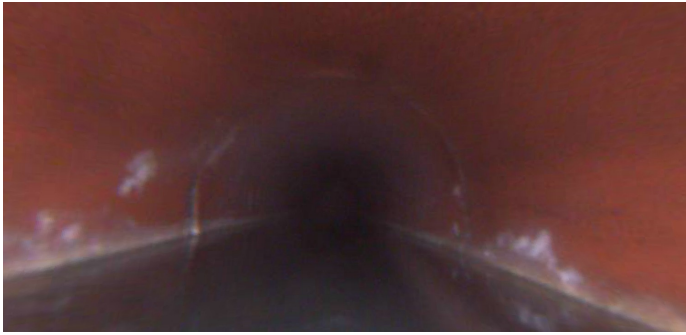
Code: **DAGS**
Description: **Deposits Attached Grease**

Distance (ft): **144.2**
Structural Grade: **0**
O&M Grade: **2**
Clock Start/From: **8**
Clock To: **4**
1st Value:
2nd Value:
Value Percent: **5.000**
Continuous Index: **S01**
Within 8" of Joint: **NO**
Remarks:

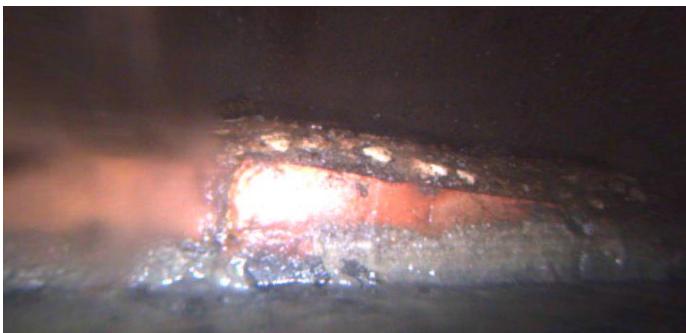
Code: **DAGS**
Description: **Deposits Attached Grease**

Distance (ft): **338.6**
Structural Grade: **0**
O&M Grade: **2**
Clock Start/From: **8**
Clock To: **4**
1st Value:
2nd Value:
Value Percent: **5.000**
Continuous Index: **F01**
Within 8" of Joint: **NO**
Remarks:

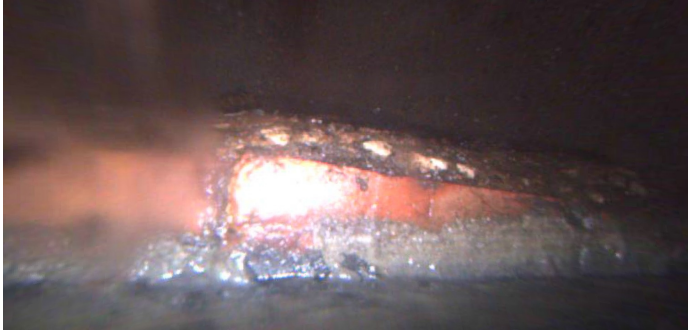
Code:	AMH
Description:	Manhole
Distance (ft):	338.6
Structural Grade:	0
O&M Grade:	0
Clock Start/From:	
Clock To:	
1st Value:	
2nd Value:	
Value Percent:	
Continuous Index:	
Within 8" of Joint:	NO
Remarks:	M-203-060
